Site DC48B: Salmon River

Date Assessed: 26/08/04

Road Crossing: Bridge (wooden), 14.4m

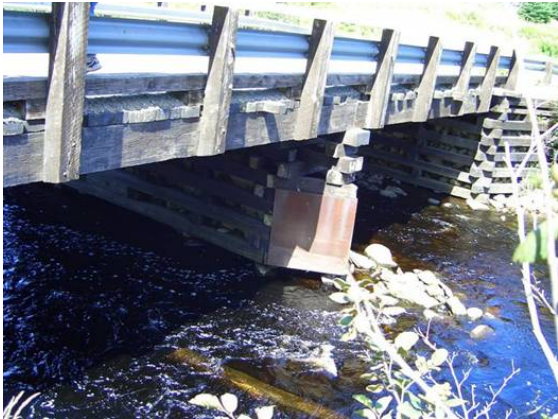
Downstream of Crossing

Figure 1. Downstream view of crossing

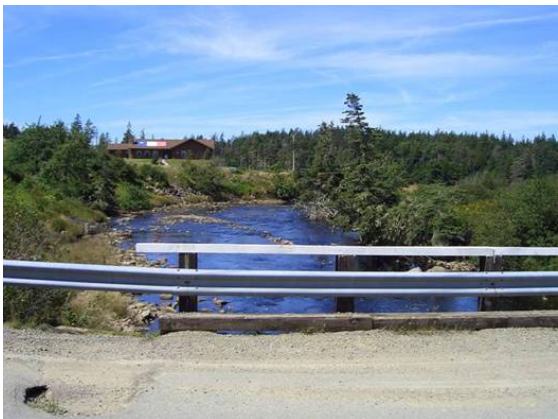
Creek: 18m wide, straight flow. Stream is widening due to erosion, banks are very unstable, trees bordering river are falling in.

Figure 2. Downstream of crossing showing bank erosion and collapse of trees into river

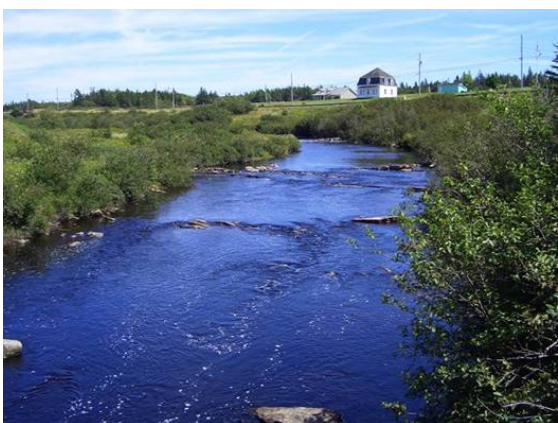
Creek: Unstable banks, turbulent flow, not very tidal at this point due to elevation.

Figure 3. Upstream of crossing
