**Site DC6C:** Winchester Point (Railway)

**Date Assessed:** 30/11/04

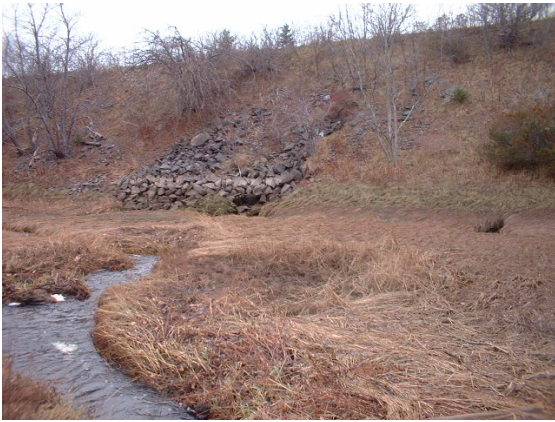
**Crossing Condition:** Complete structure failure

**Comments:** This site needs to be excavated and the culvert beneath replaced. Since the culvert is completely covered it is not possible to tell what the size of the opening presently is. There is some water seepage through the rock/debris that has collapse around the crossing. Upstream DC7C culvert crosses Route 1 and should be considered at the same time as this crossing. Further upstream there is a drainage area and culvert for highway 101.

**Figure 1.** Upstream view of crossing

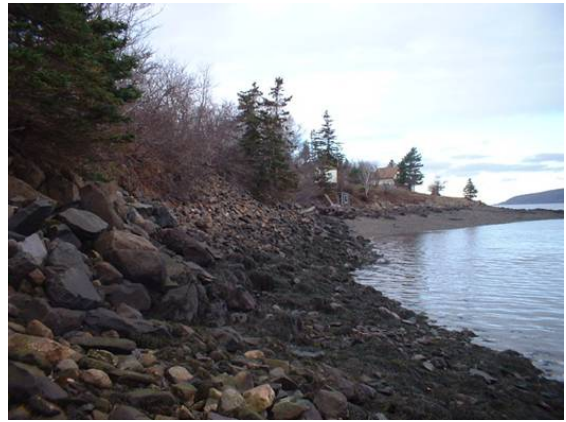
**Figure 2.** Downstream view of crossing
