**Site DC7C:** Winchester Point

**Date Assessed:** 30/11/04

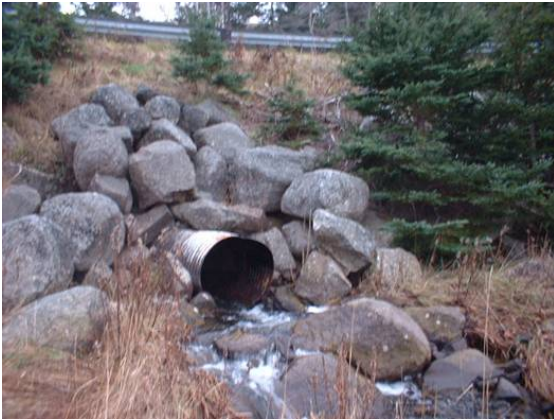
**Crossing Condition:** Intact but rusted

**Figure 1.** Downstream view of culvert  
Area is wooded

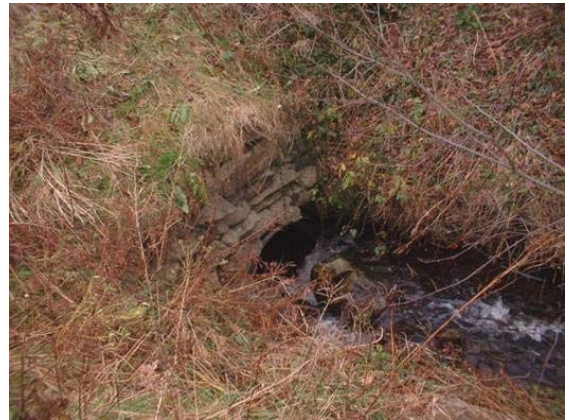
**Creek:** 2m wide, channel flows towards highway 101 off ramp which has a drainage culvert.

**Figure 2.** Upstream view of crossing.

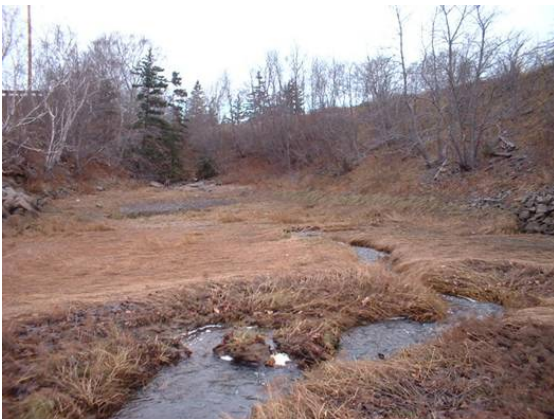
**Creek:** 1m wide, large boulders eroding into creek. Channel flows towards crossing DC6C which is completely blocked by rock, however some water is seeping through.

**Figure 3.** Downstream of crossing.

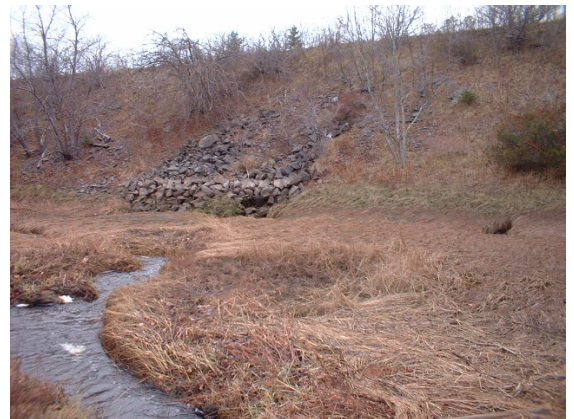
**Comments:** Should the downstream restriction (DC6C) be opened this culvert would need to be widened as it may then pose as a restriction to tidal exchange. In its current state this culvert is serving as drainage from the upland and from highway 101 culvert.

**Figure 4.** Downstream view of crossing DC6C,  
completely obstructed by rock.
