Site N15B: Walton River

Date Assessed: 08/05/01

Road Crossing: Bridge (concrete/steel)

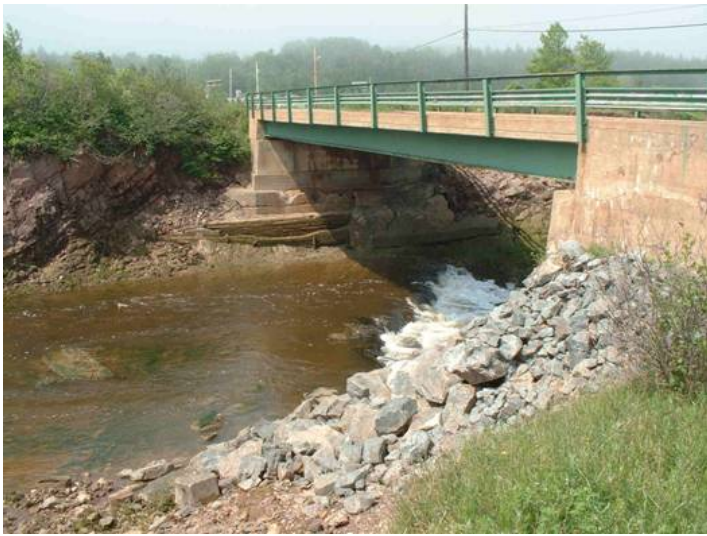
Figure 1. Upstream view of crossing

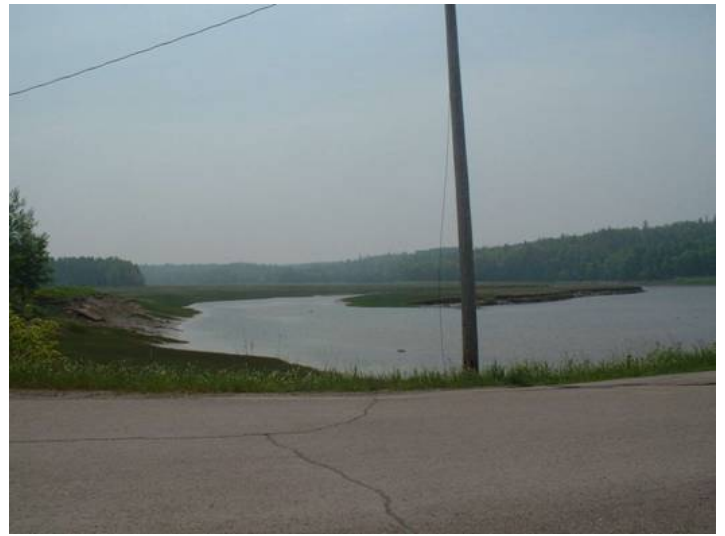
Figure 2. Upstream of crossing

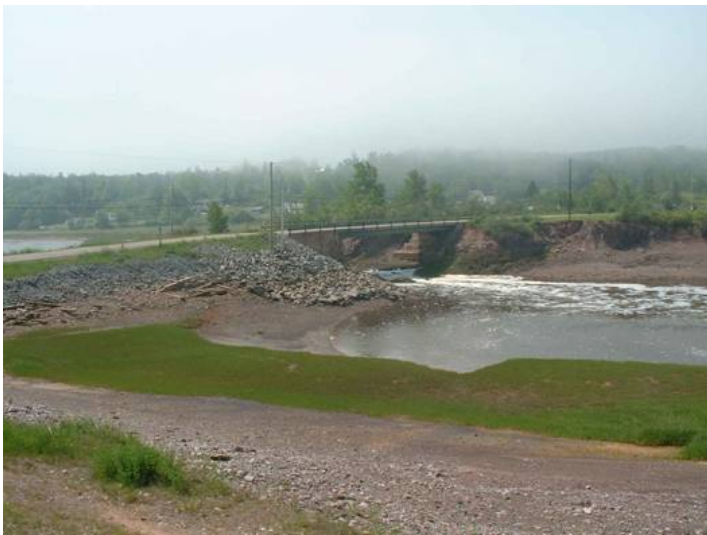
Figure 3. Downstream view of crossing

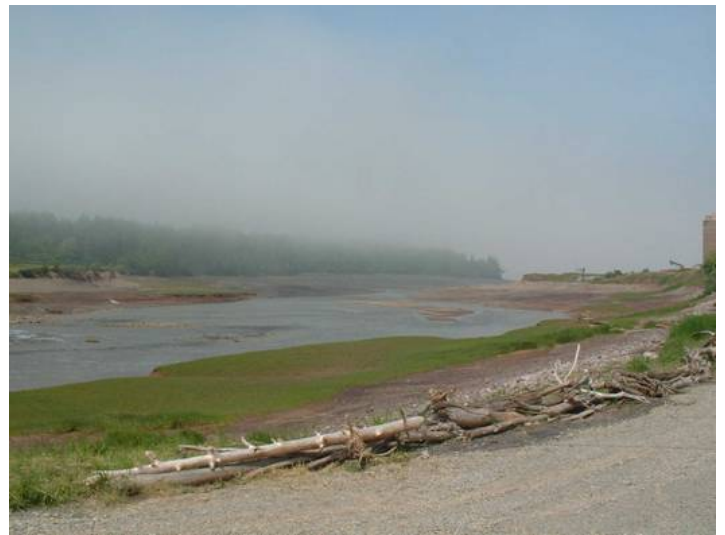
Figure 4. Upstream of crossing
