Site N16C: Rainy Cove**Date Assessed:** 15/05/01

Crossing Status: Complete restriction

Road Crossing: Culvert (concrete)

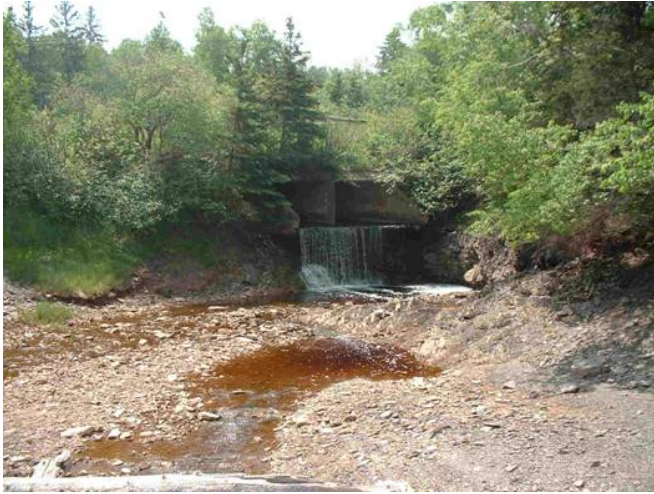
Creek: 30m wide, some slack water, turbulent flow and eddies in areas, scour pools.

Figure 1. Downstream view of crossing

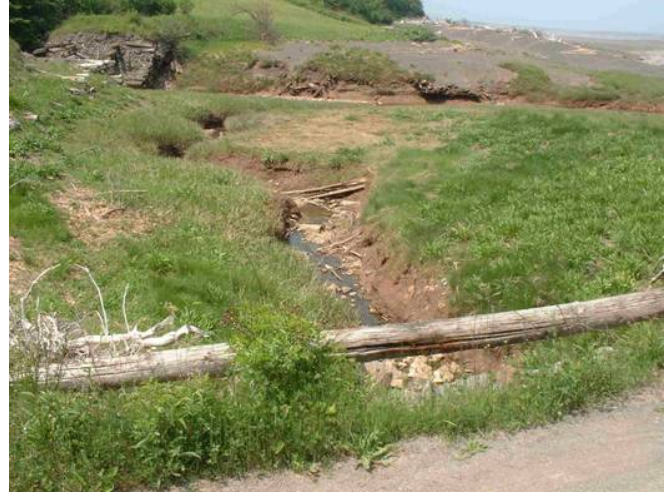
Figure 2. Downstream of crossing

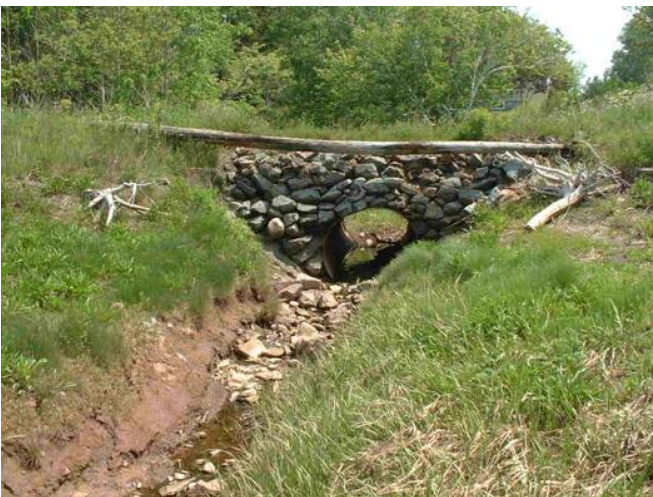
Land: Salt marsh and beach. Remnants of old bridge restricting flow.

Figure 3. Remnants of old bridge downstream of crossing causing some further restriction

Comments: Culvert should be lower to improve flow upstream. The downstream bridge should be removed if it is no longer in use.

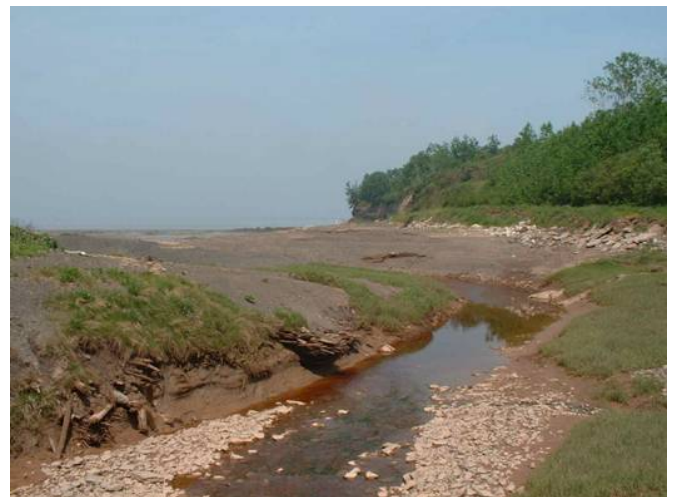
Figure 4. Downstream of crossing

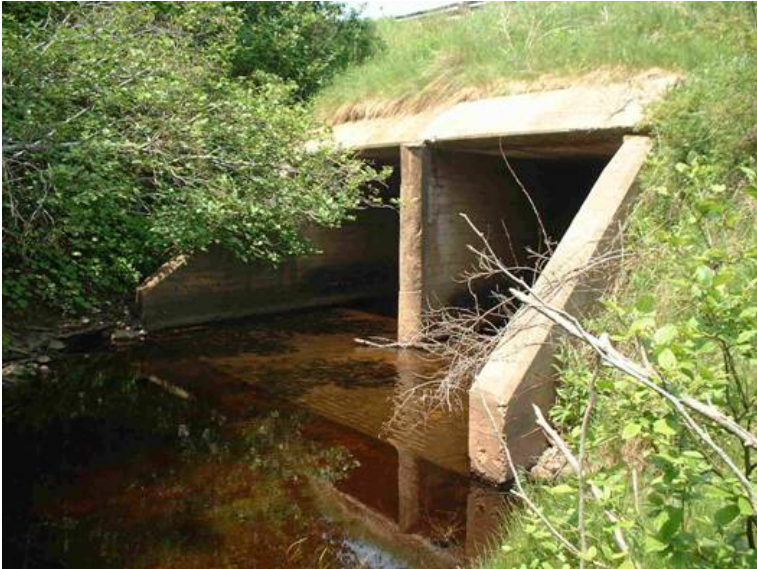
Creek: 10m wide, smooth flow, slack water

Figure 5. Upstream view of crossing

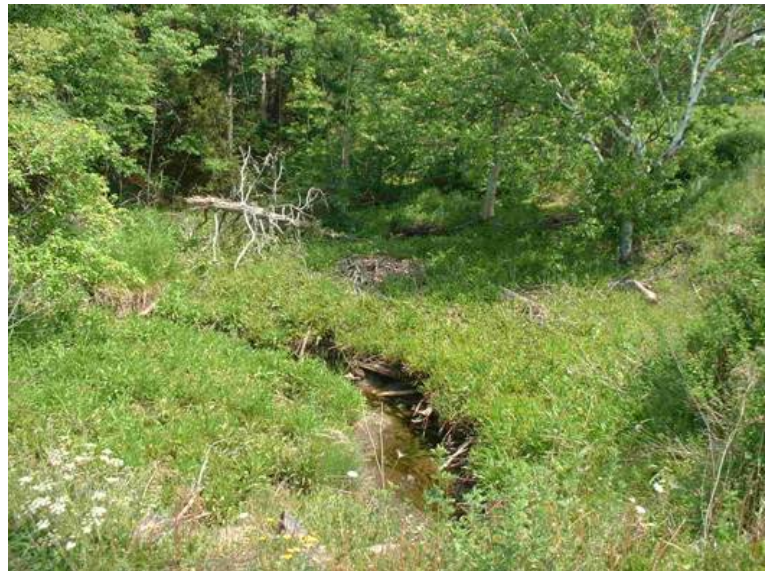
Figure 6. Upstream of crossing
