Site N21C: Cheverie Creek

Date Assessed: 15/05/01

Road Crossing: Culvert (wooden box)

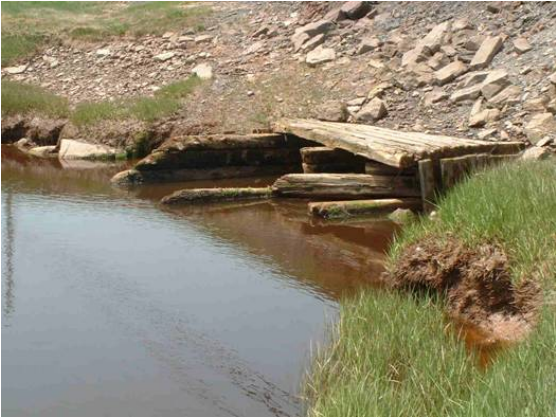
Figure 1. Upstream view of crossing

Comments: Culvert should be replaced with a larger opening.

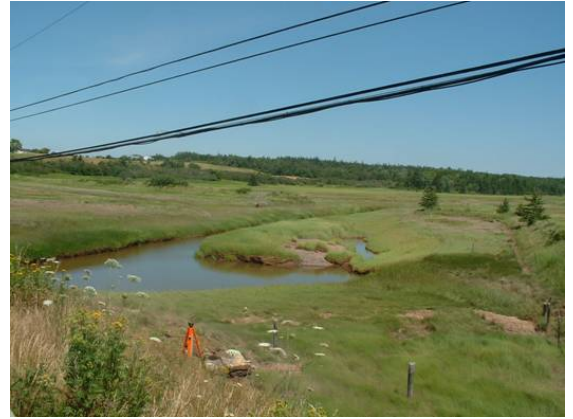
Creek: 6m wide, large scour pool, bank slumping, divergent channel

Figure 2. Upstream of crossing

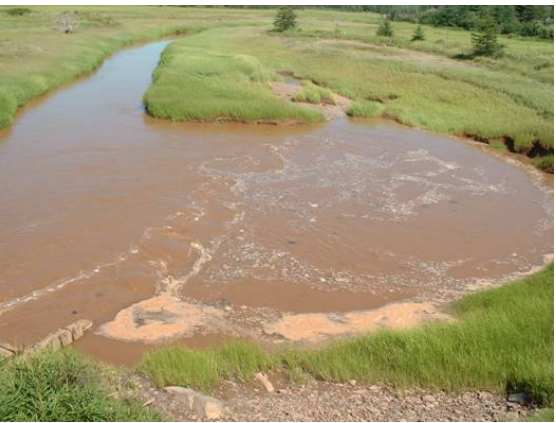
Figure 3. Upstream scour pool

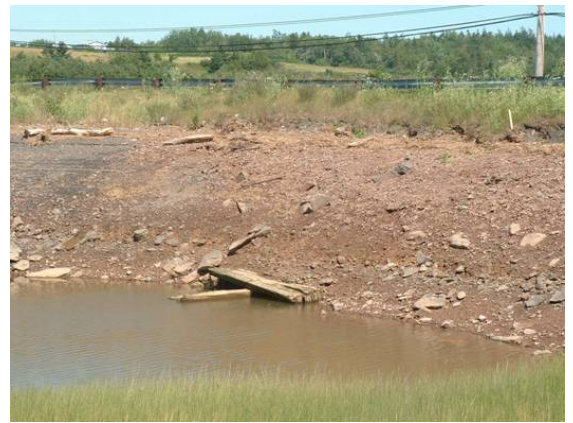
Figure 4. Downstream view of crossing

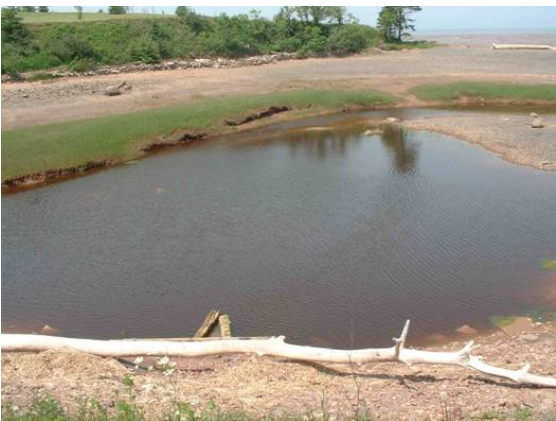
Creek: Large scour pool causing a whirl pool at high tide, opens onto beach. Channel is divergent from original path, bank slumping

Figure 5. Downstream scour pool

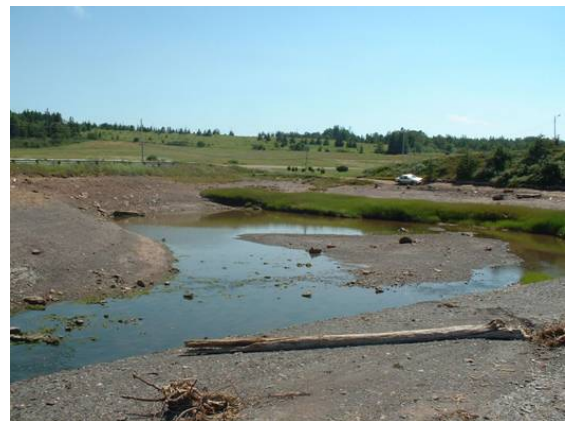
Figure 6. Downstream of crossing
