Site N3B: Maitland

Date Assessed: 08/05/01

Crossing Status: Partial restriction

Road Crossing: Bridge (wooden)

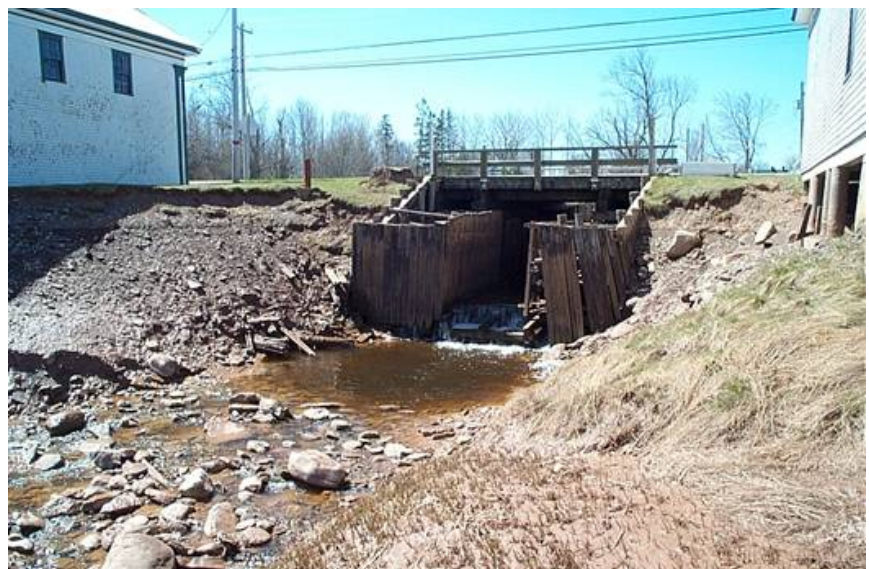
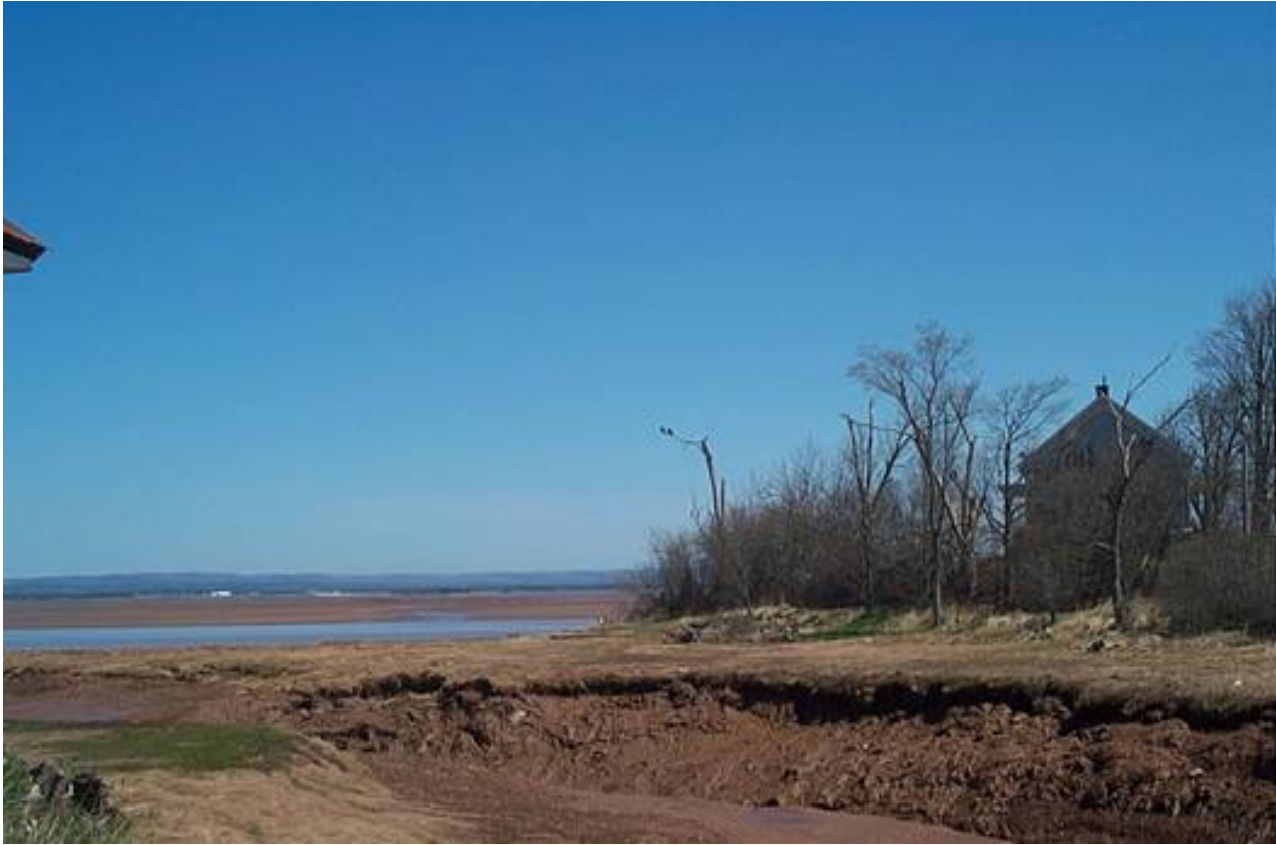
Creek: Turbulent flow, bank slumping and scour pool.

Figure 2. Downstream of crossing
