Site HCMB 11B: Kennetcook River (Hwy 215)

Date Assessed: 04/09/03,
05/12/03

Crossing Status: No restriction

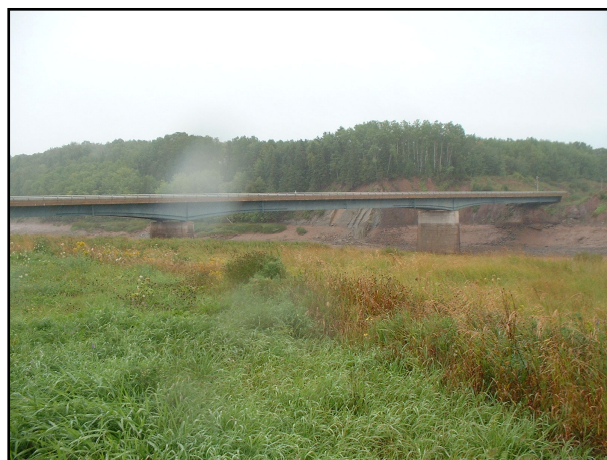
Crossing Condition:
Good condition, original design intact.

Comments: Bridge stretches bank to bank across river with two support structures within the river channel. When replacement/repair is needed, maintain the size of the opening. The dykelands along north side of river near crossing continue to be actively farmed, however small sections of dyked marshes upstream are no longer being farmed and there may be opportunities or salt marsh restoration.

Figure 1: View of the bridge from downstream standing on the dyke. The cliffs on the south side visible.
