**Site HCMB 13C:** Miller Creek**Date Assessed:** 04/09/03,  
05/12/03**GPS Coordinates:** N 45° 00' 36''  
W 64° 03' 55''**Crossing Status:** Partial restriction.**Road Crossing:** Two 1.3m wide concrete culverts.**Crossing Condition:** Crossings appear to be new, or recently maintained, evidence of recent work on marsh surface and roadside.**Restriction Indicators:**

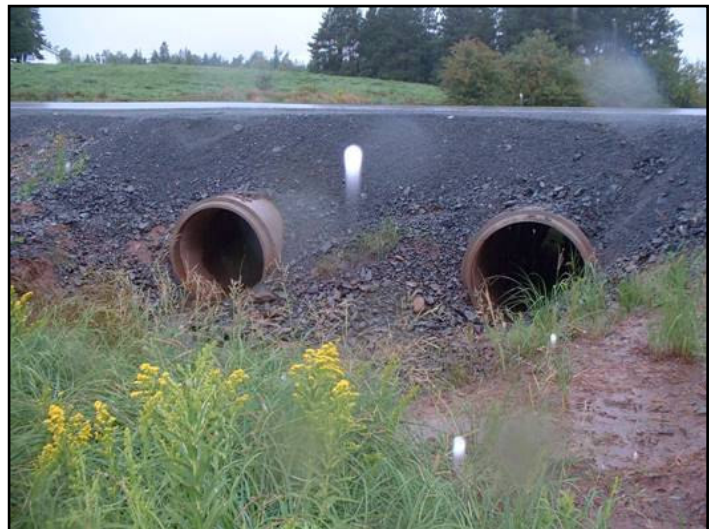
**Figure 2:** Downstream end of culverts showing a divergent channel, evidence of recent work and a new shoulder.

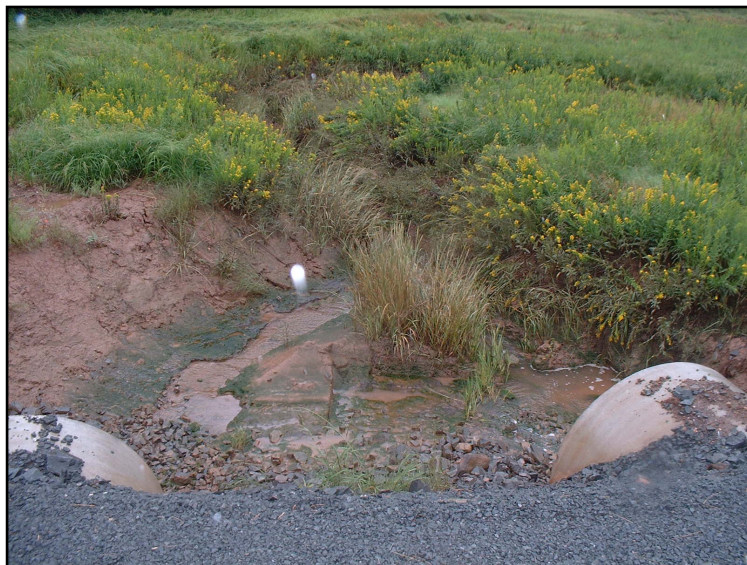
**Figure 3:** Wetland vegetation downstream of crossing
