Site HCMB 14C: Avondale**Date Assessed:** 04/09/03,
05/12/03**GPS Coordinates:** N 45° 01' 21.0''
W 64° 07' 48.5''**Crossing Status:** No restriction.**Road Crossing:** 1.5m round, steel culvert.**Crossing Condition:**

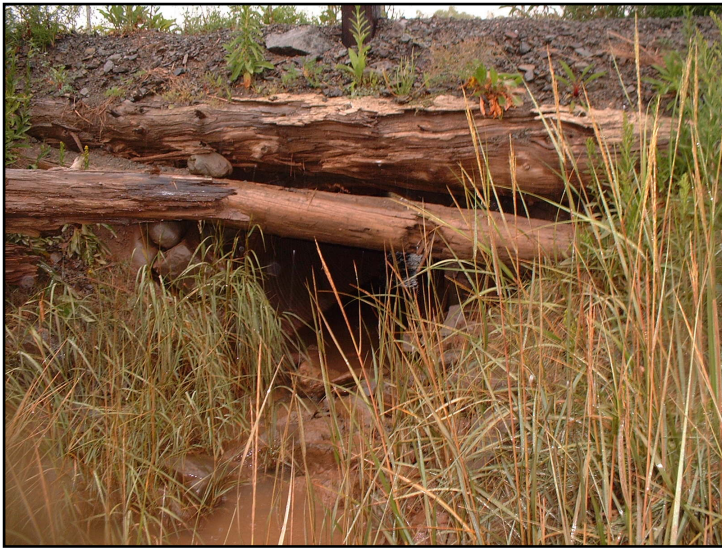
The culvert is in fair condition, but is partially blocked by woody debris on downstream end.

Figure 1: *Old wooden support structures and woody debris partially block downstream end of crossing.*

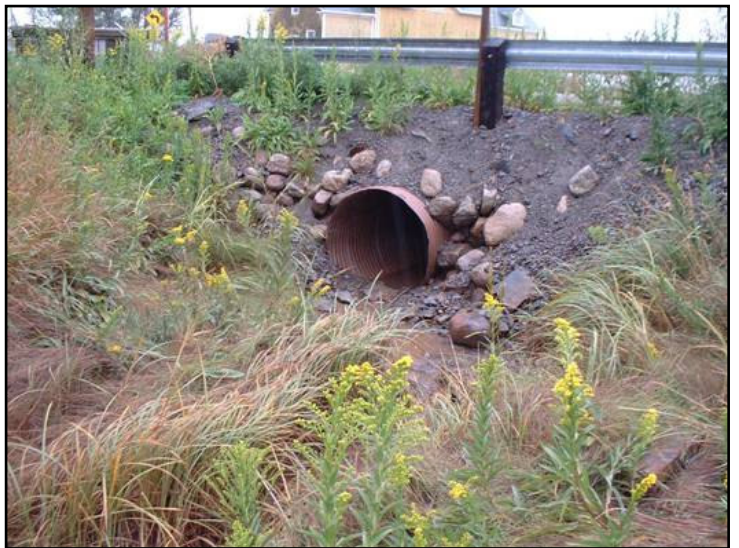
Figure 2: *Downstream of the culvert showing tidal wetland and ship building museum/shop to the left.*
