Site HCMB 15C: Avondale

Date Assessed: 04/09/03,  
05/12/03GPS Coordinates: N 45° 01' 21.0''  
W 64° 07' 47.4''**Crossing Status:** No restriction.**Road Crossing:** Concrete culvert, 0.5m  
in diameter.**Crossing Condition:** Poor to fair  
condition.**Restriction Indicators:** None**Downstream of Crossing****Creek:** Basically a drainage ditch leading  
to a small stream flowing to crossing  
HCMB14C.**Land:** Small wetland area fringed by a  
road and upland woodland.**Upstream of Crossing****Creek:** 0.5m wide with even flow.**Land:** Quick rise in elevation to surrounding agricultural land.**Comments:** Both ends of culvert could benefit from site cleanup but not critical to function. Culvert drains a small wetland area upstream bordered by road and agricultural land.

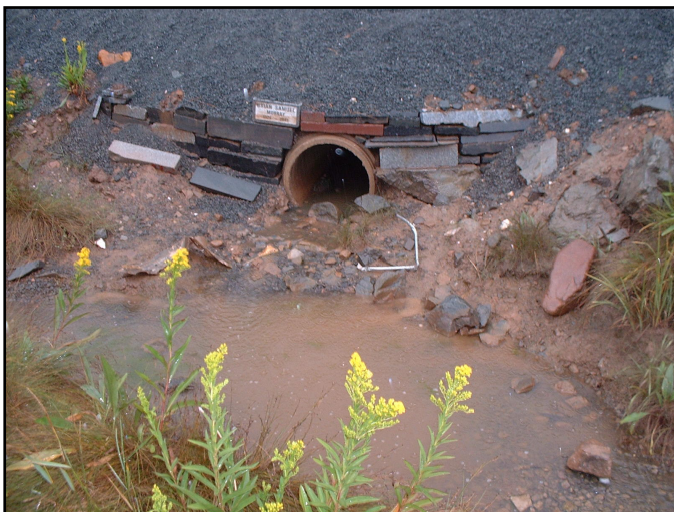
**Figure 1:** Downstream view of the culvert  
with the gravel build up and the pool.

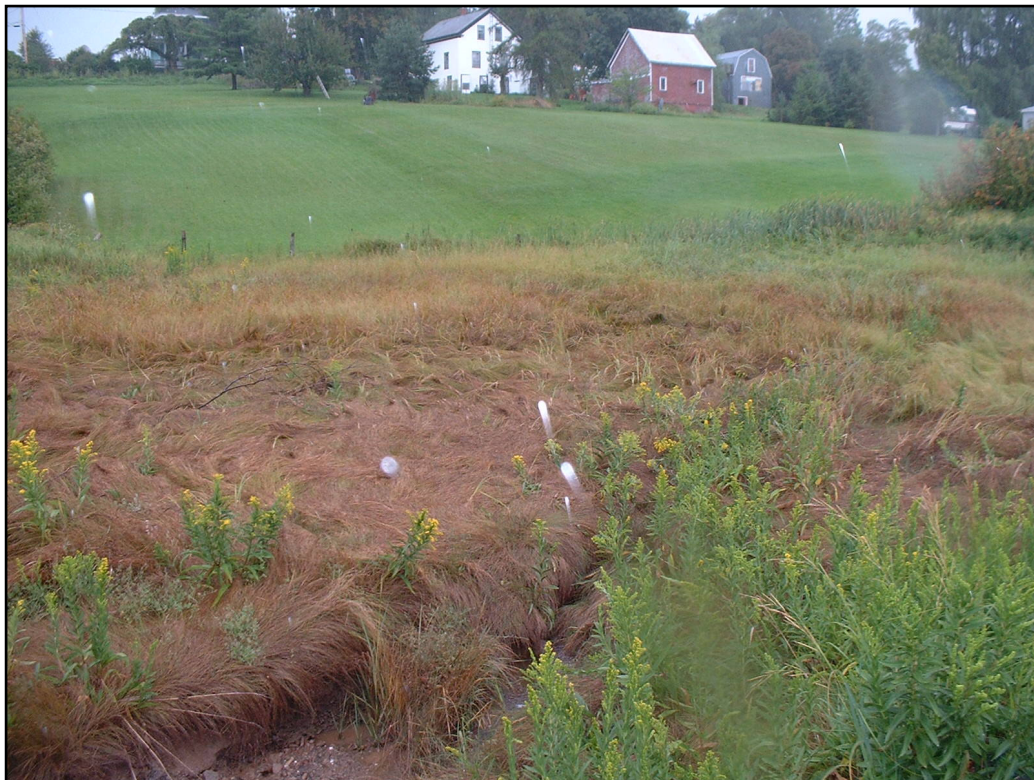
**Figure 2:** *The farm upstream of the culvert and the obvious elevation rise.*
