Site HCMB 16C: Mantua

Date Assessed: 04/09/03,
05/12/03

Road Crossing: Steel culvert with a 0.5m diameter.

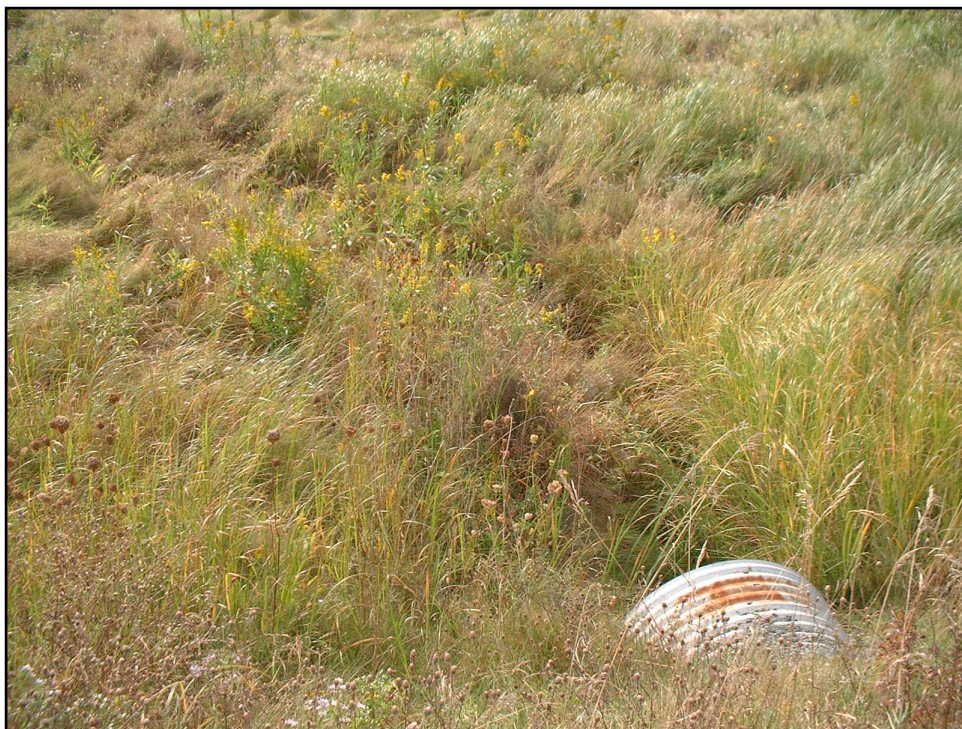
Figure 1: *Downstream end of culvert and wetland surface.*

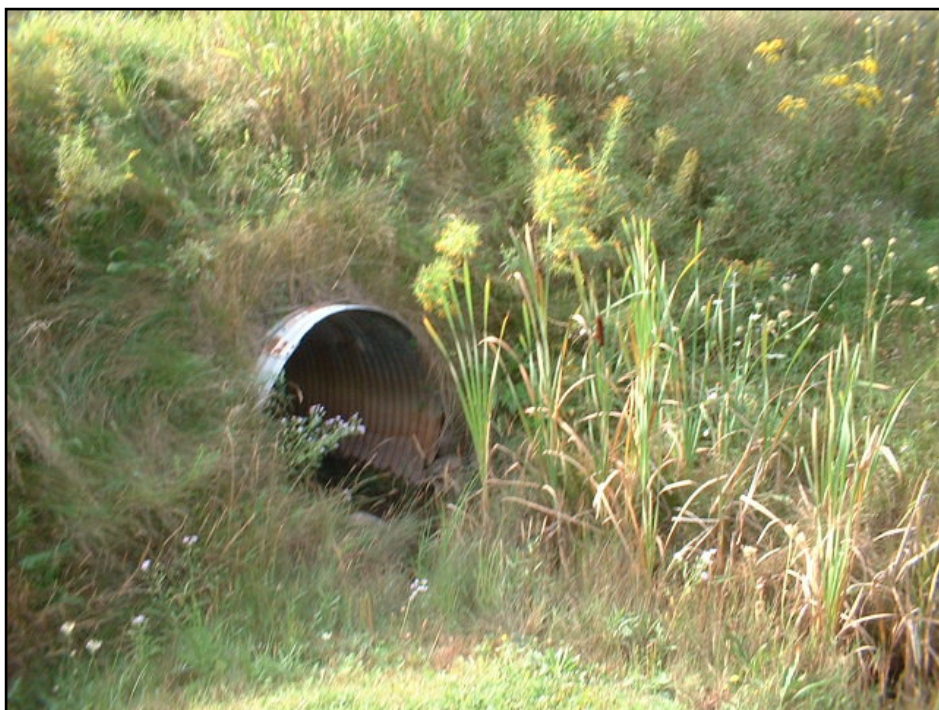
Figure 2: *Upstream of the culvert is fresh with cattails and other freshwater vegetation evident.*
