Site HCMB 19B: St Croix River (Hwy 101)

Date Assessed: 04/09/03, 05/12/03

Crossing Status: No restriction.

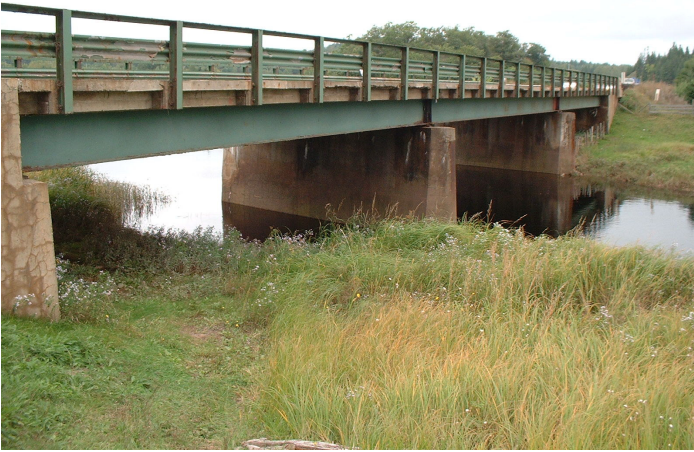
Comments: Large bridge, reaching bank to bank with large support structures in middle of channel. Crossing planned to be replaced by divided highway. When replacing, new crossing should continue non restrictive trend, but with no support structure(s) in the channel. Be conscious of river meander pattern.

**Figure 1.** The large concrete supports don't seem to have an effect creek. Bridge is in good condition.

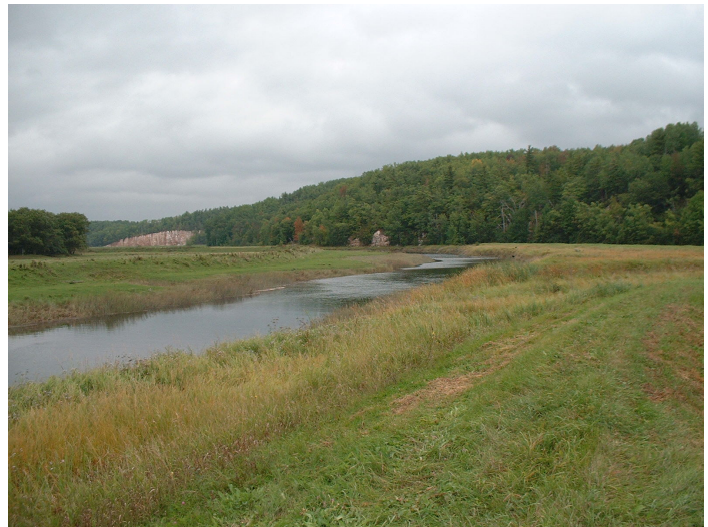
**Figure 2.** The dykes on each side of the creek are apparent. Photo taken looking downstream from the bridge.

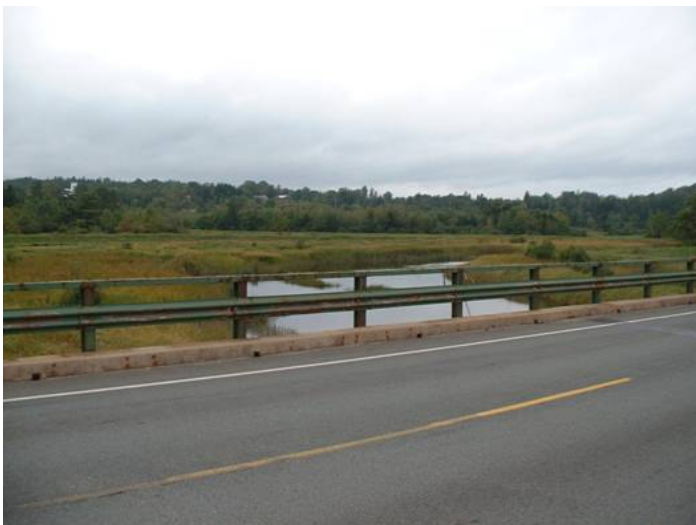
**Figure 3.** Looking upstream from the bridge.
