Site HCMB 1B: Cogmagun River (Hwy 215)**Date Assessed:** 04/09/03,
05/12/03**GPS Coordinates:** N 45° 05' 01''
W 64° 07' 06''**Crossing Status:** No restriction.**Road Crossing:** A 100m long concrete bridge.**Crossing Condition:** Structure is intact.**Restriction Indicators:** None**Downstream of Crossing****Creek:** 80m wide with a smooth flow and no problem with bank erosion.**Land:** One side of the river is bordered by a steep cliff, and the other has dykes running along the bank protecting farmland.**Upstream of Crossing****Creek:** 80m wide with a smooth flow and little evidence of bank erosion, stable channel.**Land:** One side of the river is cliff, and the other has dykes running along the bank protecting farmland.**Comments:** When repair or replacement is needed, maintain the 100m opening.

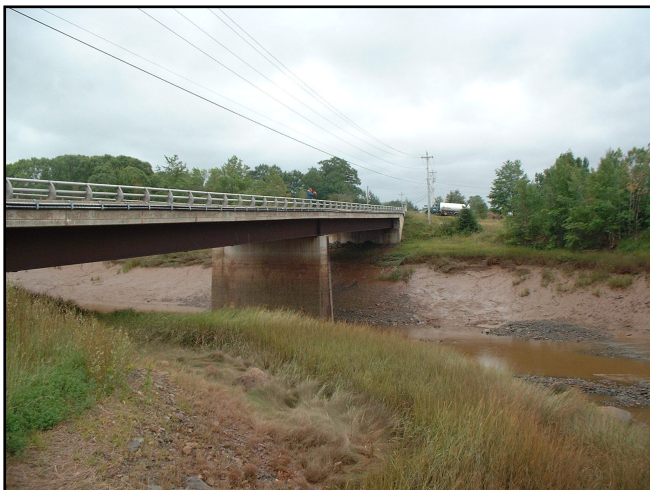
**Figure 1:** *Downstream view of the bridge from the dyke.*
