**Site HCMB 20B:** St. Croix River (dirt road off Hwy 101) **Date Assessed:** 04/09/03,  
05/12/03

**Road Crossing:** 8m long wooden bridge. Does not appear to be DOTPW roadway.

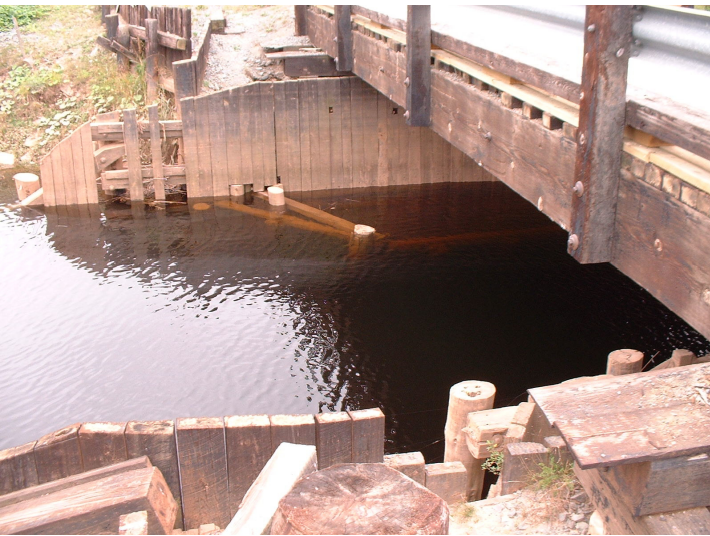
**Figure 1.** Some of the boards from the wooden support structures have come off. Bridge does pinch river channel but not significantly.

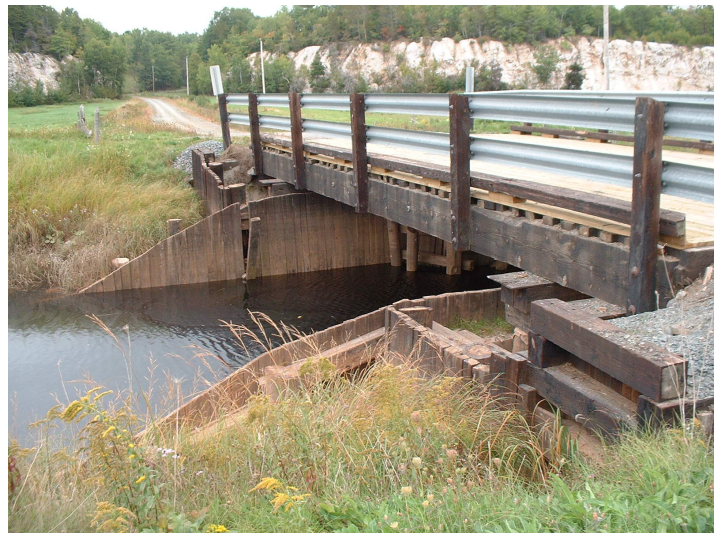
**Figure 2.** The support structures on this side of the bridge are not as damaged as the other side, but there are some loose boards ready to fall off.
