**Site HCMB 22B:** Mt. Denison (Hwy 101)  
05/12/03

**Date Assessed:** 04/09/03,

**Road Crossing:** Steel and concrete bridge on Highway 101, Mt. Denison, crossing river and highway access road.

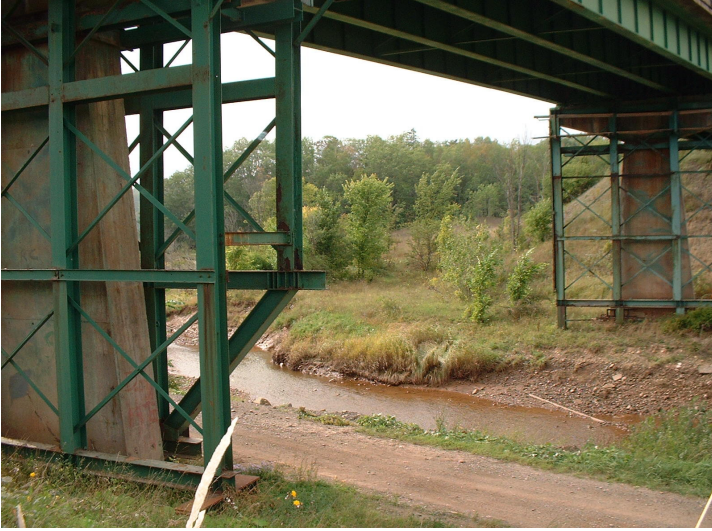
**Crossing Condition:** Intact

**Figure 1.** Photo taken from the road under the bridge.

**Comments:** This is part of the Highway 101 to be twinned. Expansion and/or new structures at this location should maintain opening size and the trend of minimal impact on rivers.

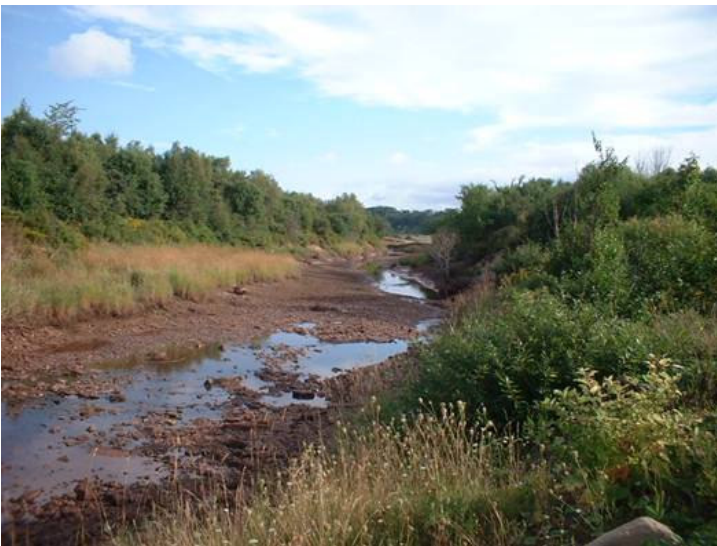
**Figure 2.** Downstream of bridge.
