**Site HCMB 23A:** Hantsport Rail Crossing

**Date Assessed:** 04/09/03,  
05/12/03

**Crossing Status:** Complete restriction.

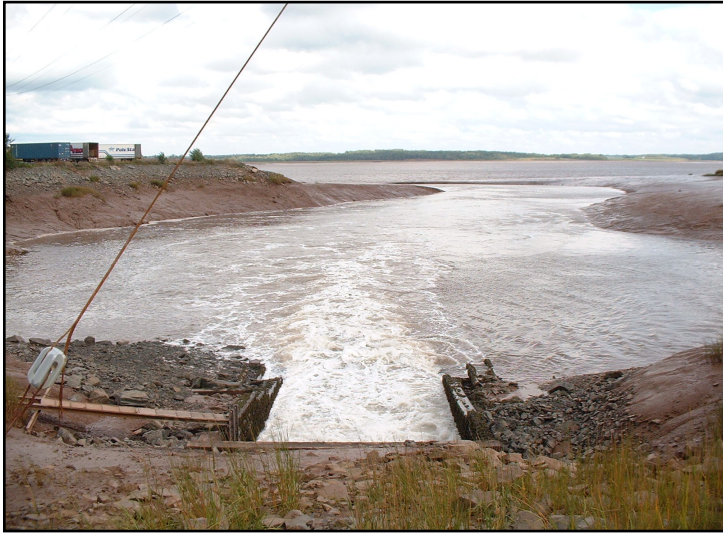
**Figure 1:** The extremely turbulent outflow through the comparatively small culvert.

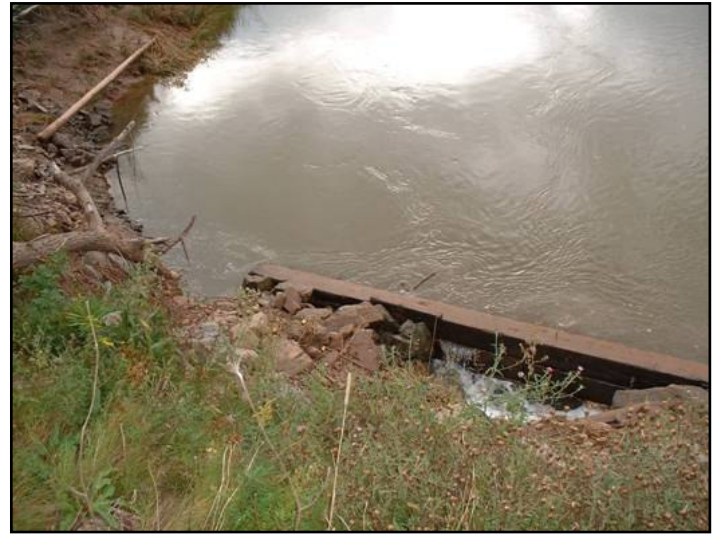
**Figure 2:** Swirling and small eddies as the water is trying to drain through the upstream side of the culvert.

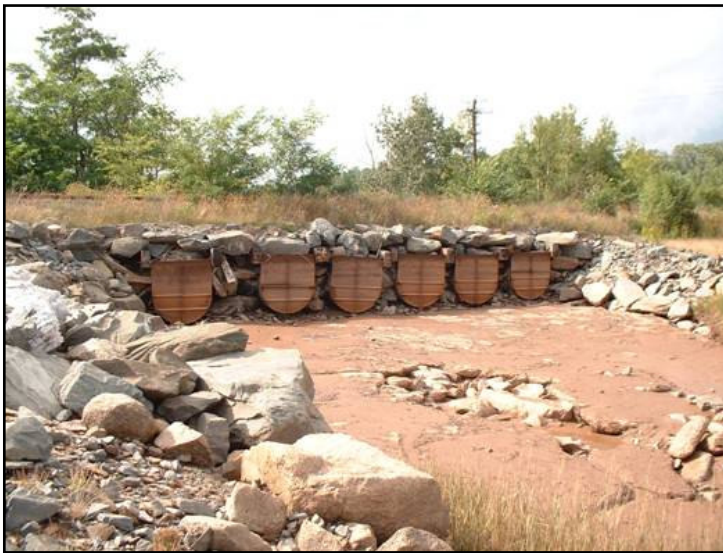
**Figure 3:** Downstream of the six overflow aboiteaux.

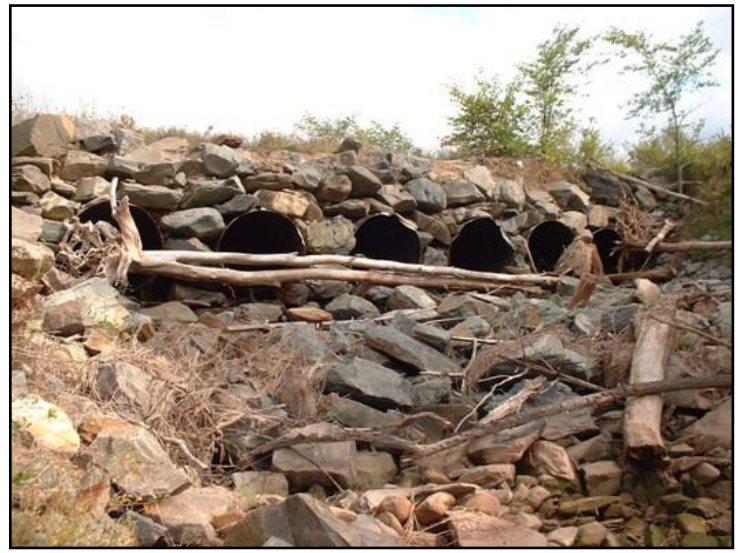
**Figure 4:** Upstream of the six overflow aboiteaux.

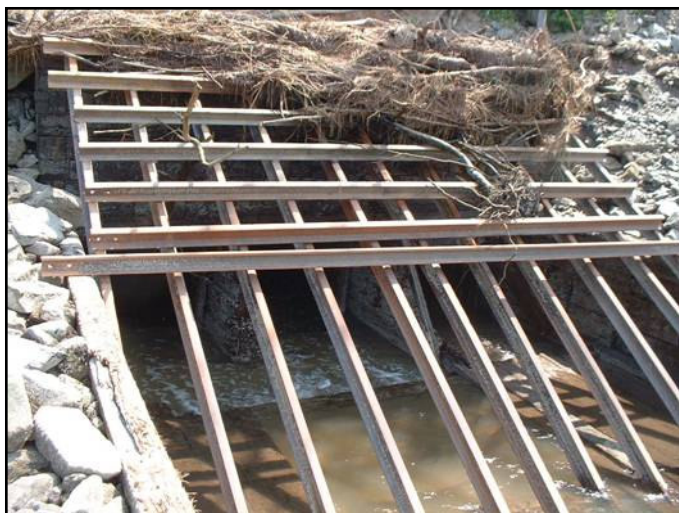
The gates on each chamber of main crossing are dislocated and partially blocking culverts. Spillway is intact.

**Figure 5:** replacement or removal of broken gate would reduce the accumulation of debris

**Comments:** Crossing originally designed to completely restrict tidal flow upstream but since failure of all 3 gates, tidal flow has been reaching upstream. If area is not going to be fully restored by replacement with a larger opening, the existing broken gates should be removed. This would improve hydrology to upland system however a larger opening would substantially improve river condition. Land use upstream of crossing HCMB24B would need to be assessed to determine impact and potential for habitat restoration or agricultural loss.

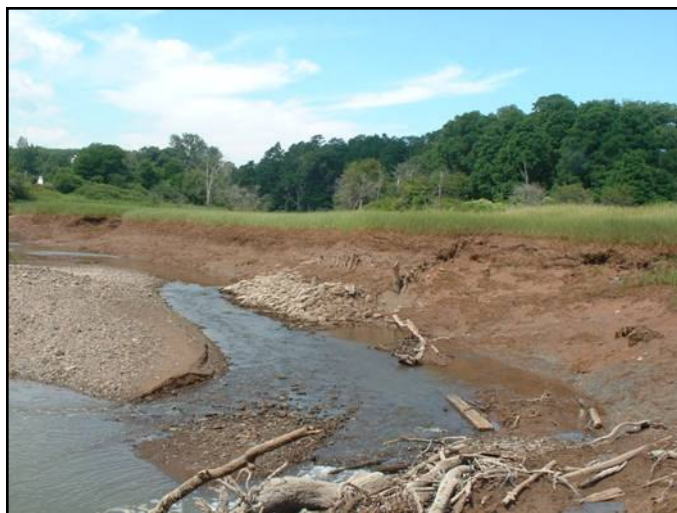
**Figure 6:** Bank scour downstream of aboiteaux

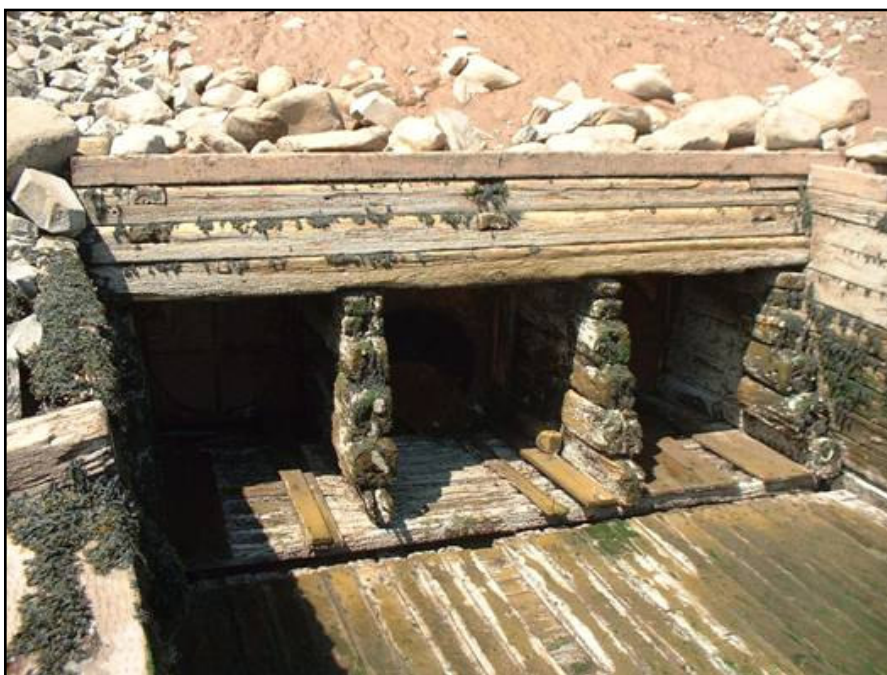
**Figure 7:** close up view of culvert
