**Site HCMB 24B:** Hantsport

**Date Assessed:** 04/09/03, 05/12/03

**Crossing Status:** No restriction  
(upstream of complete restriction)

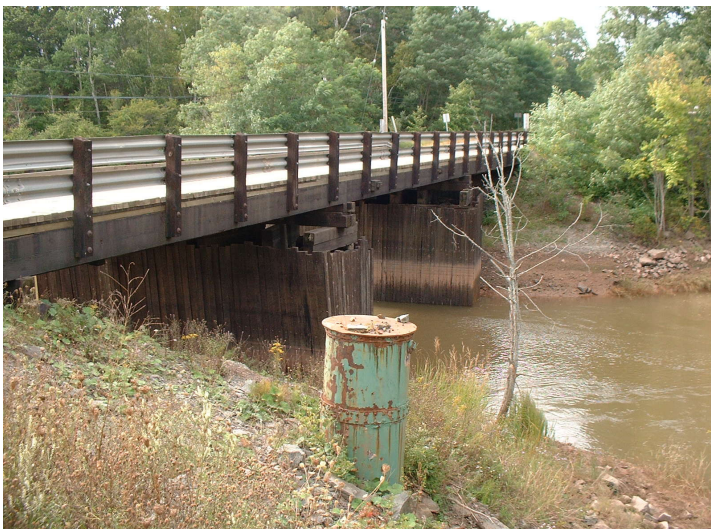
**Crossing Condition:** Structure is intact.

**Figure 1.** Upstream photo of the bridge.

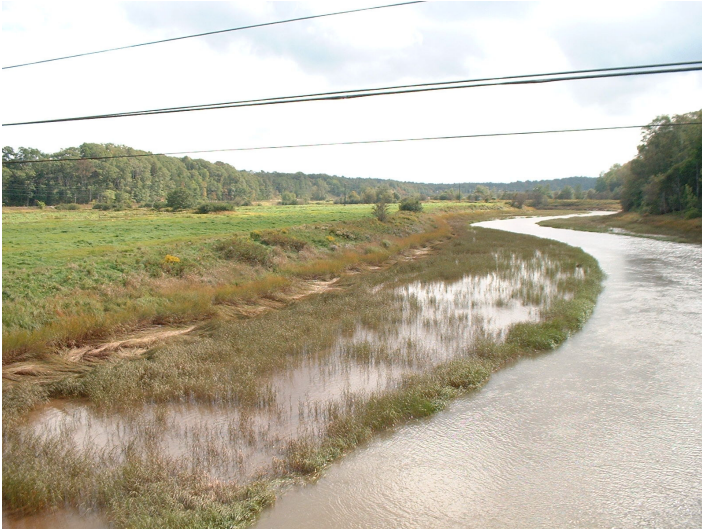
**Comments:** Crossing was not tidal while crossing HCMB23A was intact. Since failure of HCMB23A, limited tidal flow has been restored to this system.

**Figure 2.** The marsh is being flooded up to the dyke. The other side of the creek is forest.
