Site HCMB 2B: Cogmagun River

Date Assessed: 04/09/03,
05/12/03

Road Crossing: A 46m long wooden bridge, with an opening between the two large supports of 10m.

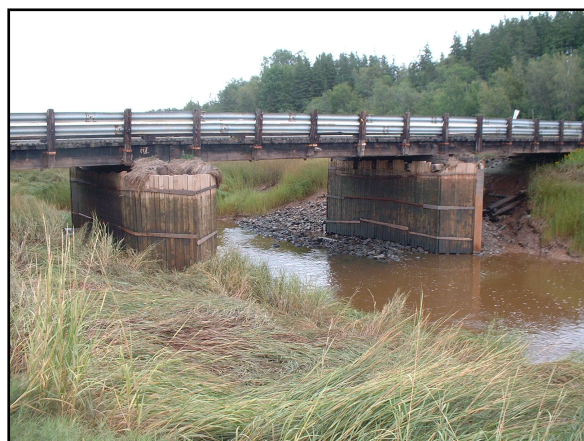
Crossing Condition: Fair condition.

Figure 1: The large support structures narrow the opening under the bridge, but still allow adequate tidal flow.

Comments: When repair or replacement is necessary, maintain opening width. A new structure without the large in stream support structures would reduce effect on tidal flow and movement of ice in winter/spring.

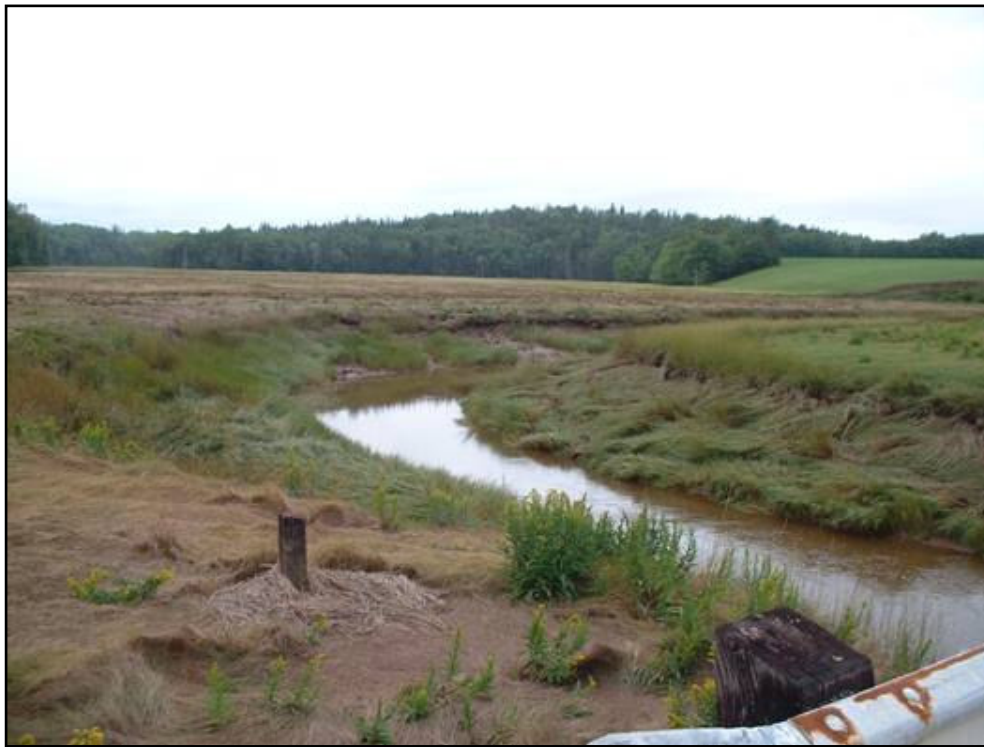
Figure 2: *downstream*

Creek: 7m wide with a smooth flow.

Land: At one time the land was probably farmed, but is now predominantly tidal wetland.

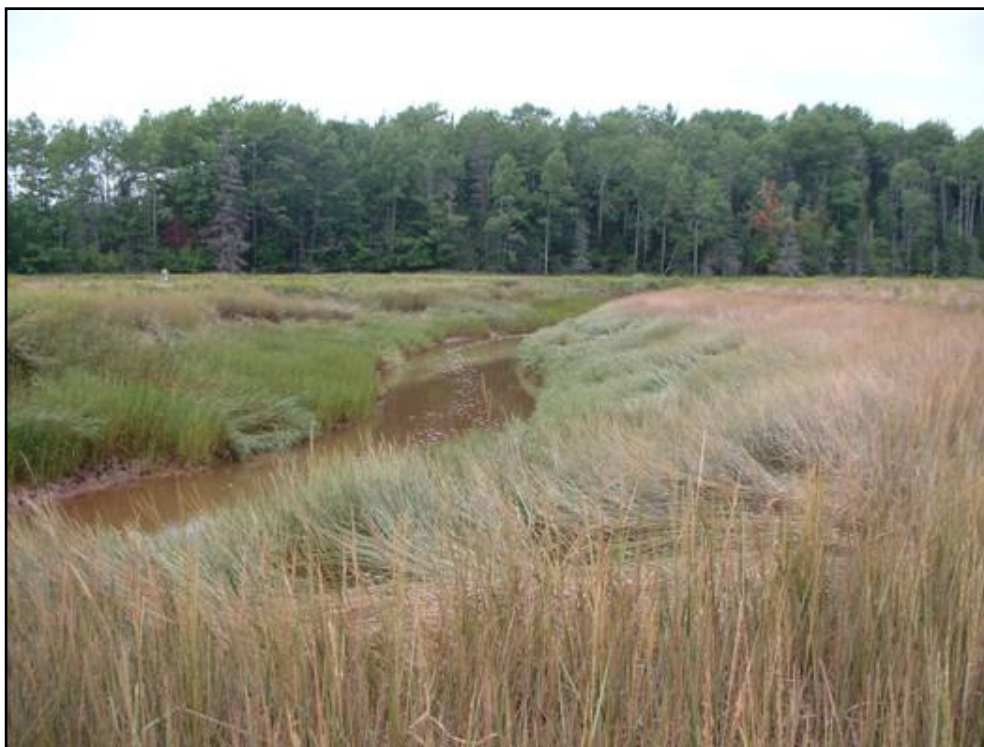
Figure 3: *upstream*

Creek: 7m wide with a smooth flow.

Land: At one time the land was probably farmed, but is now salt marsh.
