Site HCMB 3C: Red Brook (Centre Burlington)

Date Assessed: 04/09/03,
05/12/03

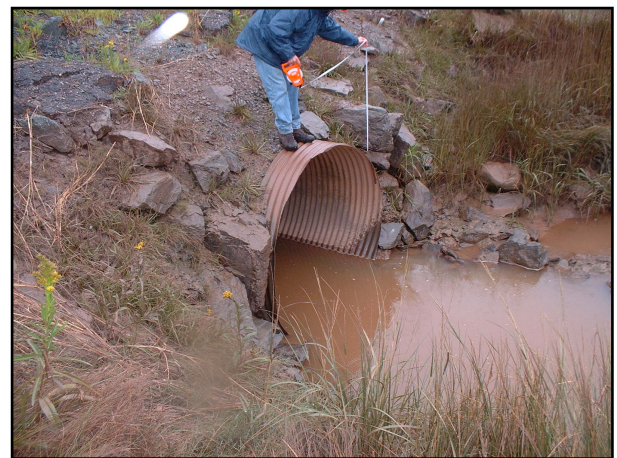
Crossing Status: Partial restriction.

Road Crossing: A steel culvert with a diameter of 1.7m.

Crossing Condition:
Good condition but rock material in channel.

Figure 1: This photo shows the creek being wider than the culvert.

Comments: Enlarge the opening to at least a diameter of 3.5m.

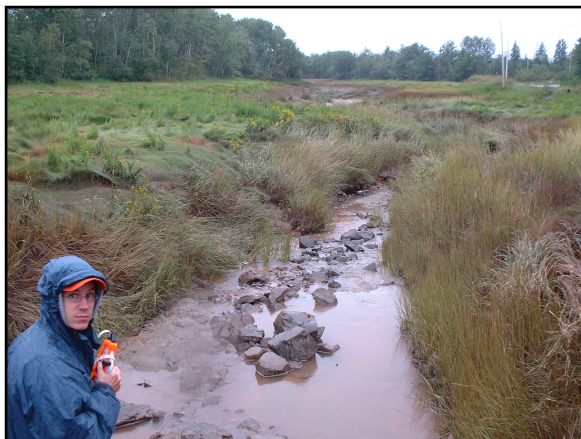
Figure 2: Upstream of the culvert.
