Site HCMB 5B: Kennetcook River (Scotch Village)**Date Assessed:** 04/09/03,
05/12/03**GPS Coordinates:** N 45° 03' 53''
W 64° 00' 11''**Crossing Status:** No restriction.**Road Crossing:**

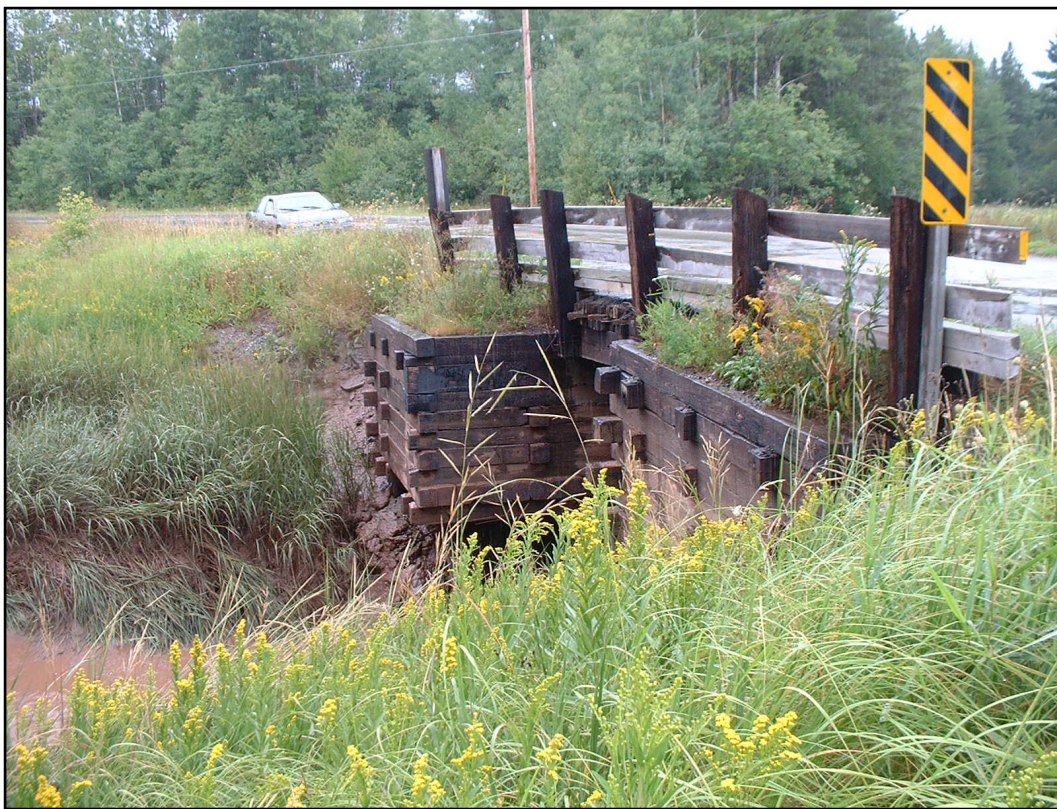
Some of the barrings are tilting in and may become a problem in the near future.

Figure 1: The downstream side of the bridge. The support structures can be seen and salt marsh vegetation on the far bank.

Comments: When repair or replacement is needed, the structure should remain a bridge with the opening no smaller than 3m.

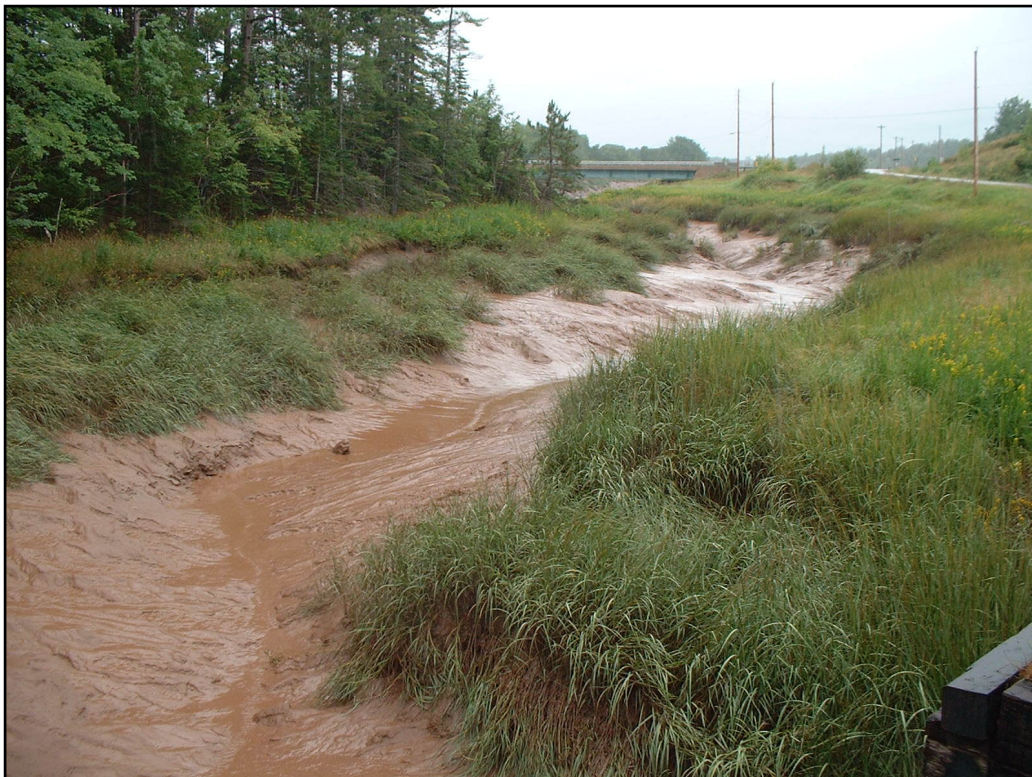
Figure 2: Downstream view of creek. HCMB4B can be seen. The creek thins quickly due to the elevation rise. There is salt vegetation along the banks, but not an extensive marsh surface, with trees growing on one side, and a road on the other.
