Site HCMB 9B: Little River (near Mosherville)**Date Assessed:** 04/09/03,
05/12/03**GPS Coordinates:** N 45° 04' 55.3''
W 63° 56' 15.0''**Crossing Status:** Partial restriction.**Road Crossing:** A 13m long bridge with an opening of 5.5m.**Crossing Condition:**
Structure is intact but narrow opening does pinch river channel. As well old rail crossing downstream near mouth of channel is adversely affecting tidal flow.**Restriction Indicators:**
Difference in stream width
Scour pool
Difference in vegetation
Bank slumping**Downstream of Crossing****Creek:** 10m width with a smooth flow, but some bank slumping. Rail crossing downstream adversely affecting tidal flow.**Land:** Mix of marshland, farmland and woodland. .**Upstream of Crossing****Creek:** 10m width with a smooth flow, but some bank slumping.**Land:** Marsh species are present. One side of the creek is being used for grazing, and the other is possibly being cut.**Comments:** Downstream rail crossing should be assessed for impact on tidal flow and bridge opening maintained or enlarged.

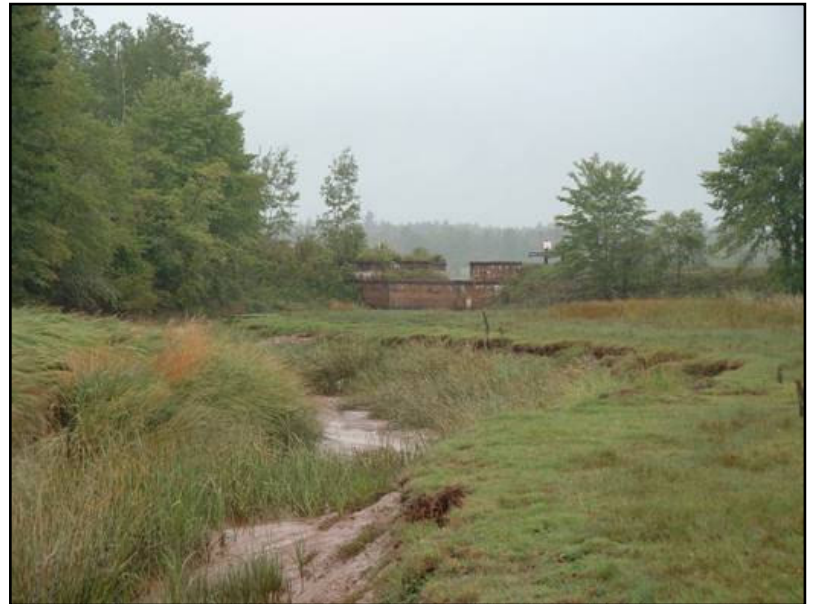
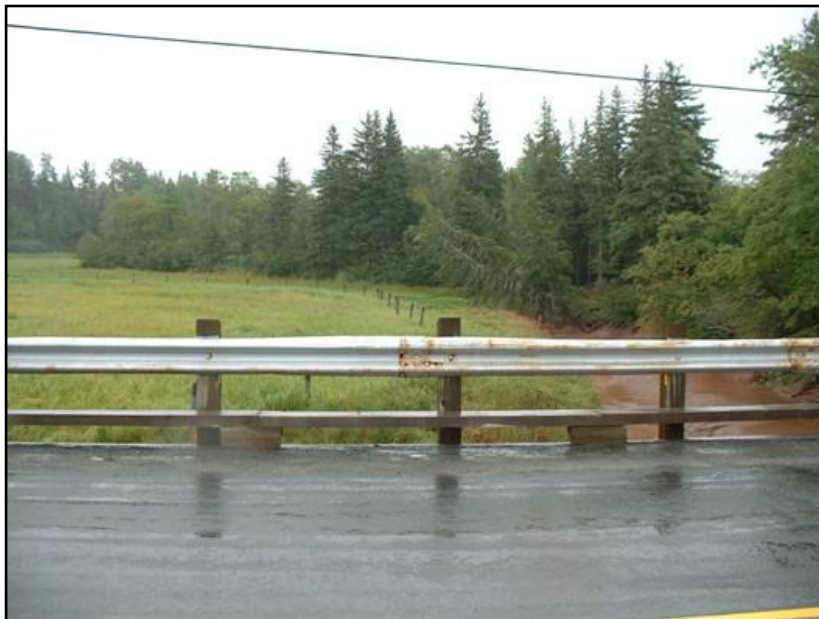
Figure 3: *Upstream of the road crossing,*
