Site KCMB 11C: Lower Canard

Date Assessed: 04/09/03

Road Crossing: Steel culvert.

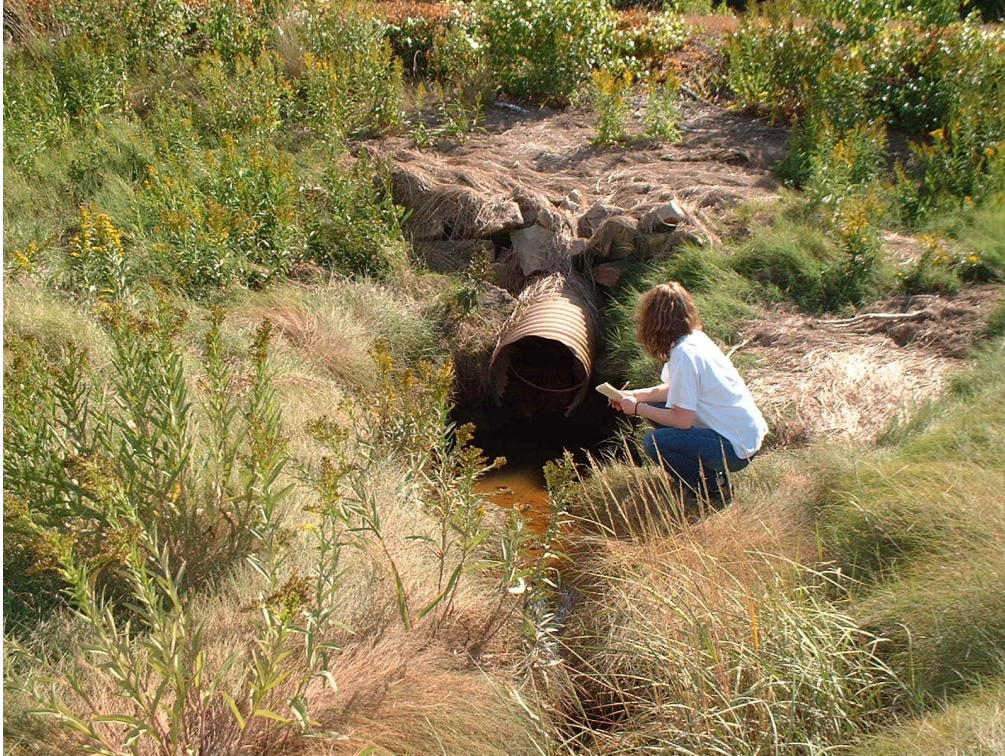
Crossing Condition: Culvert is in disrepair (bottom rotting out).

Figure 1. Downstream view of the culvert with rotting bottom.

Comments: Roadway runs along upland edge of a tidal marsh and is primarily a drainage channel for upland area. A larger structure would improve hydrology but would not result in significant habitat benefits upstream or down. Crossing will need to be repaired or replaced in the near future.
