Site KCMB 13C: Kingsport Marsh 1 (near sign)

Date Assessed: 03/08/04

Crossing Status: Partial restriction

Road Crossing: 1.5m concrete culvert

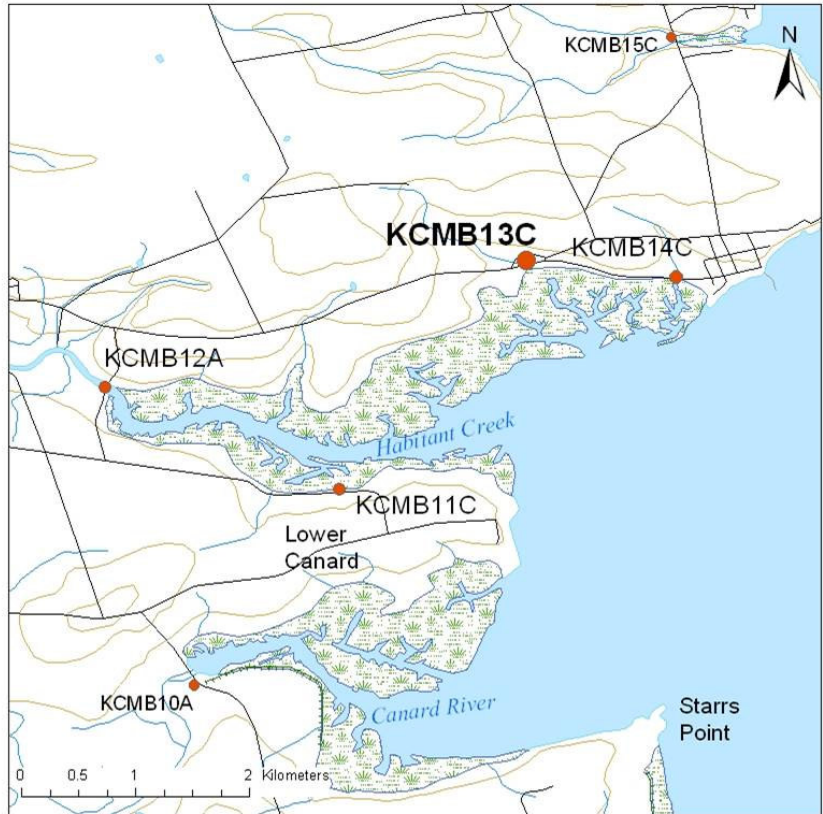
- Difference in water level
- Bank slumping
- Difference in stream width
- Turbulent water flow
- Scour pool
- Hanging culvert

Figure 1. Downstream end of culvert at low tide.

Comments: Enlargement and lowering of crossing would improve tidal flow and fish passage to upland area but would put driveway just upstream of this crossing at risk of flood damage. Restoration activities at this site would have to involve driveway condition as well. Improved tidal flow through roadway and beyond the driveway would improve tidal wetland habitat to the upstream area.

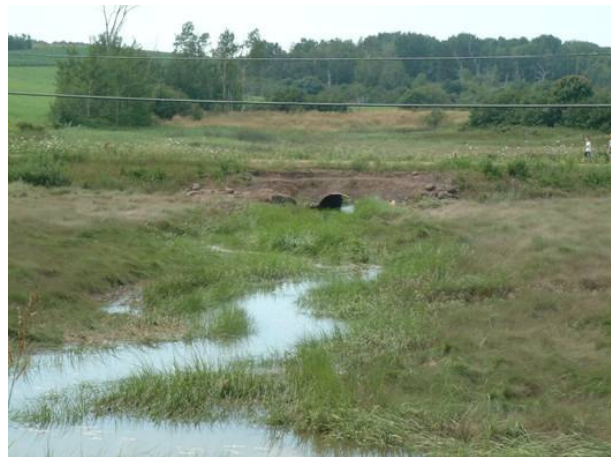
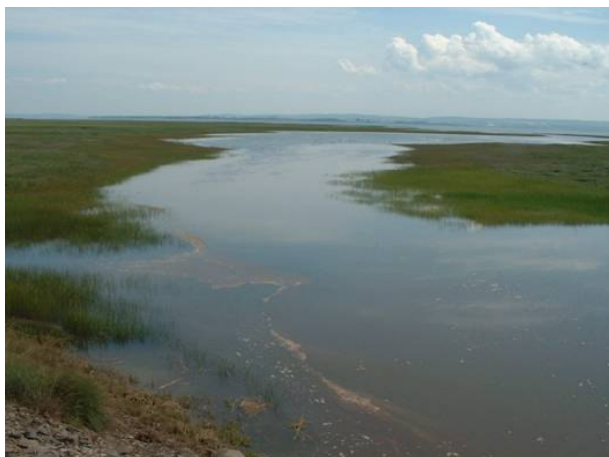
Figure 3. Downstream of crossing on a wetland area and driveway culvert.
