Site KCMB 14C: Kingsport Marsh 2

Date Assessed: 03/08/04

Road Crossing: Two chambered wooden box culvert

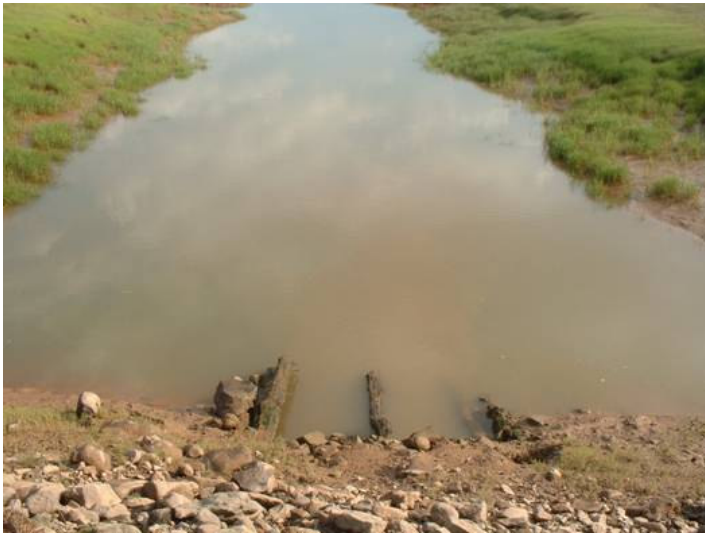
Comments: Culvert is old, severely damaged and is a significant tidal restriction. A larger opening would improve tidal flow, fish passage and upstream habitat conditions.

Figure 1. Downstream of crossing at mid tide

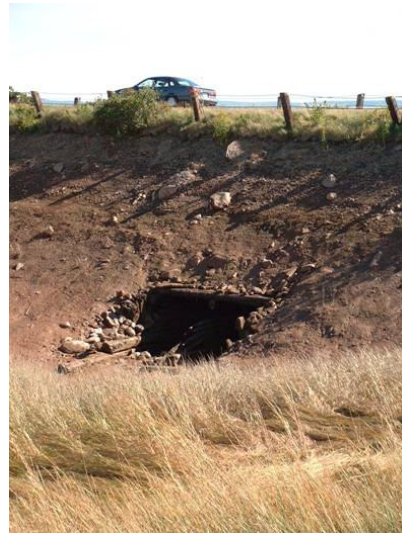
Figure 2.

Crossing Condition: Crossing is in considerable state of disrepair. Structure is damaged at both ends, and internally is partially blocked by debris.

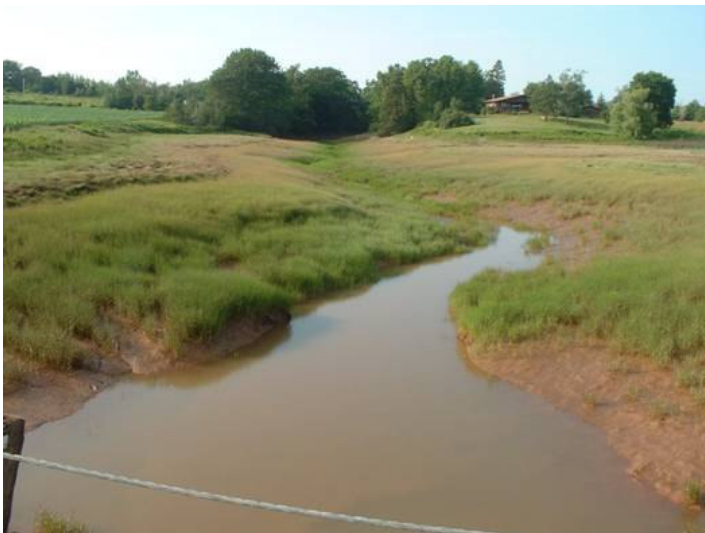
Figure 3. Upstream view from crossing
