Site KCMB 15C: Bass Creek Brook (Medford)

Date Assessed: 03/08/04

Crossing Status: Partially restricted

Road Crossing: 1.5m corrugated culvert

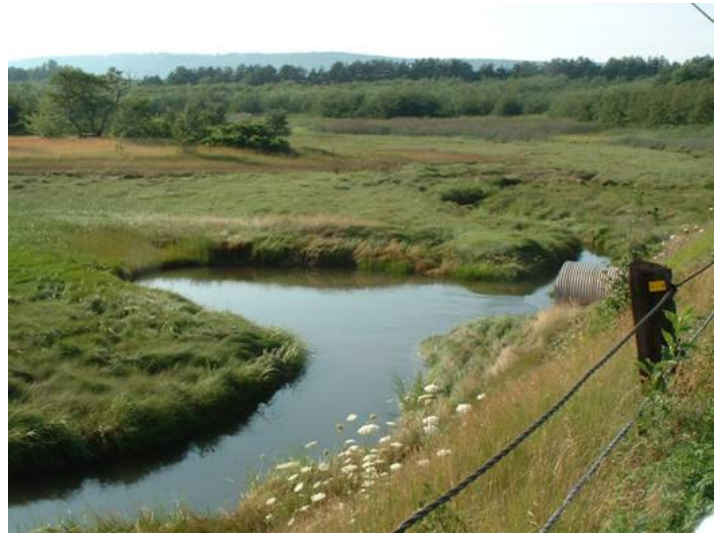
Figure 2.Downstream of crossing

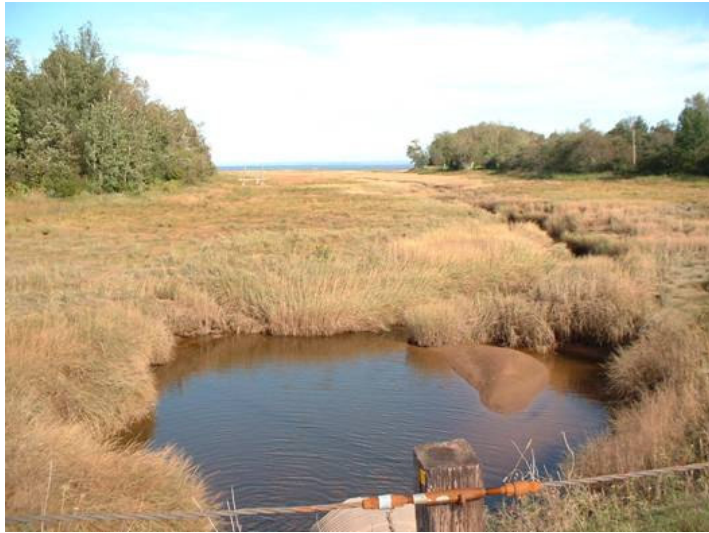
Figure 3. Downstream end of culvert
