Site KCMB 17C: Pereaux culvert 1

Date Assessed: 03/08/04

Road Crossing: 1m wooden box culvert

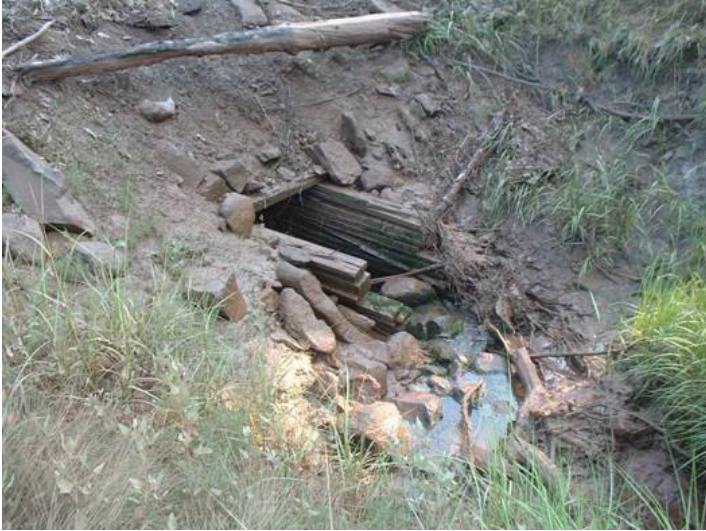
Crossing Condition: Damaged at both ends, collapsing and partially blocked by debris

Figure 1. Culvert upstream

Comments: Culvert is in need of repair/replacement and although a larger opening would improve flow, the wetland area upstream is small and not able to expand due to rise in elevation.

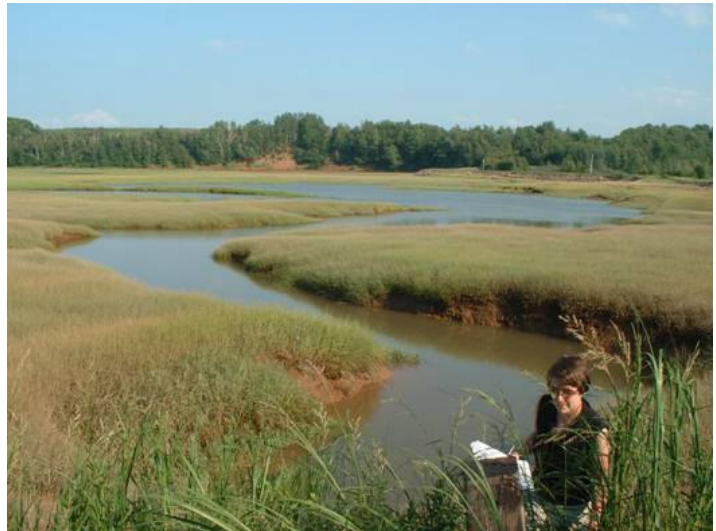
Figure 2. Downstream of crossing at low tide

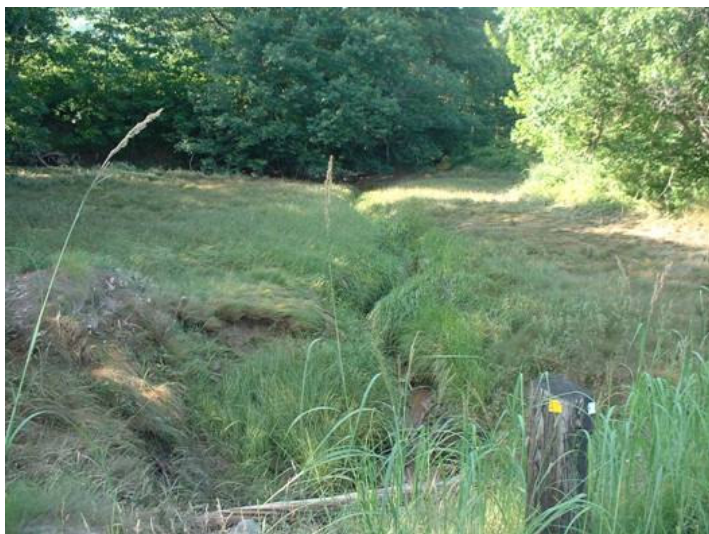
Figure 3. Up stream of crossing at low tide
