**Site KCMB 18C:** Pereaux culvert 2

**Date Assessed:** 03/08/04

**Road Crossing:** Wooden box culvert

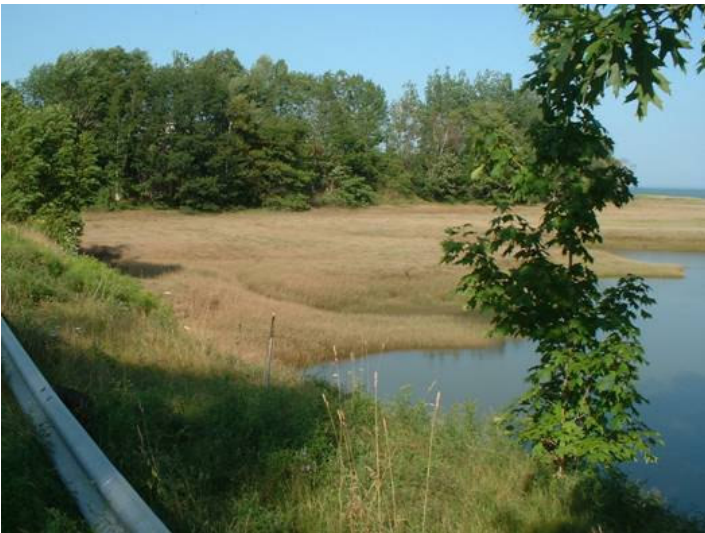
**Figure 1.** Downstream of crossing

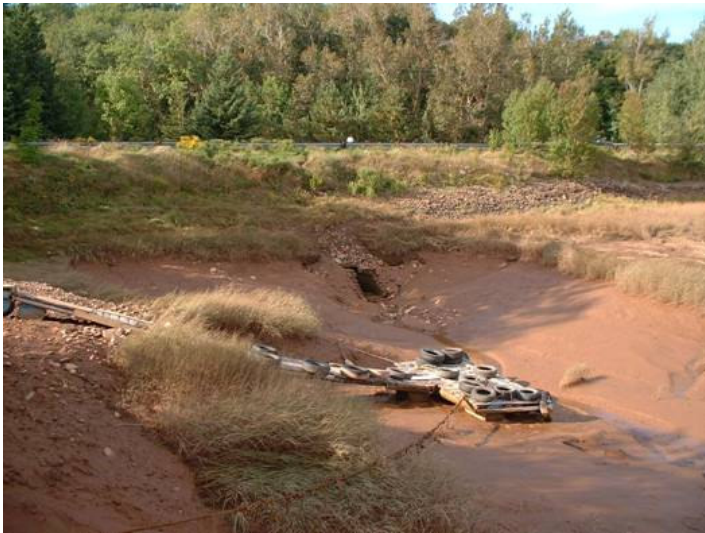
**Figure 2.** Downstream at low tide

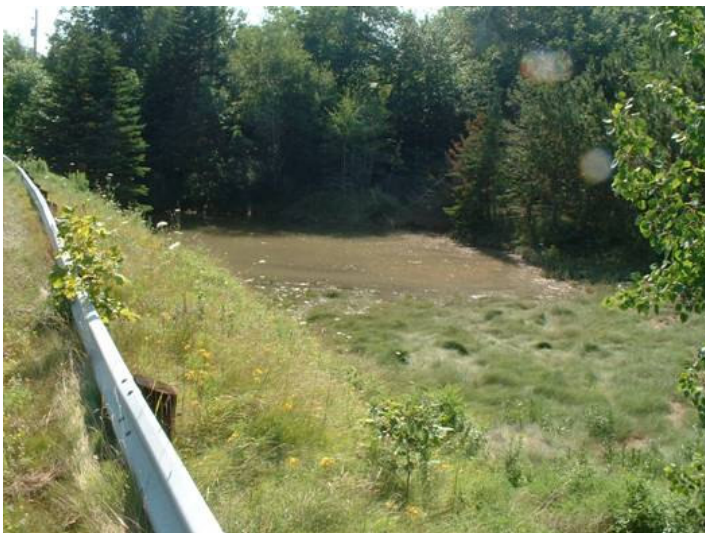
**Figure 3.** Upstream of crossing
