Site **KCMB 19C**: Delhaven Harbour

Date Assessed: 03/08/04

Crossing Status: Partially restricted

Road Crossing: Corrugated culvert

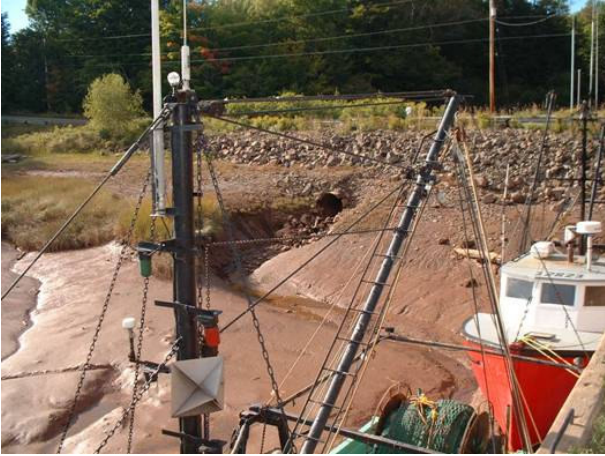
Figure 1. Downstream of crossing

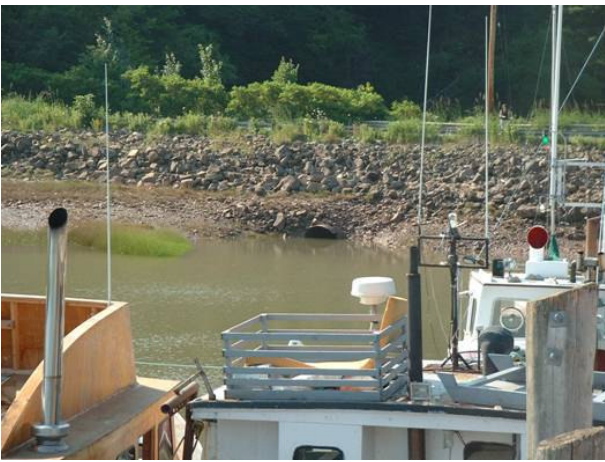
Figure 2. Upstream of culvert during high tide

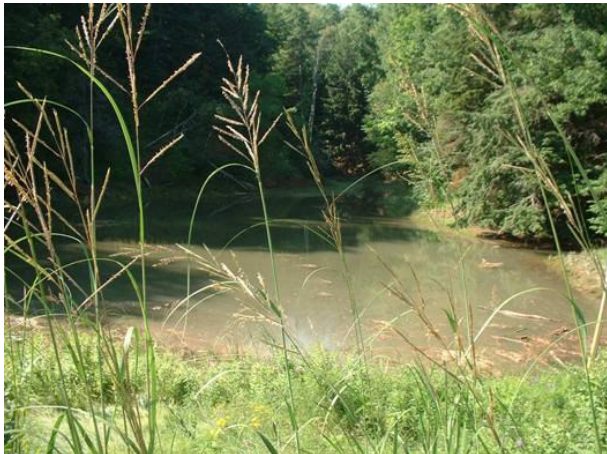
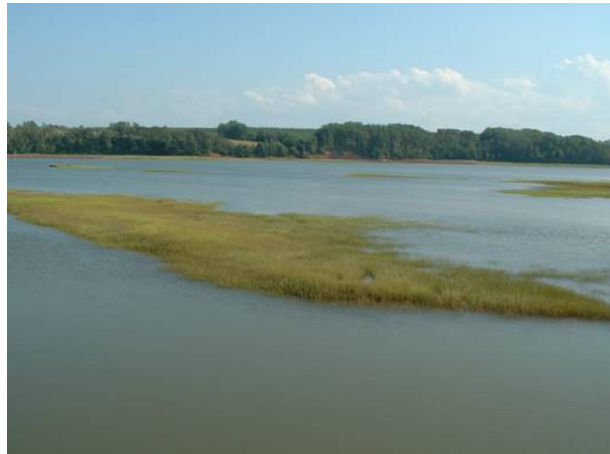
Figure 3 and 4. Downstream of crossing at mid tide
