Site KCMB 2B: Gaspereau River (Hwy 101)

Date Assessed: 04/09/03, 05/12/03

Road Crossing: Two 100m steel bridges,
Highway 101

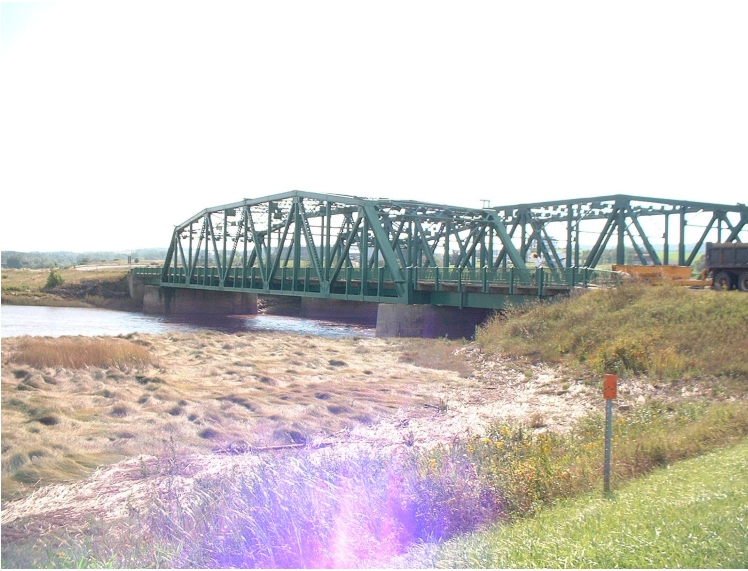
Figure 1. Two steel bridges side by side, not creating a restriction to tidal flow. Photo was taken from one of the dykes.

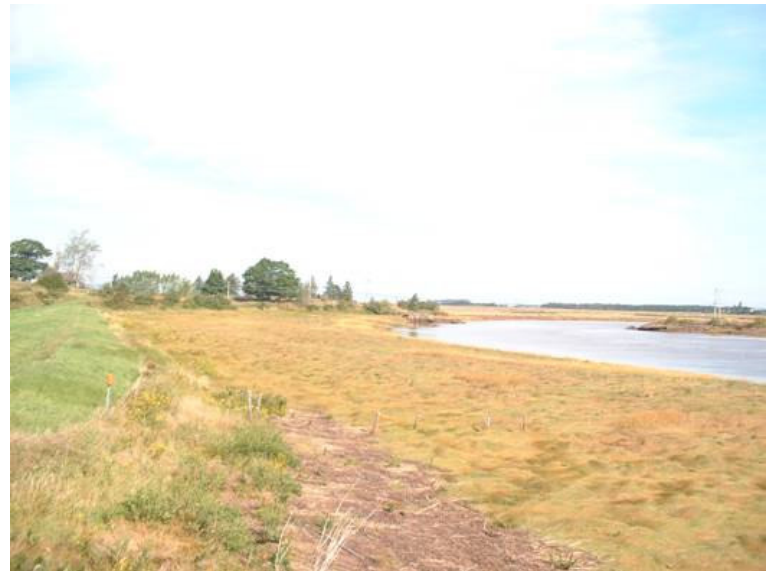
Figure 2. Upstream showing dykes along the river edge.
