Site KCMB 3C: Creek off Gaspereau River

Date Assessed: 04/09/03, 05/12/03

Road Crossing: 1.5m diameter steel culvert

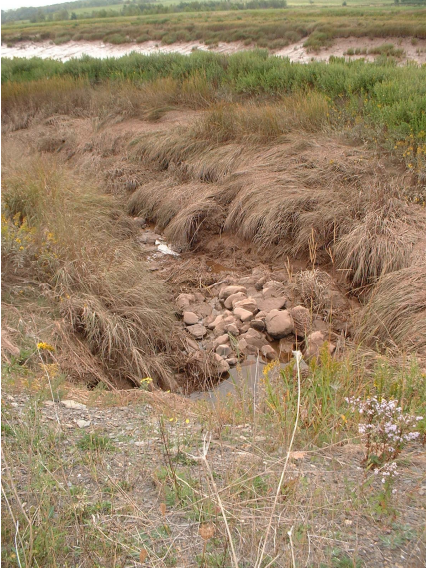
Creek: A small pool has formed in front of the culvert. There is a blockage of debris approximately 3m downstream.

**Figure 1.** Downstream of creek.

Comments: Clear away debris. When repair or replacement is necessary, maintain the size of the opening.

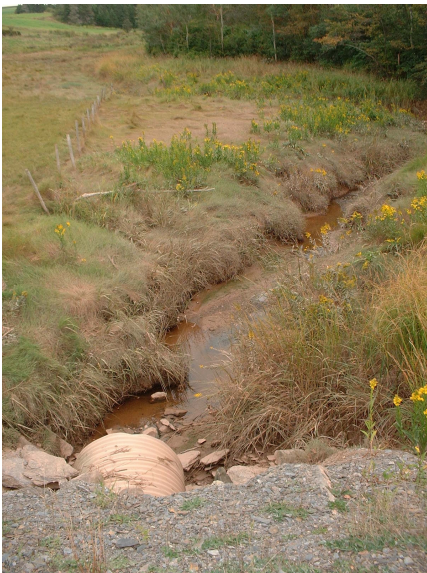
Creek: 1m wide creek with smooth flow.

**Figure 2.** Upstream of creek.
