Site KCMB 4B: Wallbrook

Date Assessed: 04/09/03, 05/12/03

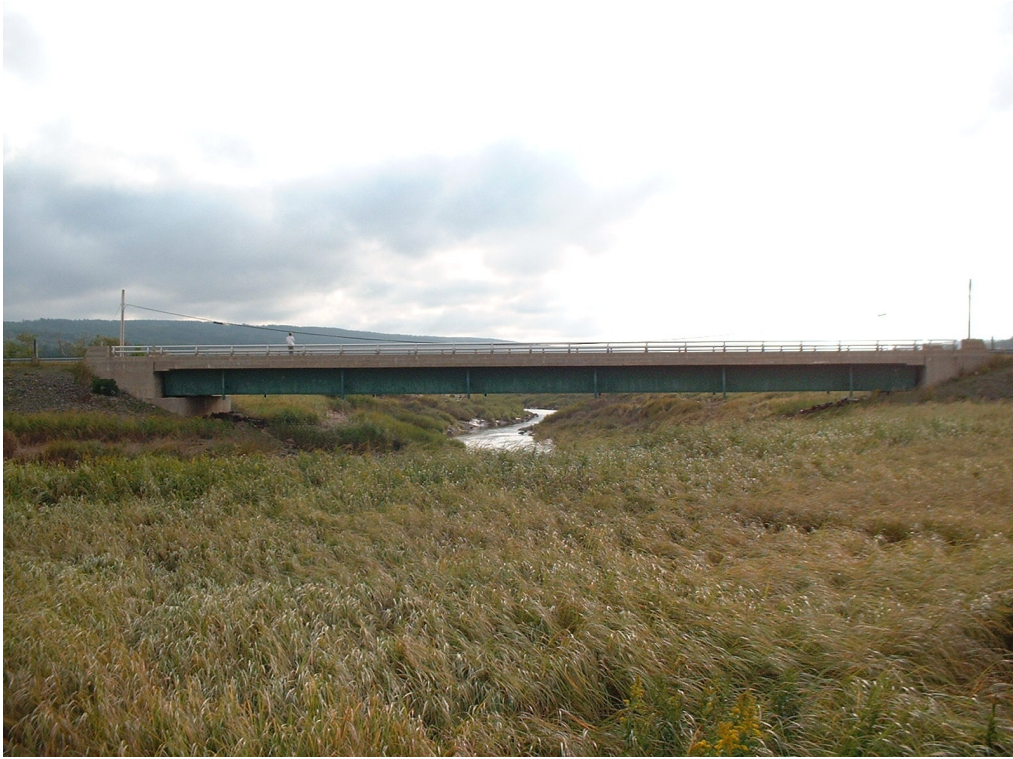
Road Crossing: 60m long concrete and steel bridge.

Crossing Condition: Intact.

Comments: Bridge spans the main river channel and creates very little obstruction to tidal flow. Adjacent lands are dyked and appear to be actively farmed. .

Figure 1. Full view of the bridge.
