**Site KCMB 5B:** Melanson

**Date Assessed:** 04/09/03, 05/12/03

**Road Crossing:** 26m steel and wood bridge.

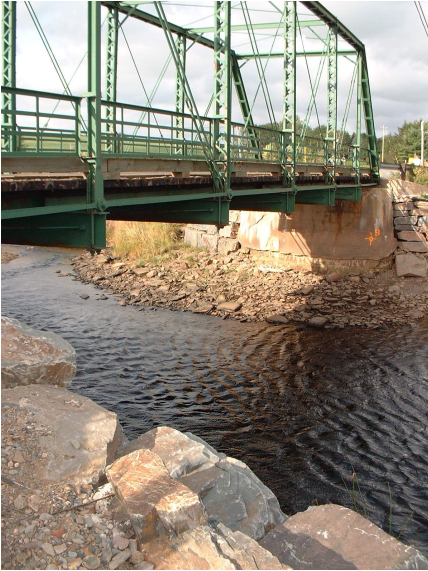
**Crossing Condition:** Structure is old and in fair condition.

**Figure 1.** Photo of the bridge taken from the support structure of boulders on one of the banks.

**Comments:** When repair or replacing the bridge, maintain the size and location of existing bridge.

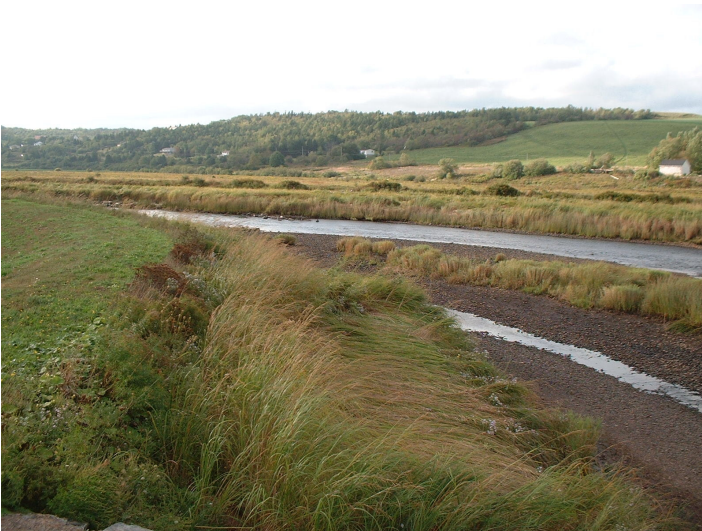
**Figure 2.** Downstream of crossing showing fringe marsh and agricultural lands.
