**Site KCMB 7C:** Kentville

**Date Assessed:** 04/09/03, 05/12/03

**Crossing Status:** No longer tidal

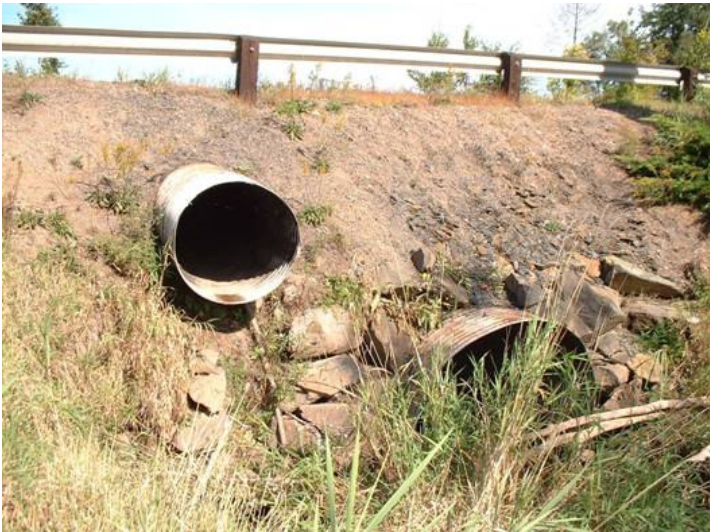
**Crossing Condition:** Lower culvert is collapsing and partially blocked (downstream) by rock and woody debris. The smaller, higher culvert appears newer and in good condition.

**Figure 1.** The culvert and drainage pipe.

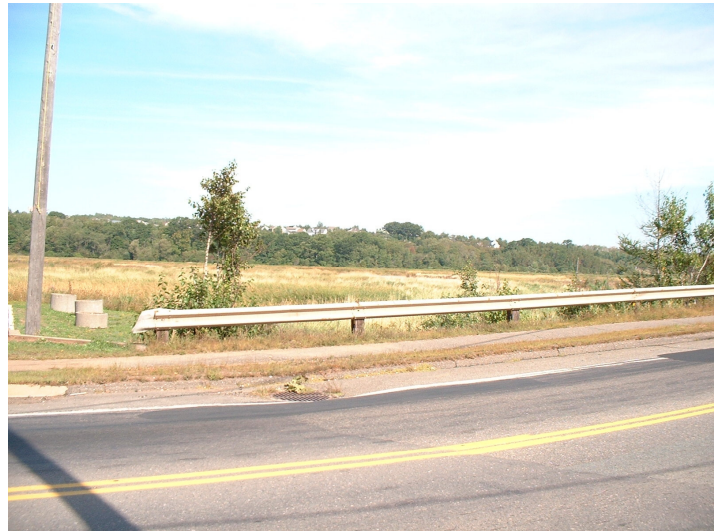
**Figure 2.** Downstream of the crossing. The ridge at the distant edge of the field is the dyke.

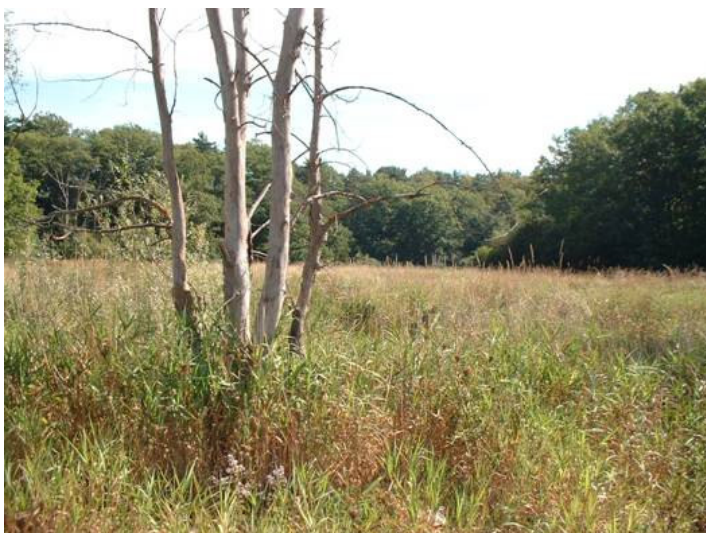
**Figure 3.** Upstream of the crossing.
