Site KCMC22B: Harbourville

Date Assessed: 02/12/04

Road Crossing: Bridge (wooden), 12m

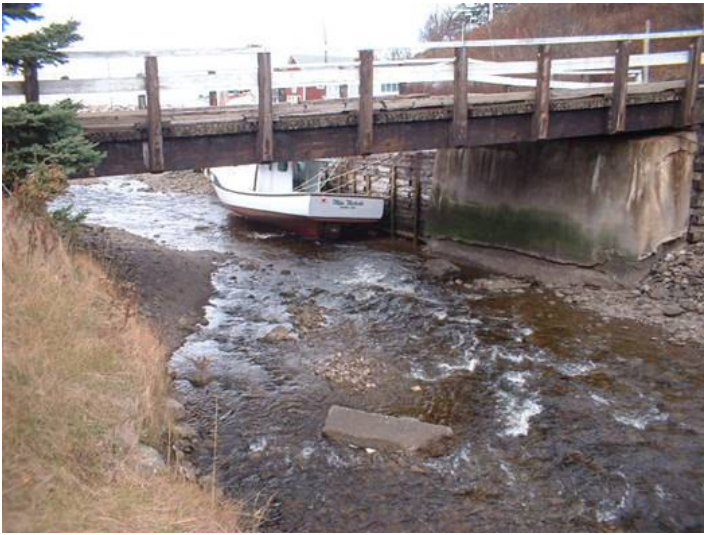
Crossing Condition: Intact but showing wear

Comments: This crossing does not restrict tidal flow or fish passage. When repair is necessary maintain the size of opening.

Figure 1. Upstream view of crossing

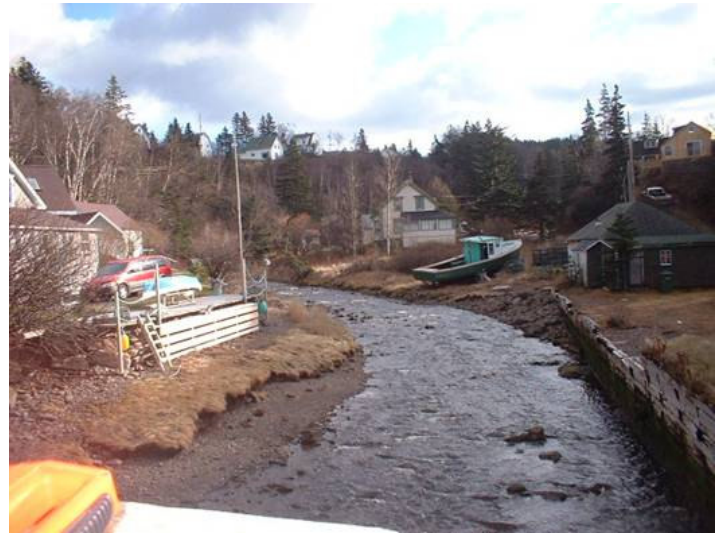
Figure 2. Upstream of crossing

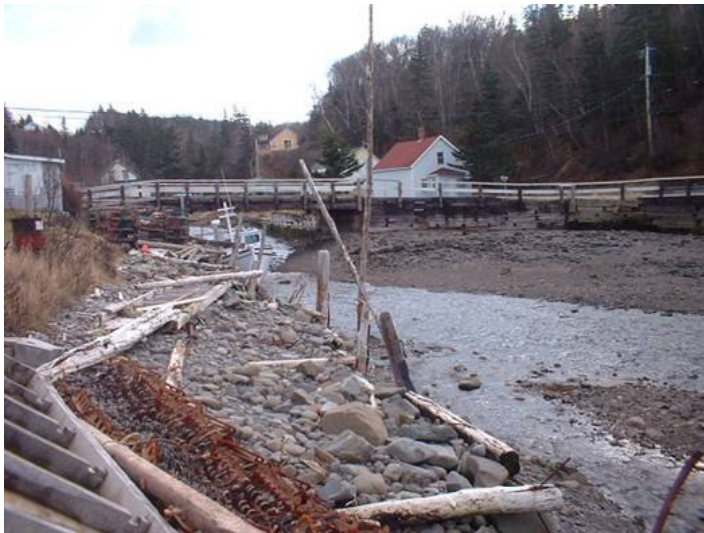
Figure 3. Downstream view of crossing

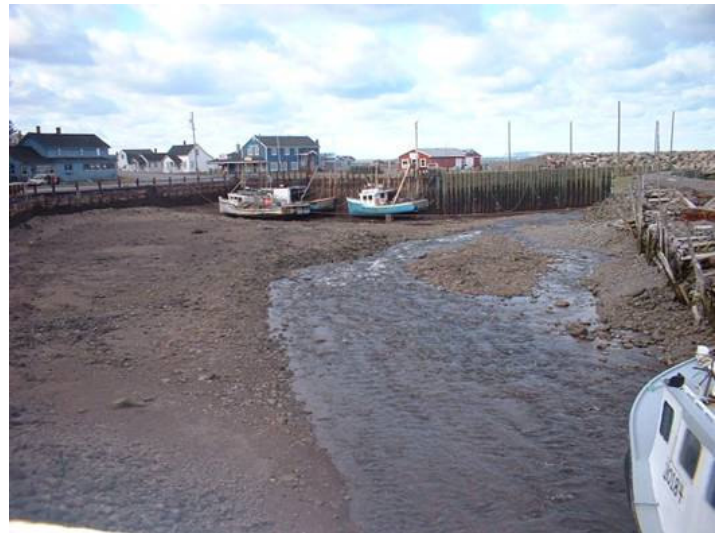
Figure 4. Downstream of crossing
