# MARSHES, TIDES, AND CROSSINGS

## COLCHESTER COUNTY TIDAL BARRIERS AUDIT REPORT 2002

Coastal Issues Committee Special Publication Number 1

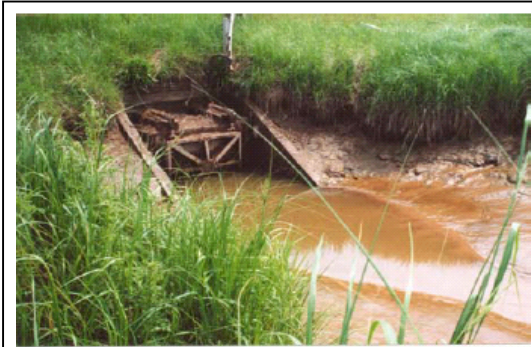
**Figure 1.** Photograph of an aboiteau within a dyke system at site SH7A

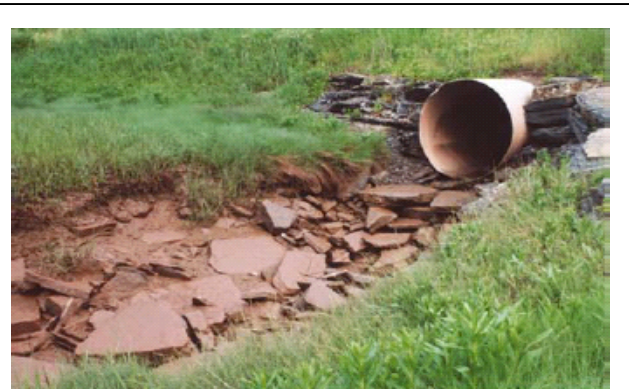
**Figure 2.** Photograph of a culvert situated at site SH2C.

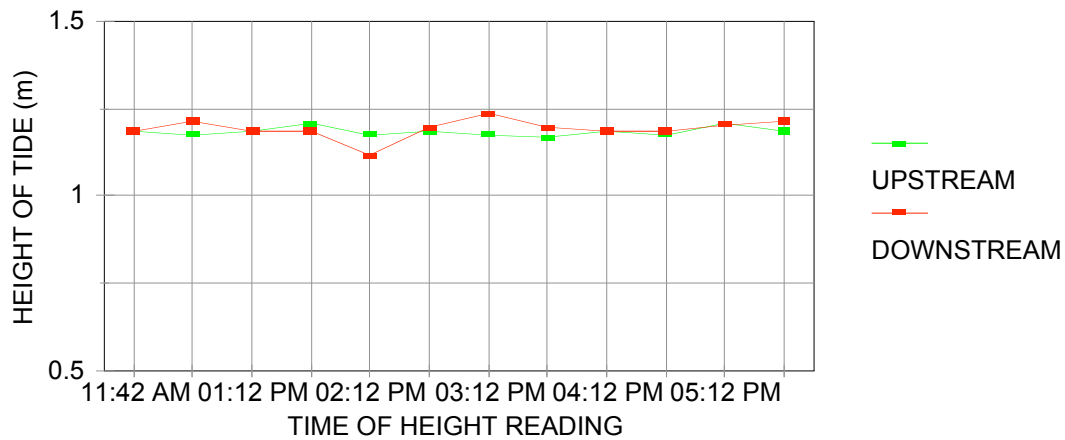
### TIDAL HEIGHT CHANGES AT CROSSING CBSS9C

**Figure 21.** Six hour tidal observing cycle at site CBSS9C. This demonstrates a culvert located too high above the streambed, illustrating a change in height from the water surface downstream, while little change was noted upstream. Small changes recorded downstream suggests a possible downstream restriction at site CBSS8C. High tide, as recorded at Burntcoat Head, was at 2:34 pm.

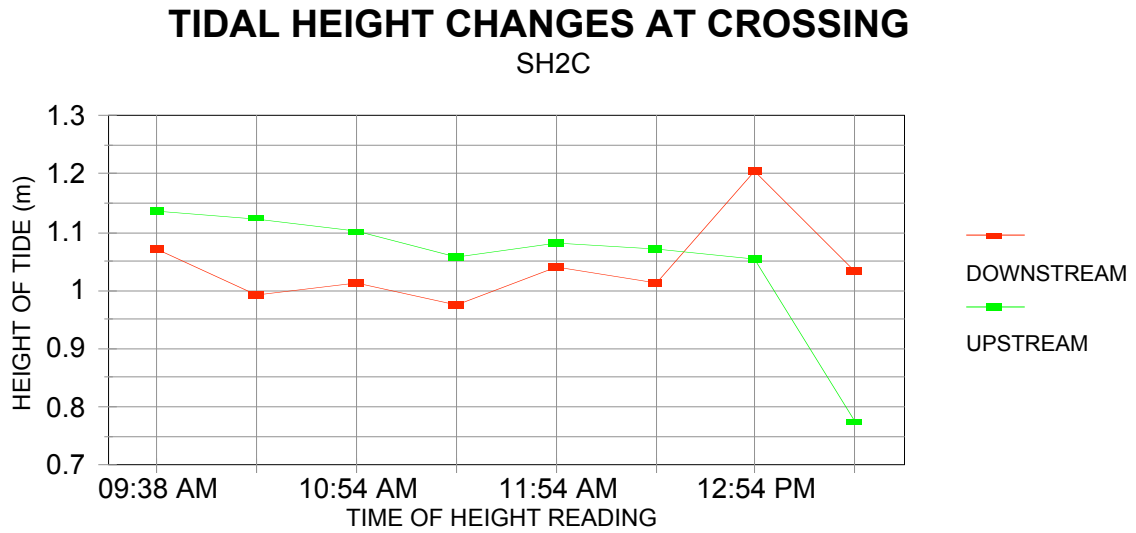
**Figure22.** Four hour tidal observing cycle at site SH2C. The culvert being placed too high prevented changes in height caused by tidal flow to the upstream side. Since high tide did not pass through the culvert, measurements ceased an hour after this recording. High tide, as recorded at Burntcoat Head, was at 12:04 pm.

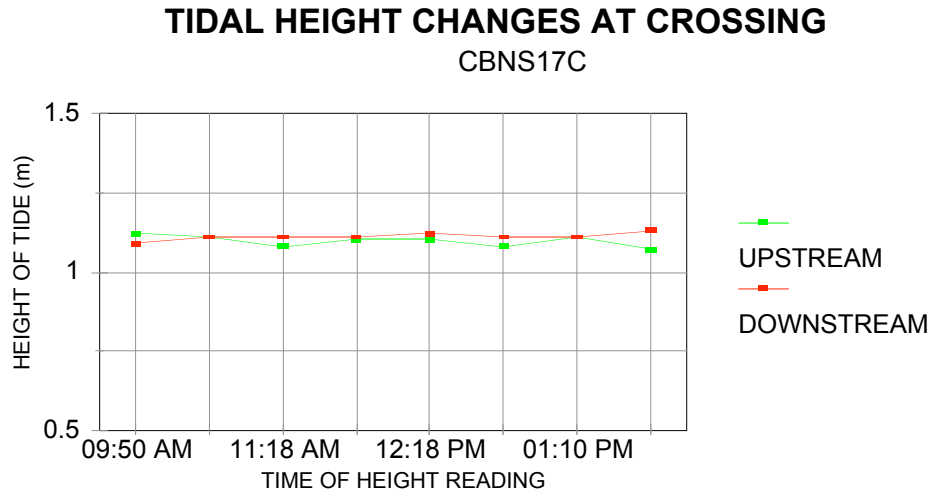
**Figure23.** Over a four hour period, a change in tide was not observed on both upstream and downstream sides possibly due to a decreased tidal force resulting from natural landscape features (numerous pools and bends) of the inlet. High tide, as recorded at Burntcoat Head, was 12:50 pm.

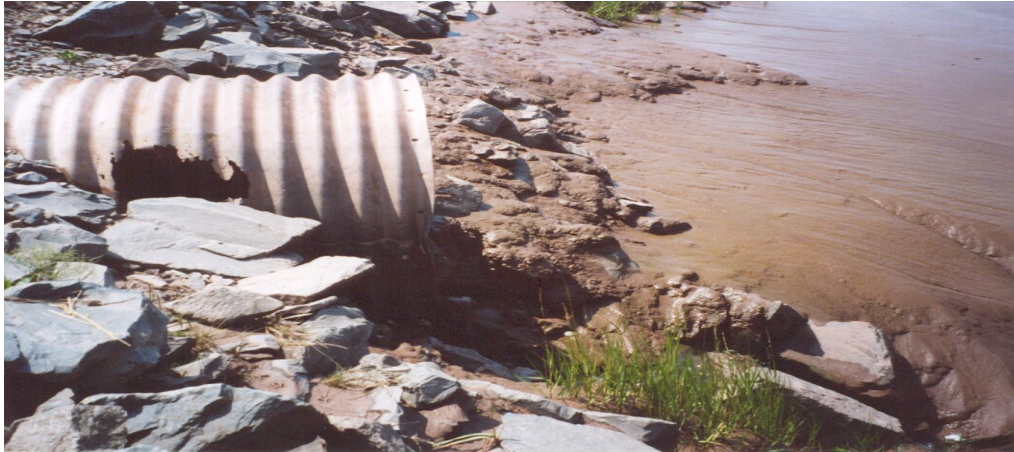
**Figure 24.** Downstream view of a corrugated steel culvert at site CBSS8C (Cobequid Trail).

<b>Site</b>	<b>Location</b>	<b>Restoration Potential</b>	<b>Photograph (Appendix G)</b>
CBSS8C	Cobequid Trail	Replace rusting culvert that is beginning to collapse with new culvert to allow for adequate water flow upstream.	Figure 24
CBSS14A	Black Rock	Replace old wooden aboiteaux with small culvert to restore water flow to this area.	Figure 25
SH1C	Princeport	Lower wooden block culvert to allow for tidal flow upstream.	Figure 26
ST7C	MacKay Siding Road	Lower wooden box culvert and widen opening to increase water flow to the upstream side of the crossing.	Figure 27
CBNS1A	Chiganoise River	Open one to three tide gates, to allow for salt marsh re-establishment	Figure 28

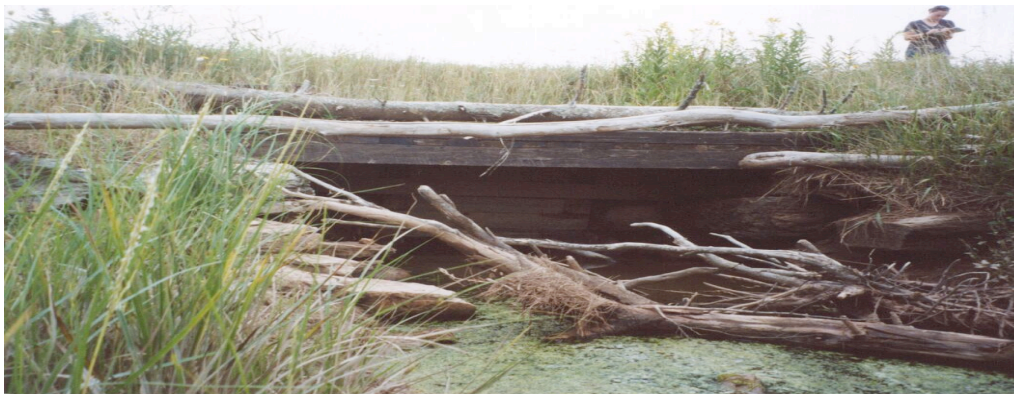
**Figure 25.** Downstream view of an old wooden aboiteau at site CBSS14A (Black Rock).

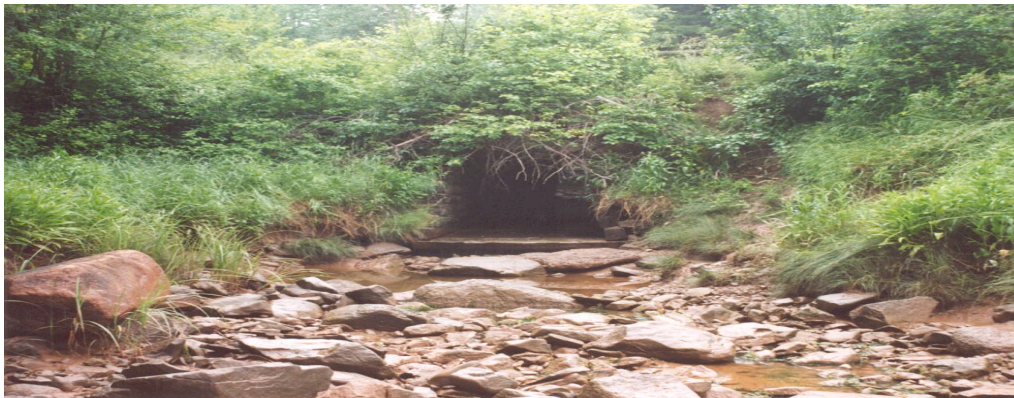
**Figure 26.** Downstream view of a wooden box culvert at site SHIC (Princeport).

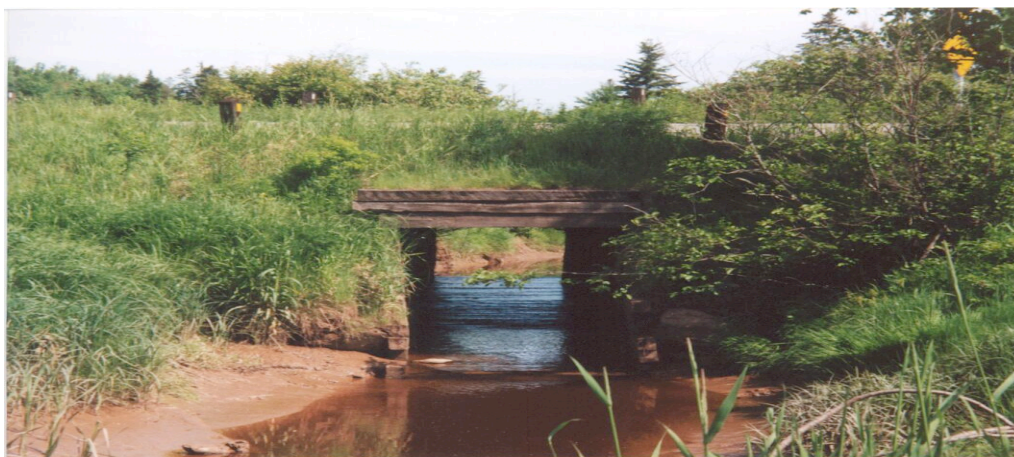
**Figure 27.** Downstream view of a wooden box culvert at site ST7C (MacKay Siding Road).

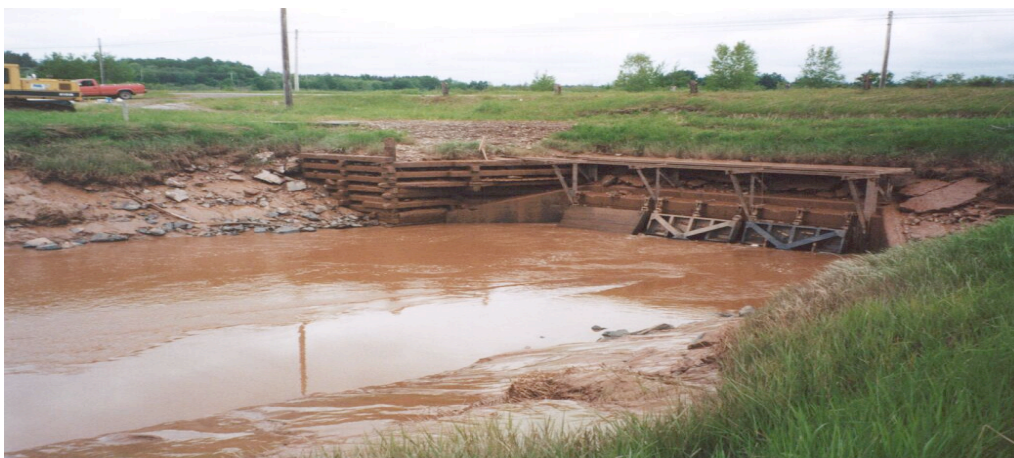
**Figure 28.** Downstream view of an aboiteau system with three tide gates at site CBNS1A (Chiganois River).

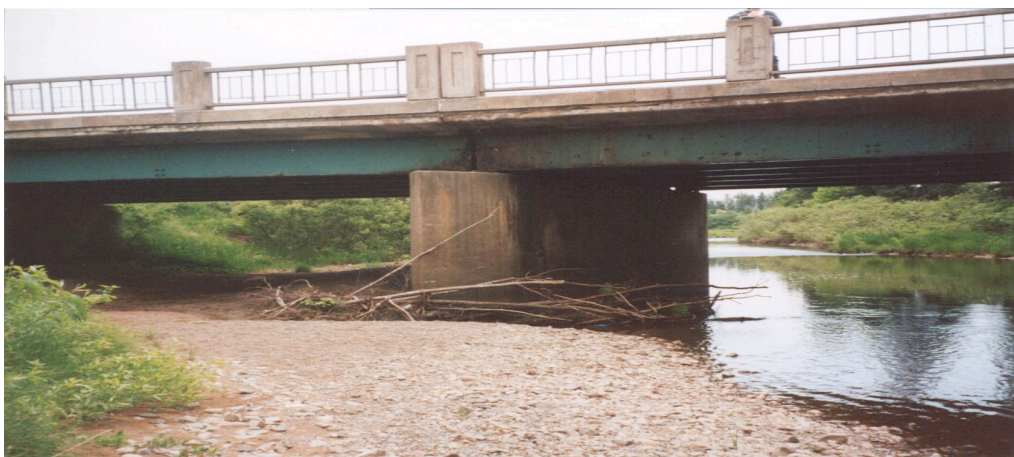
**Figure 29.** Upstream view of debris built up at site CBNS2B (Debert River).

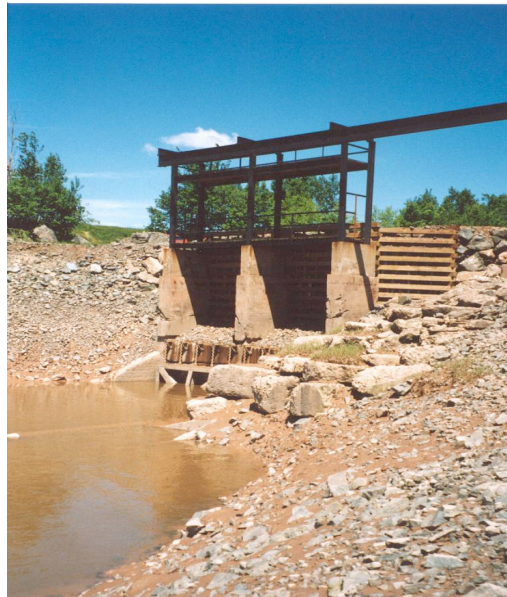
**Figure 30.** Downstream view of a large aboiteau at site CBNS5A (Great Village River).

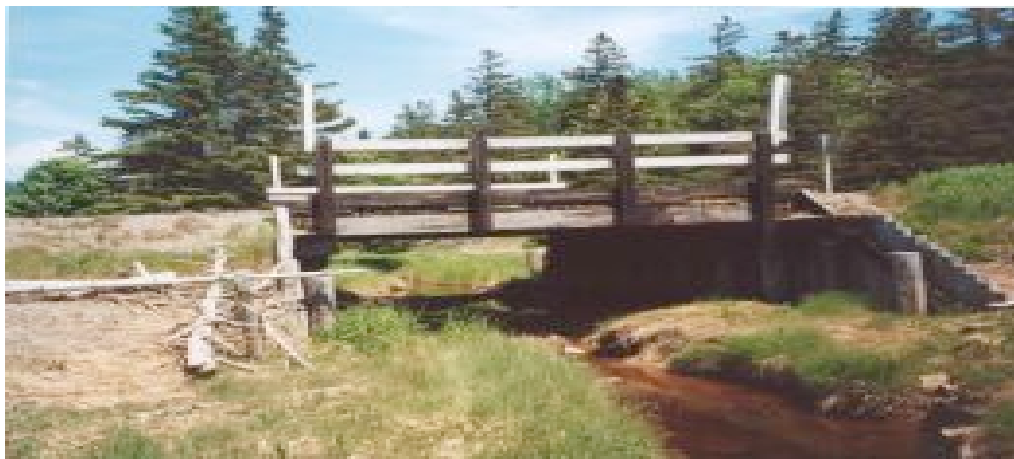
**Figure 31.** Downstream view of a bridge at site CBNS13B (Carrs Brook).

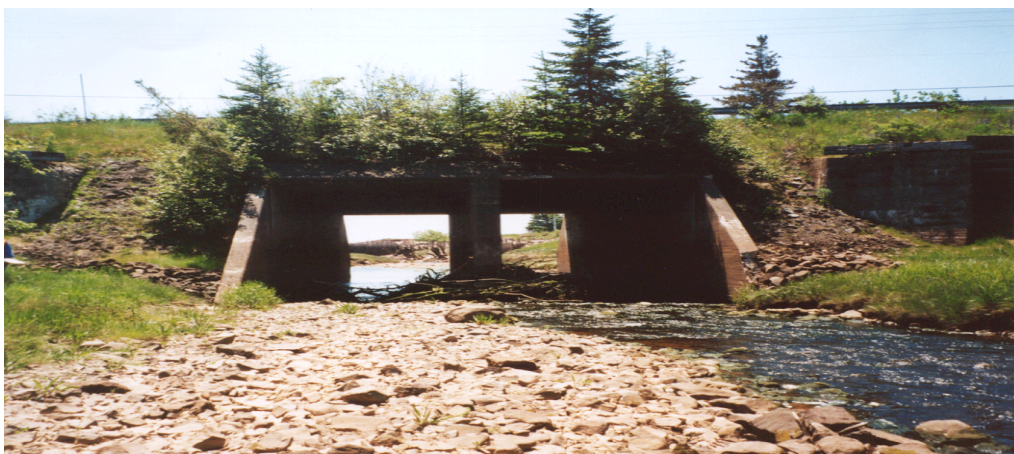
**Figure 32.** Upstream view of debris built up at site CBNS14C (Carrs Brook Road).
