**Tidal Barriers & Opportunities for
Salt Marsh and Tidal River Restoration in the
Southern Bight of the Minas Basin, Nova Scotia**

By Nicole Hynes, Tony Bowron,
and Dawn-Marie Duffy

April 2005

Coastal Issues Committee Special Publication # 4
Ecology Action Centre

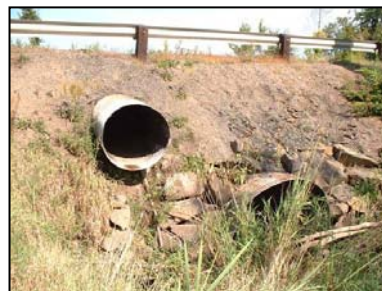
Figure 2. Hanging culvert within a causeway, Kentville, NS. Site KCMB7C

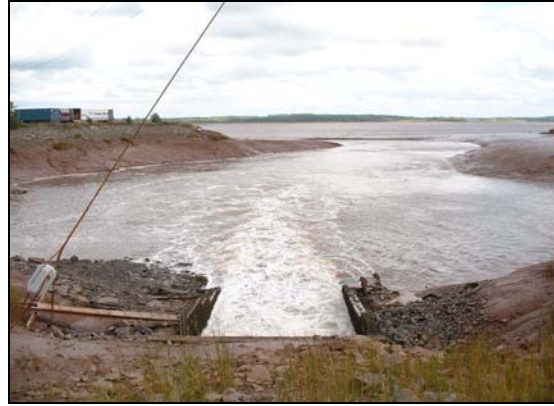
Comments: The limited restoration of tidal flow to the system due to the failure of the aboiteau does not appear to have adversely affected upstream infrastructure or land use, but should be reviewed in greater detail than allowed by this audit. At a minimum, the broken gates should be removed to allow increased flow and fish passage. Full restoration of tidal flow and fish passage could be achieved by replacing the entire structure with a crossing designed to better mimic natural conditions. However, upstream land use and additional road and highway crossings should be assessed for potential impact.

Figure 9. The extremely turbulent outflow through the comparatively small culvert.

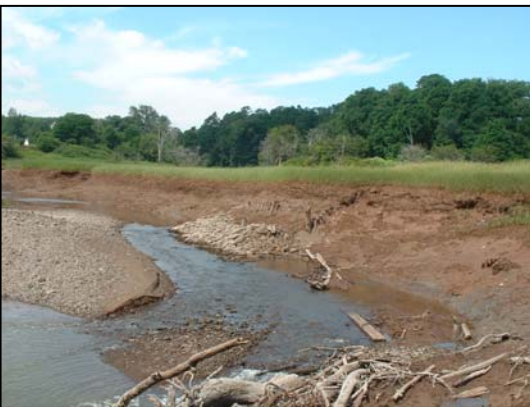
Figure 10. Collection of debris upstream of crossing.

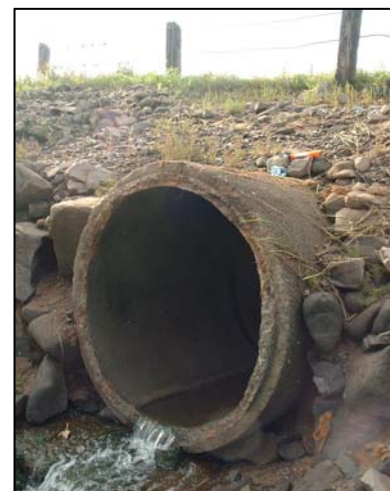
Figure 12. Downstream end of culvert at low tide.

Site Description: Hanging culvert that is restricting tidal flow to a moderately sized upstream area. Upstream channel flows through a smaller metal culvert under a residential driveway that crosses the wetland approximately 150m upstream. Together these crossings restrict hydrology to the upstream component of the system.

Comments: Enlargement and lowering of crossing would improve tidal flow and fish passage to upland area but would put a driveway a short distance upstream of this crossing at risk due to increased tidal action. Restoration activities at this site would have to take into consideration the effects on the driveway and the effect of the driveway crossings on hydrology and fish passage. Improved tidal flow through roadway and beyond the driveway would improve tidal wetland habitat to the upstream area.

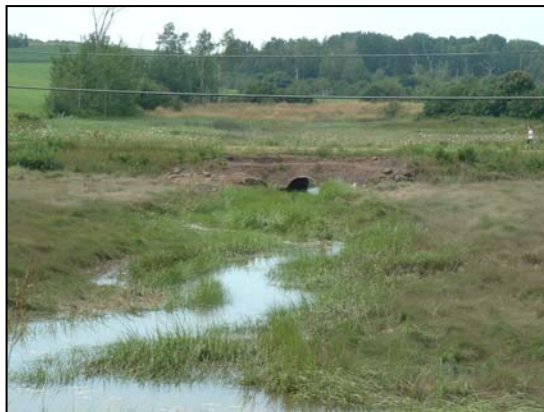
Figure 13. Upstream of crossing showing wetland area and driveway culvert.

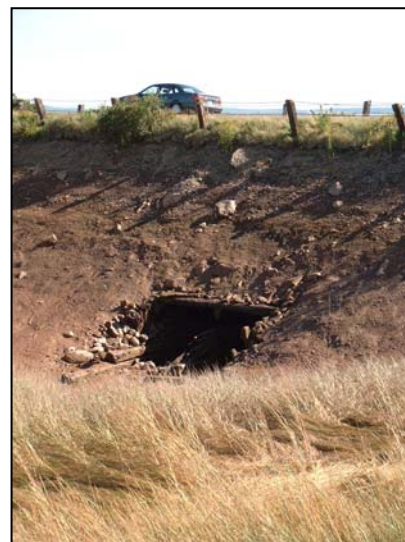
Figure 14. Upstream view of crossing at low tide

Site Description: Culvert is significantly undersized for the size of the system in which it is located. As well the crossing is of considerable age and is in very poor condition. Structure is damaged at both ends, and internally is partially blocked by debris. Crossing at one time may have been an aboiteau but no evidence remains of a tide gate. There is tidal influence and salt marsh habitat upstream, and river is of respectable size.

Comments: Crossing should be replaced by a larger structure in order to increase tidal flow and fish passage to upstream system. Replacement would result in improved tidal wetland conditions, fish passage and habitat conditions upstream.

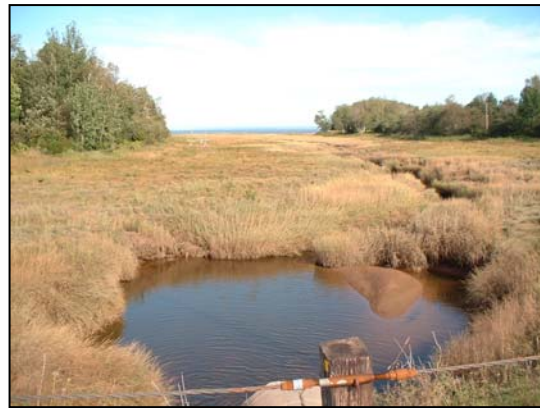
Comments: Tidal crossing is a two lane causeway-culvert structure that significantly restricts tidal flow and fish passage to the upper reaches of the Bass Creek Brook and Barkhouse Brook river systems. Current crossing is too small for the system in which it is located and its placement well above the base of the main channel substantially restricts tidal flow and fish passage. The culvert should be replaced by a larger crossing that is more appropriately sized for the system and with an invert placed flush with the river bottom. Such a crossing would considerably improve hydrology, fish passage and habitat conditions at the site.

Figure 16. Downstream of crossing at low tide

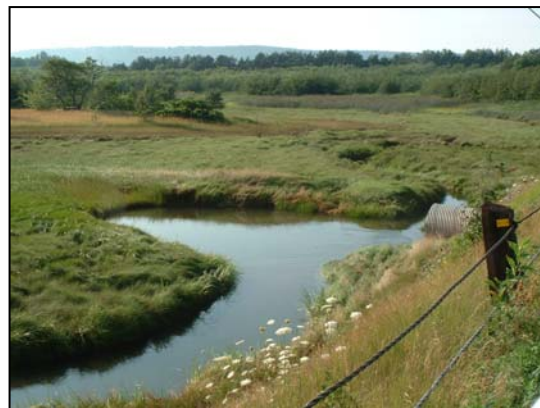
Figure 17. Upstream of crossing, large scour pool, stream branches off in two directions (low tide).

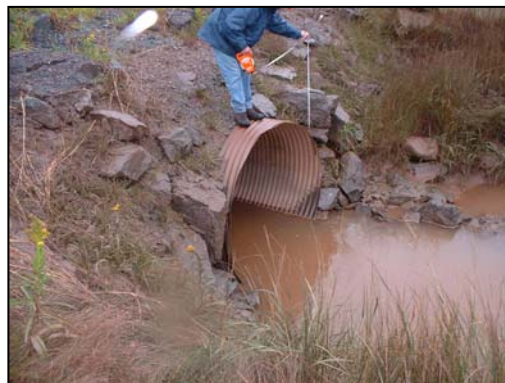
Figure 18. Culvert opening is smaller than stream width.

Comments: Replacement of the culvert with a larger opening would improve water flow through the system and better facilitate fish passage. Moderate improvement of upland wetland habitat is expected, but use of lands adjacent to the creek for agricultural grazing would need to be evaluated.

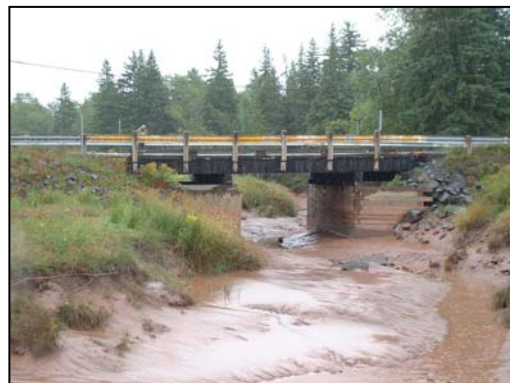
Comments: The bridge is in good condition, however, the presence of wooden cribwork and rock armouring beneath the bridge within the river channel is causing a pinching of the river. As well, the presence of an old rail crossing downstream, near the mouth of watercourse, may also be adversely affecting tidal flow to this system. Because of land use (agriculture) between the road crossing and the rail crossing, it was not possible at the time of assessment to also inspect the rail crossing to determine the degree of impact that structure is having on the tidal flow and fish passage.

Figure 19. New wooden support structures have been built half way down the banks of the creek. The pinching of the creek by the support structures can be seen by looking at the high water line. (Photo taken downstream of the bridge.)

The downstream rail crossing should be assessed for impact on tidal flow. The 13 m span of the bridge is adequately sized but the abutment structures below the bridge and well within the channel should be modified or removed to reduce restriction.

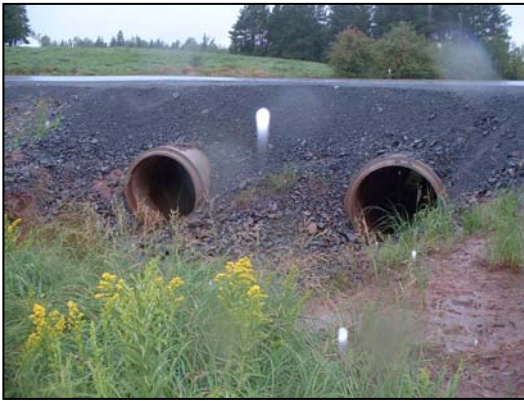
Figure 20. Downstream view showing culverts placed above the base of the channel. The background shows a definite elevation rise and a mix of agriculture and woodland upstream.

Comments: At the time of assessment, the site showed evidence of recent maintenance work, potentially the installation of the two culverts, excavation of the creek channel to match culvert placements, and the resurfacing of the roadside and slope. The wetland system downstream is dominated by tidal and freshwater wetland vegetation while the upland wetland system is mainly freshwater vegetation. Area upstream is small in size and unlikely to increase in area with the installation of a larger crossing. However, the installation of a single, large opening would improve hydrology at the site.

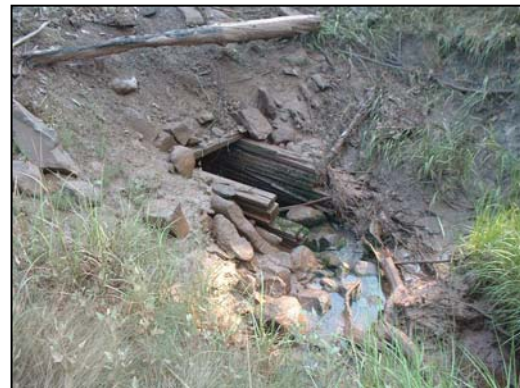
Figure 23. Upstream of crossing at low tide

Comments: The road is located very near the tidal extreme of this inlet. The culvert is in need of repair/replacement and although a larger opening would improve flow, the wetland area upstream is small and unlikely to expand due to a rapid rise in elevation. The culvert would represent a barrier to fish passage if the upland system was determined to be sufficient in size and structure to support a significant migratory fish population. An evaluation of the potential of this system to support such a population would be necessary in order to make such a determination.

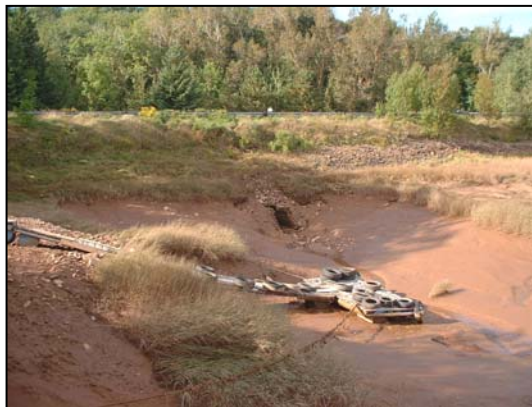
Figure 24. Downstream of crossing at low tide

Comments: The wooden culvert is definitely showing signs of aging but continues to function properly. The culvert is a tidal restriction but due to the placement of the roadway near the tidal extreme of the inlet, the impact is greatly reduced. There is little wetland restoration potential at this site as the small salt marsh above the crossing has no place to expand because of the rapid rise in elevation. Replacing the culvert with a larger structure would improve tidal flow and drainage, but is unlikely to result in significant improvement or expansion of upland wetland habitat. If migratory fish species are present in the downstream system, this crossing would be considered a barrier to fish passage.

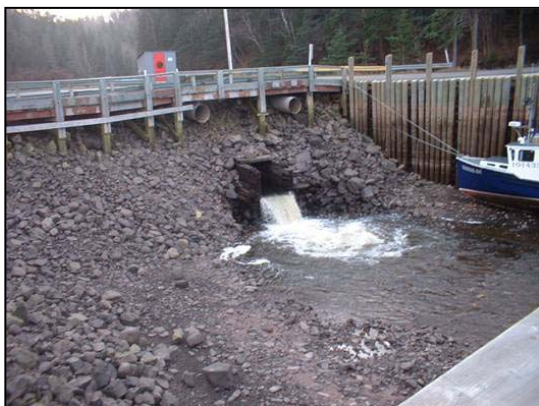
Comments: This crossing is near the mouth of Halls Harbour Brook, a moderate size river system. The tide gate was designed to control upstream water levels in order to use the outflow to dredge the downstream harbour. Further research into the functionality of the tide gate is needed. There does not appear to be any land use or crossings upstream that would be affected by installment of a larger opening. Fish passage should be examined at this site.

Figure 28. Downstream view of crossing showing outflow of freshwater into the harbour at low tide.

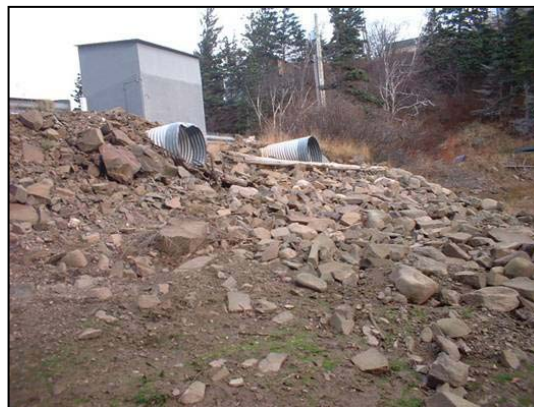
Figure 29. Upstream of crossing; two steel culverts placed high on the rock bank.

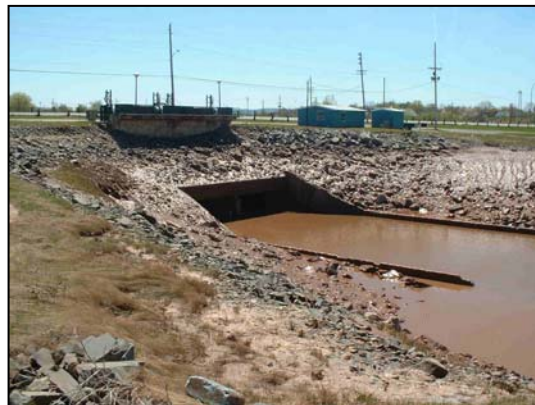
Comments: This rock filled dyke was constructed in 1969 to act both as a dam to prevent flooding of upstream agricultural lands and to provide a transportation link between Windsor and Falmouth as part of the Provincial Highway 101. A single opening with steel gates is located on the Falmouth end of the causeway and is manually operated to control water levels in the upstream head pond and river. The causeway protects 3240 acres of farmland from flooding as well the town of Windsor and local infrastructure that has developed around the head pond and river. The tide gates prevent salt water from entering the upstream system and fish passage is extremely limited. The Avon River upstream of the causeway has lost all tidal functions as a result of the causeway, and a large mudflat has developed on the downstream side. In recent years this mudflat has developed and stabilized to the point that a large salt marsh community, *S. alterniflora* dominated, has developed.

Figure 30. Downstream end of tide gate at low tide.

If it is not possible at this time to remove all or part of the causeway and restore tidal function to the upstream system, any new construction that takes place as part of the highway expansion project should be designed and undertaken in such a manner as to ensure that opportunities to restore tidal flow to the Avon River in the future are not reduced. Regardless of future mitigation/removal/expansion activities involving the causeway, fish passage through the existing structure needs to be addressed immediately.
