Site AC10B: Moose River (West)

Date Assessed: 26/08/04

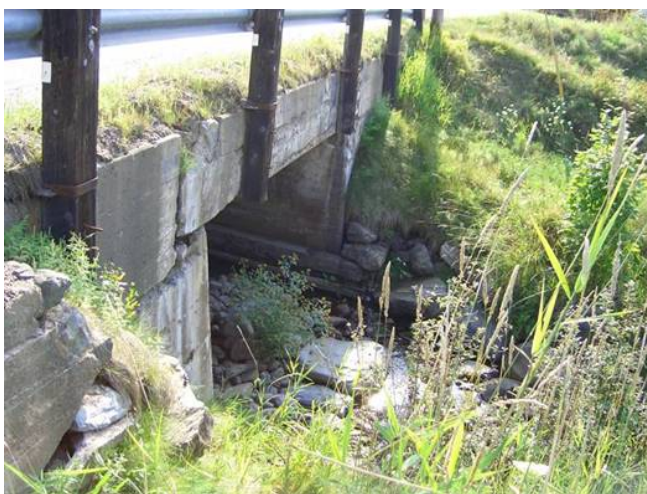
Figure 1. Downstream view of crossing

Road Crossing: Bridge (concrete), 5.7m opening

Crossing Condition: Intact but showing wear

Comments: There is little restriction to tidal flow or fish passage by this crossing.

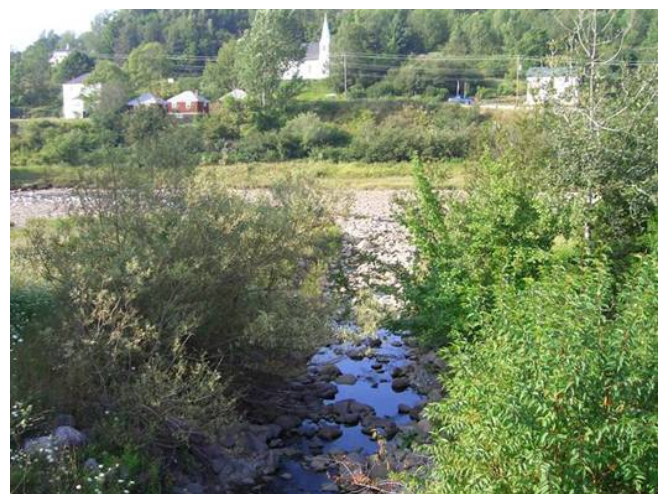
Figure 2. Downstream of crossing

Creek: 5m wide tributary of Moose River, straight flow, turbulent, rocky bottom

Land: Moose River system, edge marsh and wooded

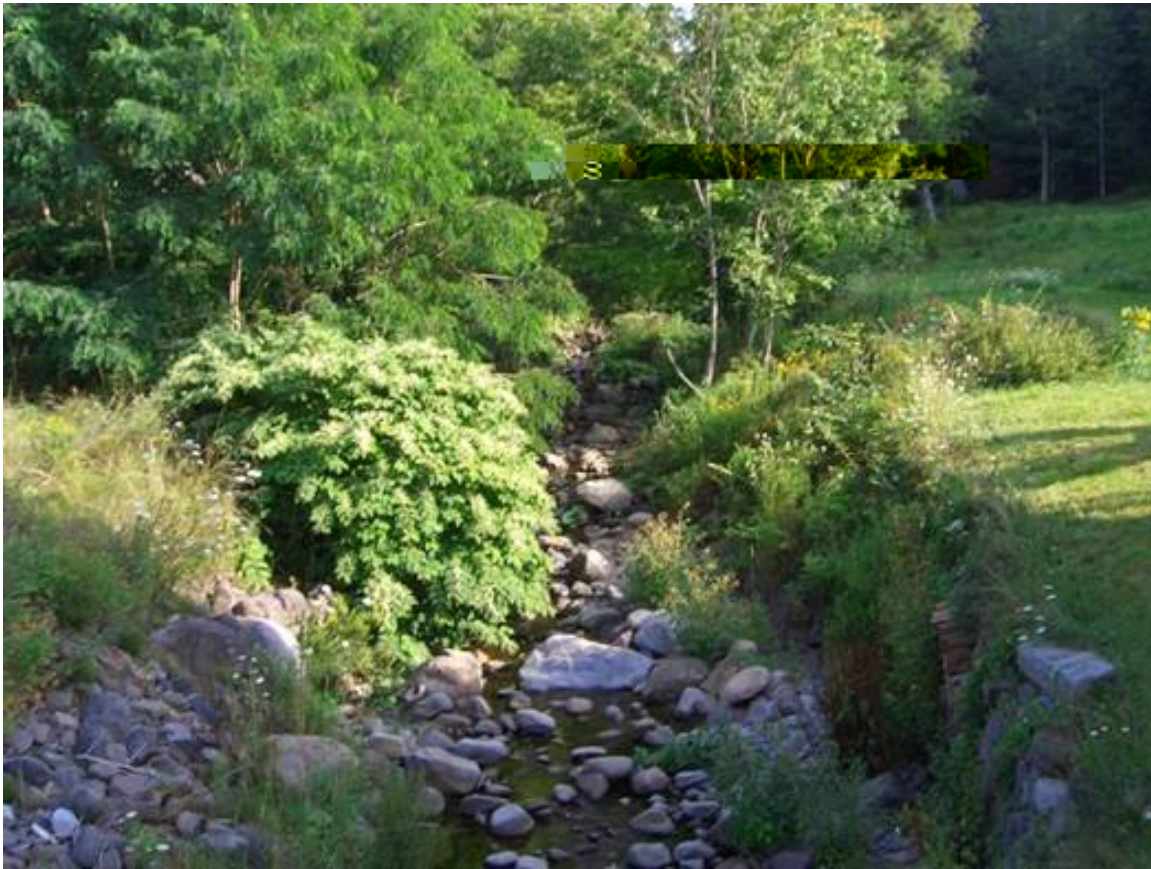
Figure 3. Upstream of crossing

Creek: 4m wide, straight flow, turbulent, rocky bottom.

Land: Wooded and residential. Creek is bordered by residential yard.
