Site AC3C: Croscup Brook

Date Assessed: 30/11/04

Crossing Status: Partial restriction

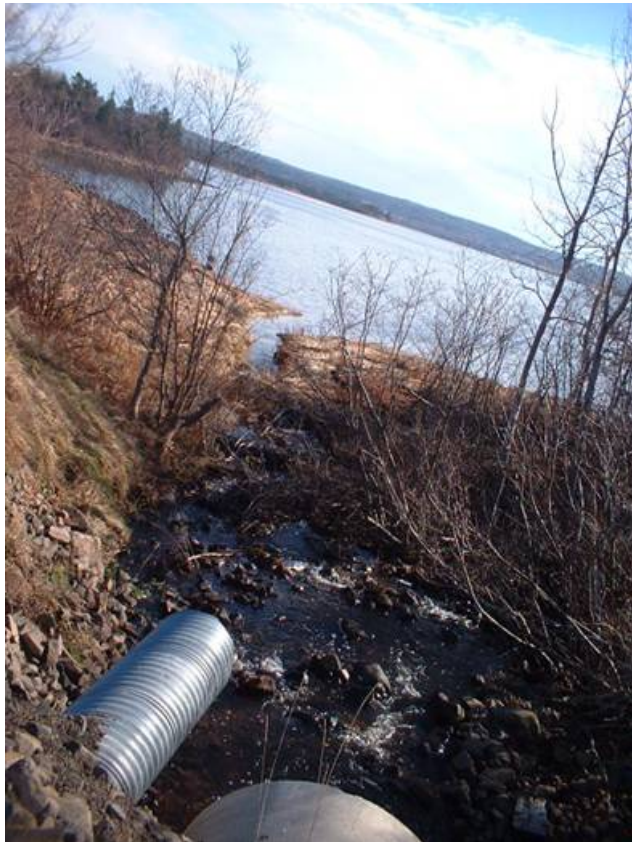
Figure 2: Downstream of crossing

Creek: 3m wide, bank slumping and
turbulent flow.

Land: Beach with some marsh
vegetation.

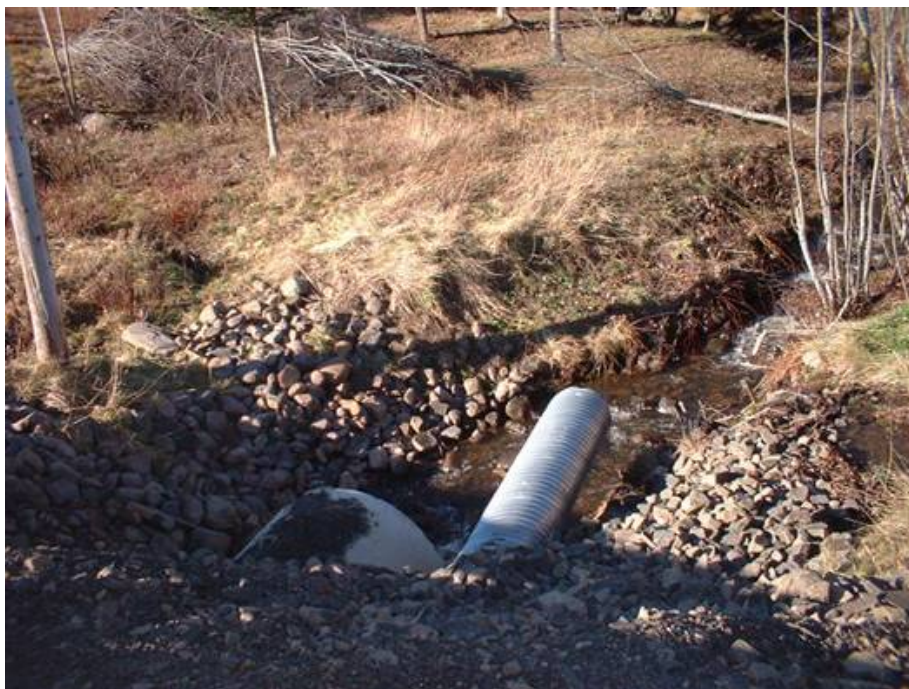
Figure 3. Upstream of crossing

Creek: 1.5m wide, turbulent flow, bank slumping, trees falling in creek.

Land: Residential and wooded.
