Site CBNS1A: Chiganois River

Date Assessed: 17/06/02

Crossing Status: Complete Restriction

Road Crossing: Aboiteau, 3 tide gates, 2m wide.

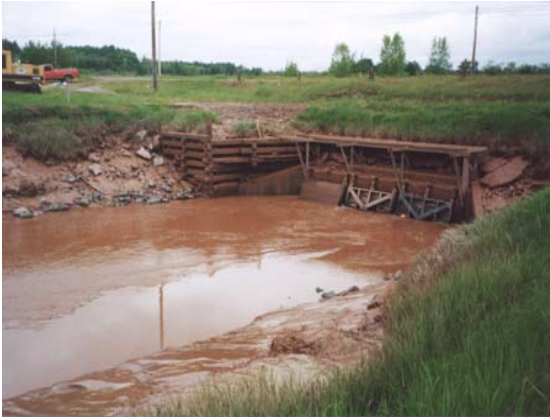
Figure 1. Downstream view of aboiteau system with three tide gates.

Crossing Condition: Intact

Creek: 24m wide, turbulent flow and swirling water, with a scour pool forming

Comments: Land use should be assessed to determine if one or more of the tide gates could be opened to allow for limited tidal flow and marsh restoration. Since this area is currently being used for agricultural purposes this may or may not be plausible at this time. However fish passage should be addressed.
