Site CBNS2B: Debert River

Date Assessed: 19/07/02

Crossing Status: No Restriction

Road Crossing: Bridge, concrete, 27m wide

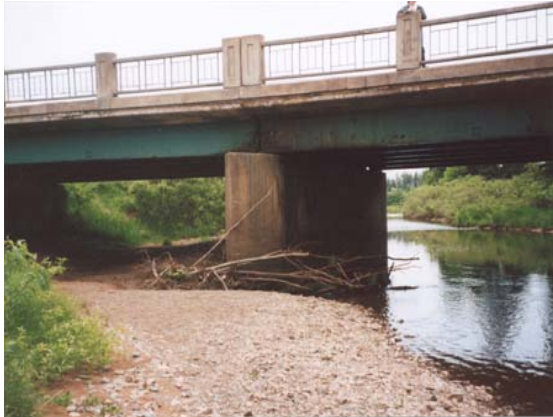
Figure 1. Upstream view of debris built up at site.

Comments: Maintain size of bridge opening. There are dyking along sides of river and a dirt road on one side cutting off an area of land that should be salt marsh. There are also three old unused culverts near bridge covered by grasses and one filled in with cement. Sediment deposits (sand and gravel) are filling in the stream on one side of the bridge supports. Consideration should be made to whether dredging of this material would benefit tidal flow.

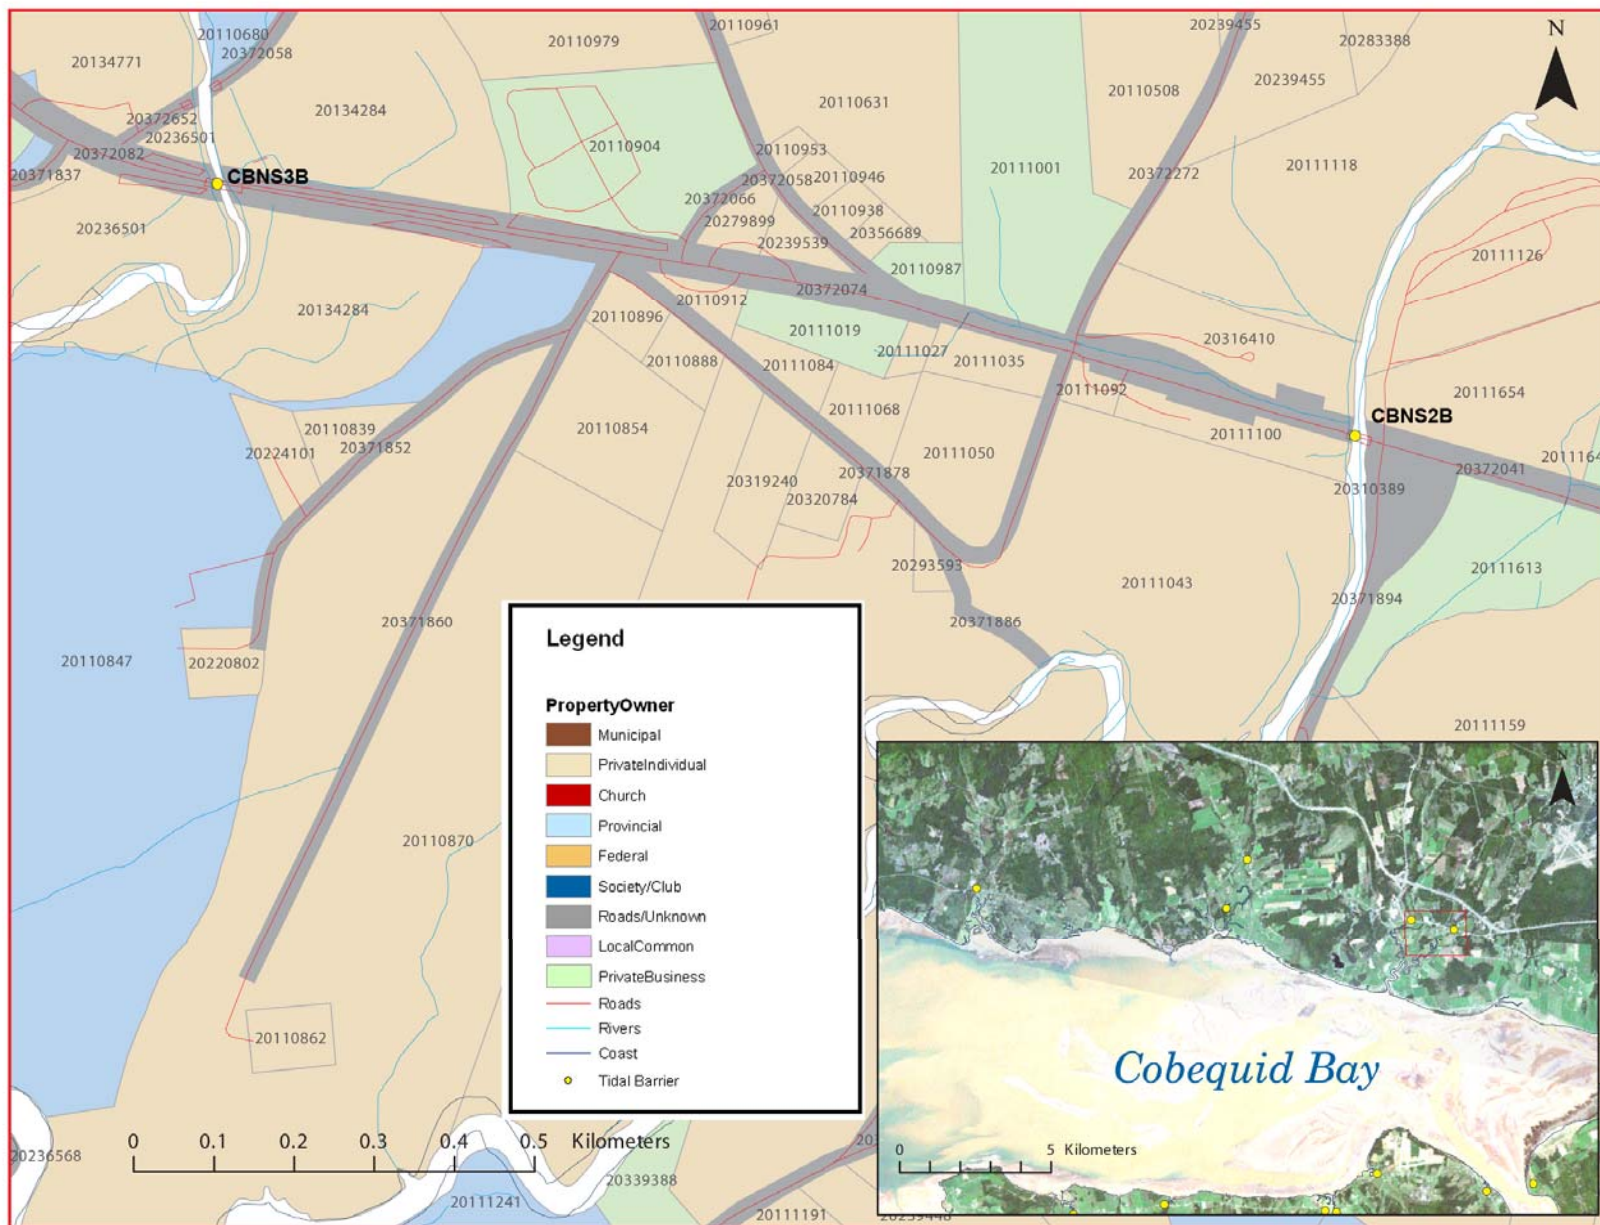
Figure 5: Property management and tidal barrier data for Nova Scotia (Service Nova Scotia, and Municipal Relations)
