Site **CBNS5A**: Great Village River

Date Assessed: 25/06/02

Road Crossing: Aboiteau, 2 tide gates, cement, 4.5m openings

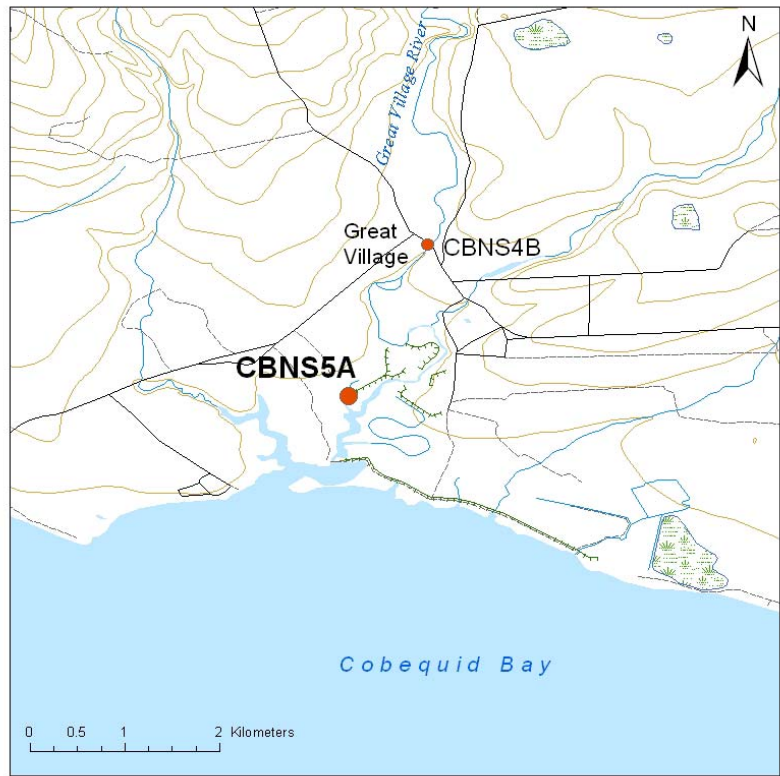
Crossing Status: Complete Restriction

Crossing Condition: Intact and part of a maintain dyke

- Difference in stream width
- Divergent channel
- Difference in water level
- Tide gate/aboiteaux
- Bank slumping

Comments: Since this aboiteau is protective agricultural land removal of the tide gates may not be possible. Further assessment as to ability of fish to pass through crossing should be considered. While it may be possible for fish to pass, it is extremely limiting.

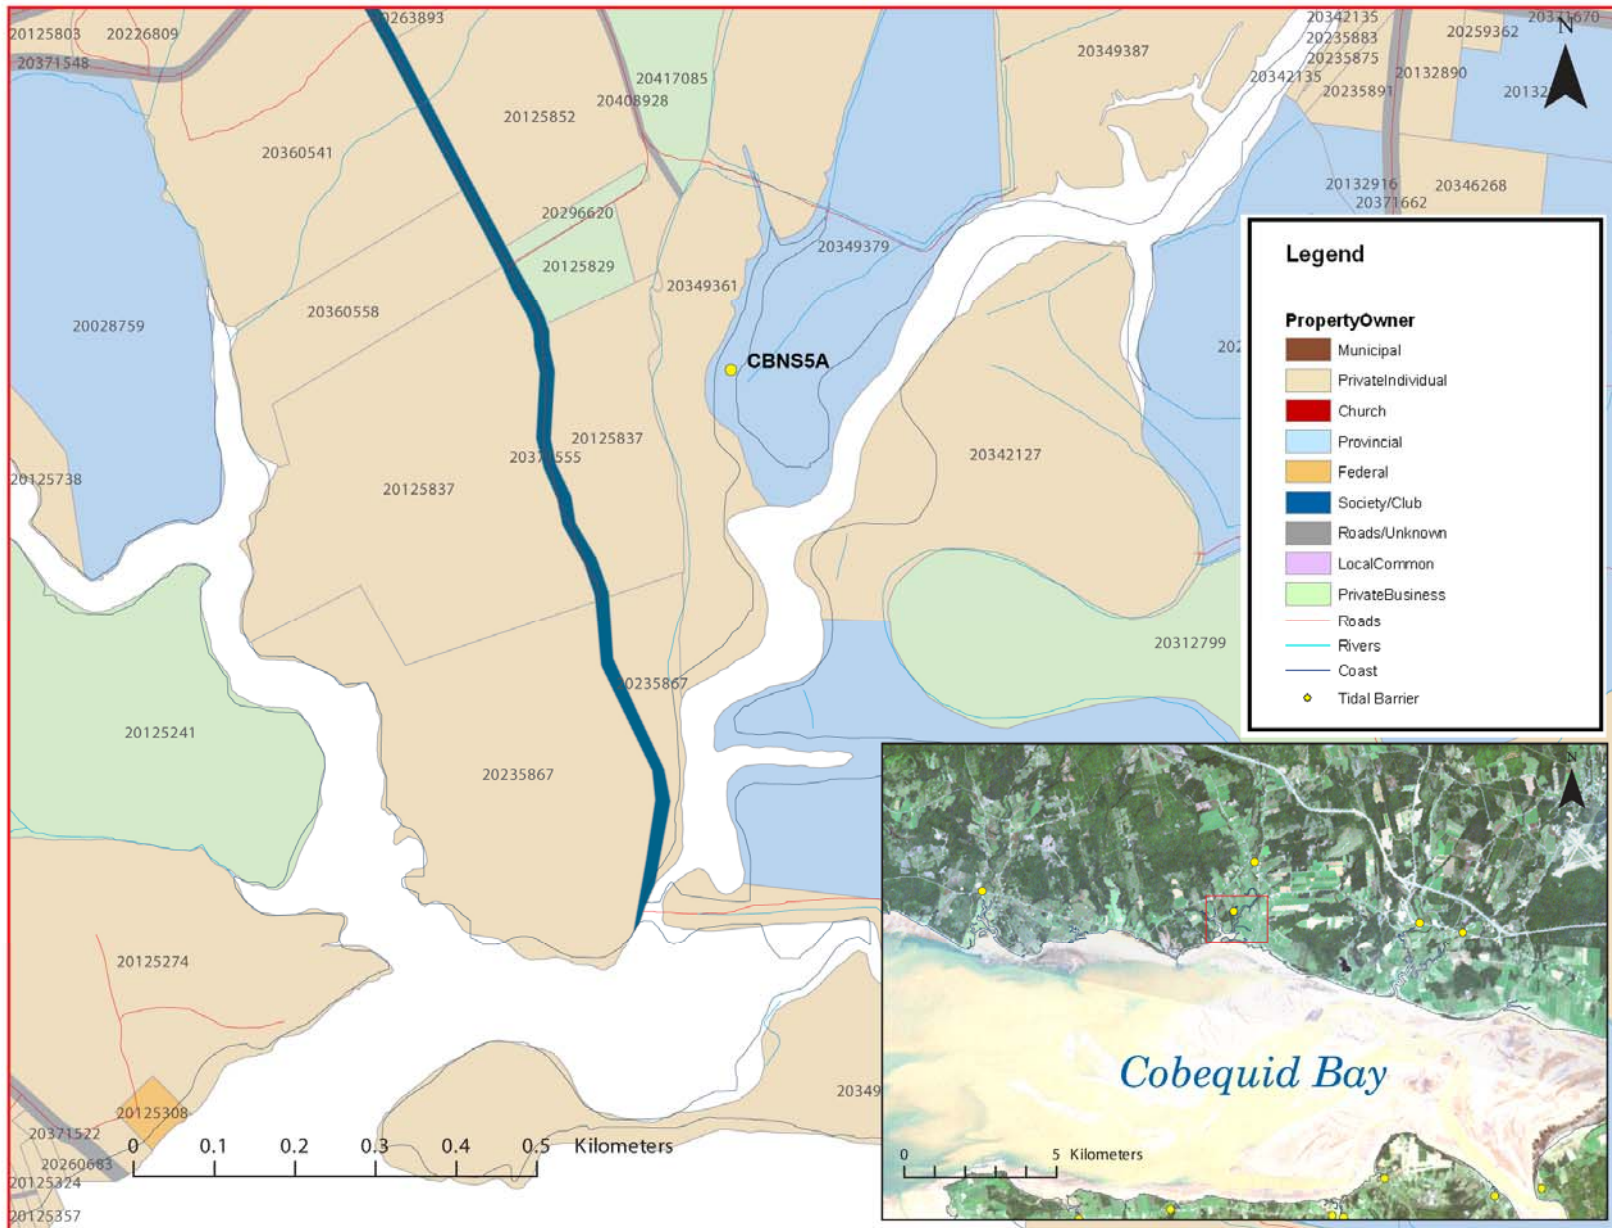
Figure 2: Property management and tidal barrier data for Nova Scotia (Service Nova Scotia, and Municipal Relations)
