Site **CBNS8B**: Bass River

Date Assessed: 25/06/02

Road Crossing: Bridge, wooden, 26.1m wide

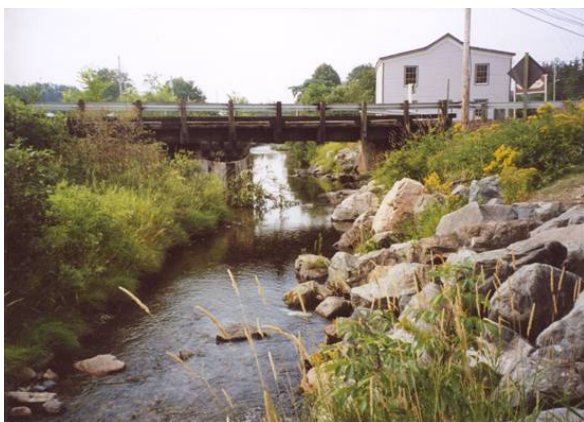
Figure 1.

Crossing Condition: Intact with some debris around base of bridge and railings are falling down

Comments: Repair bridge and maintain size of opening
