Site CBSS11C: Cobequid Trail

Date Assessed: 07/02/02

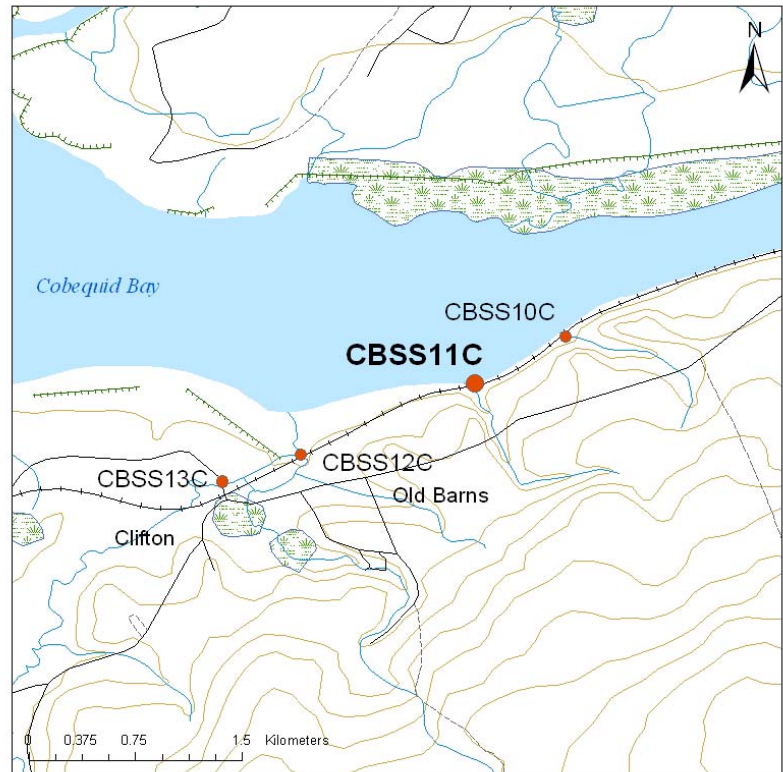
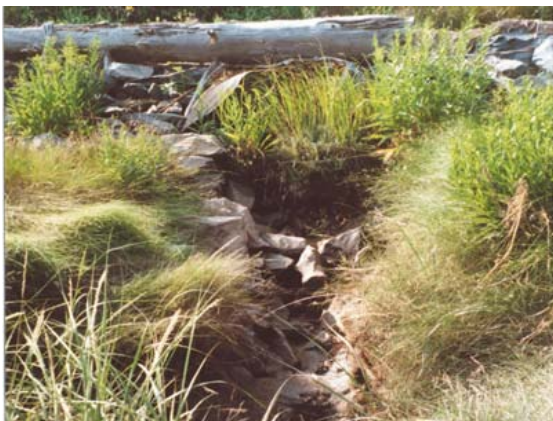
Figure 1.

Crossing Status: Partial Restriction.

Road Crossing: Culvert, corrugated steel,
~1.35m wide

Crossing Condition: Structure is intact.

Difference in water level
Bank slumping
Scour pools
Divergent channel
Slack water

Comments: Replace with larger opening
