Site CBSS14C: Black Rock**Date Assessed:** 07/02/02

Crossing Status: Complete restriction.

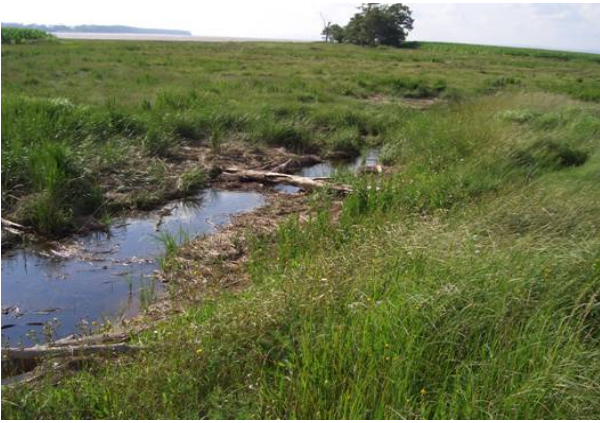
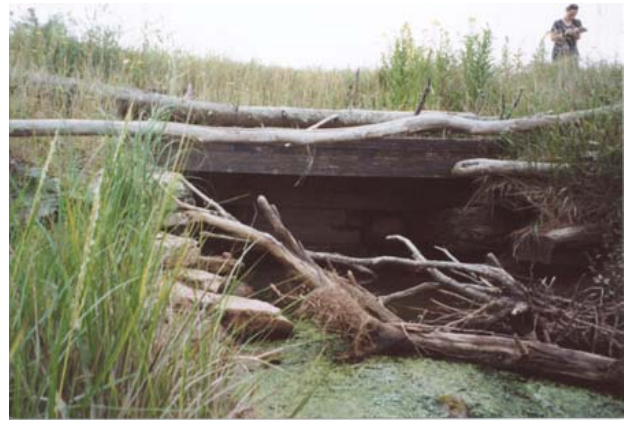
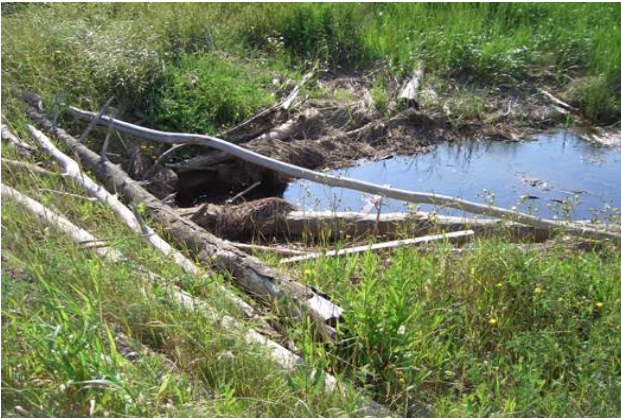
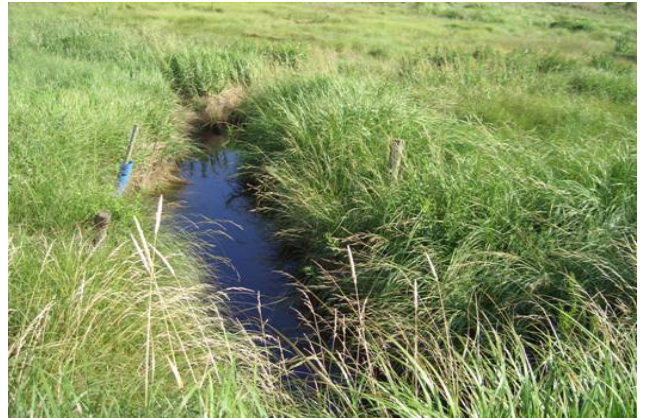
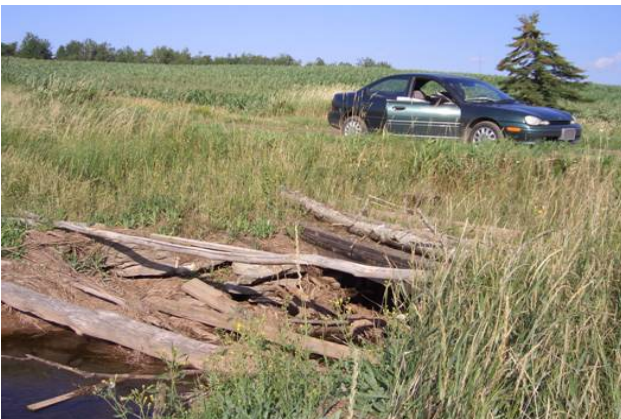
Road Crossing: Partial wooden Aboiteau. Old type of aboiteau (i.e. No tide gates, just blockage). Has partial blocking on downstream side restricting saltwater flow to upstream side.

Crossing Condition: Structure is in poor condition.

Restriction Indicators:
Difference in stream width
Slack water

Creek: 2.8m wide with smooth, straight flow.

Creek: ~1.8m wide with smooth, straight flow.

Comments: Aboiteau should be replaced with a culvert to allow tidal flow.
