Site CBSS1C: McLure Brook (Cobequid Trail)

Date Assessed: 06/27/02

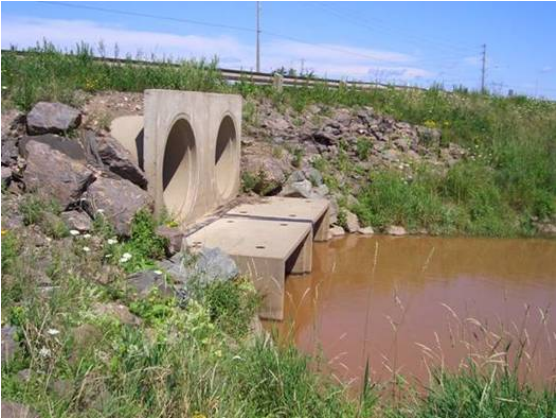
Figure 1.

Road Crossing: Two 4m square culverts on the bottom, with two 3.2m circle culverts on top.

Crossing Condition: Structure is intact.
Road banking to prevent erosion.

Restriction Indicators:
Difference in stream width
Bank slumping
Scour pool

Comments: Culverts could be replaced with a single large opening. Should downstream aboiteau be opened, crossing size would need to be reassessed.
