**Site CBSS2A:** McLure Brook (Cobequid Trail)

**Date Assessed:** 06/27/02

**Road Crossing:** Aboiteau, cement, 3 tide gates, 1.6m each

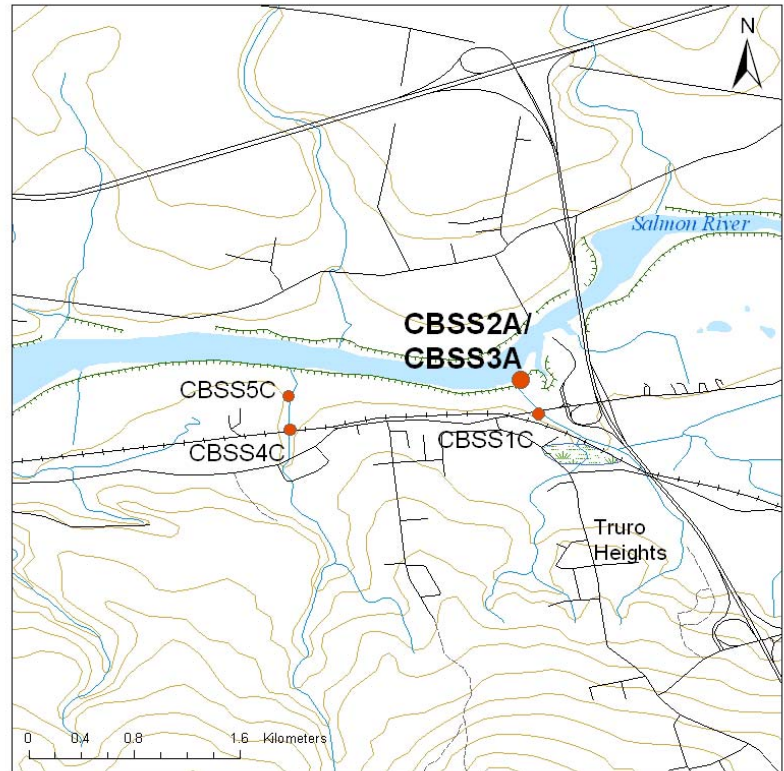
**Crossing Status:** Complete Restriction.

**Crossing Condition:** Structure is intact.

Difference in stream width  
Difference in water level  
Bank slumping  
Scour pool  
Slack water  
Tide gate/aboteau

**Comments:** This aboteau is located along side site CBSS3A and should be considered together with site CBSS1C located just upstream. Assessment of land use should be made at this site to determine if tide gates can be opened and to what degree would flooding occur. If it is not possible to open the tide gates, fish passages should still be addressed.
