Site CBSS3A: McLure Brook (Cobequid Trail)

Date Assessed: 06/27/02

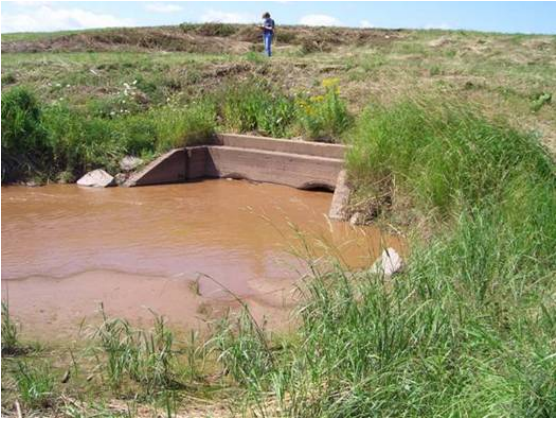
Figure 1.

Road Crossing: Aboiteau, cement, two round openings 1.6m each

Crossing Condition: Structure is intact. Some mud filling in on downstream end.

Comments: This aboiteau is located along side site CBSS2A and should be considered together with site CBSS1C located just upstream. Assessment of land use should be made at this site to determine if tide gates can be opened and to what degree would flooding occur. If it is not possible to open the tide gates, fish passages should still be addressed.
