Site CBSS6C: Lower Truro

Date Assessed: 06/28/02

Crossing Status: Partial Restriction.

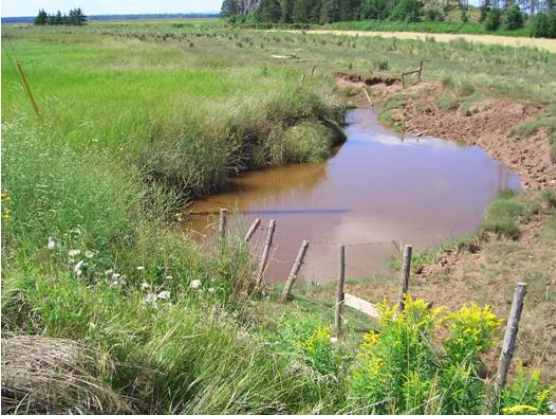
Figure 1.

Road Crossing: Culvert, cement, ~1.2m wide

Crossing Condition: Structure is intact.

Difference in stream width
Difference in water level
Bank slumping
Scour pool
Slack water

Comments: This site is used as a cow watering area, which may be causing narrowing of stream and restricting water flow. Site CBSS7C is a partial restriction upstream that should be considered in part with this site. Culvert should be replaced with a larger opening to allow for more water flow. Area could be left unused by livestock to prevent erosion by cows if possible.
