Site CBSS8C: McNutt Brook (Cobequid Trail)

Date Assessed: 07/17/02

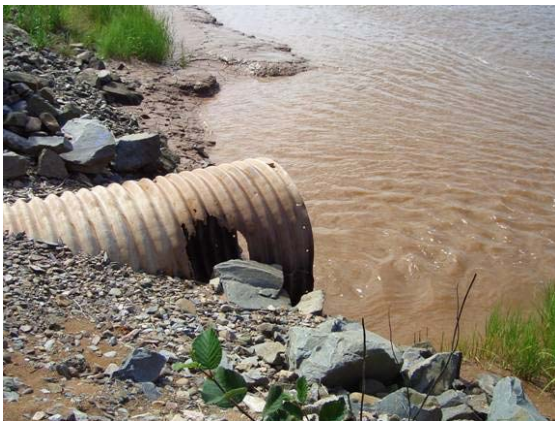
Figure 1.

Road Crossing: Culvert, corrugated, ~2m wide

Crossing Condition: Structure is intact. Rock banking around culvert to prevent erosion.

Restriction Indicators:
Difference in water level
Difference in stream width
Bank slumping

Comments: Culvert is rusting out needs to be replaced

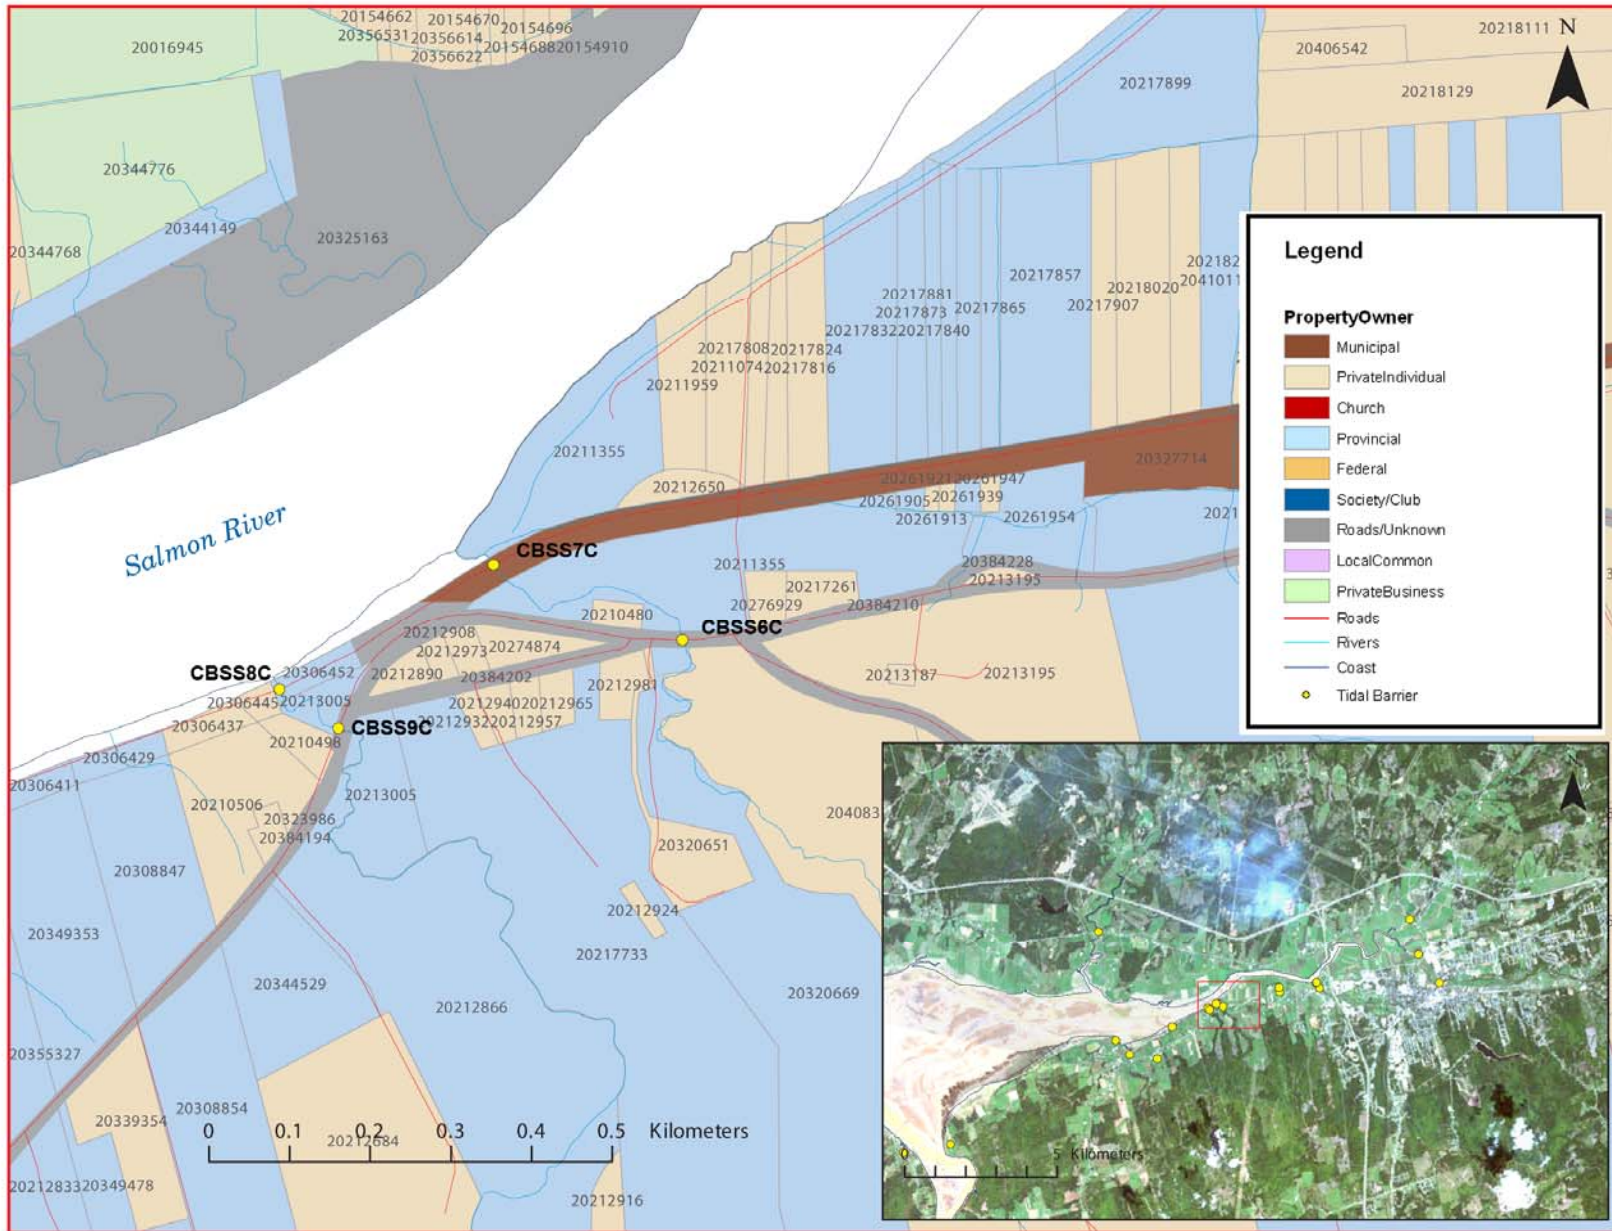
Figure 3: Property management and tidal barrier data for Nova Scotia (Service Nova Scotia, and Municipal Relations)
